November 17, 2025

**Subject: Leachate Spill Report
Chiquita Canyon Landfill
File No. 67-020**

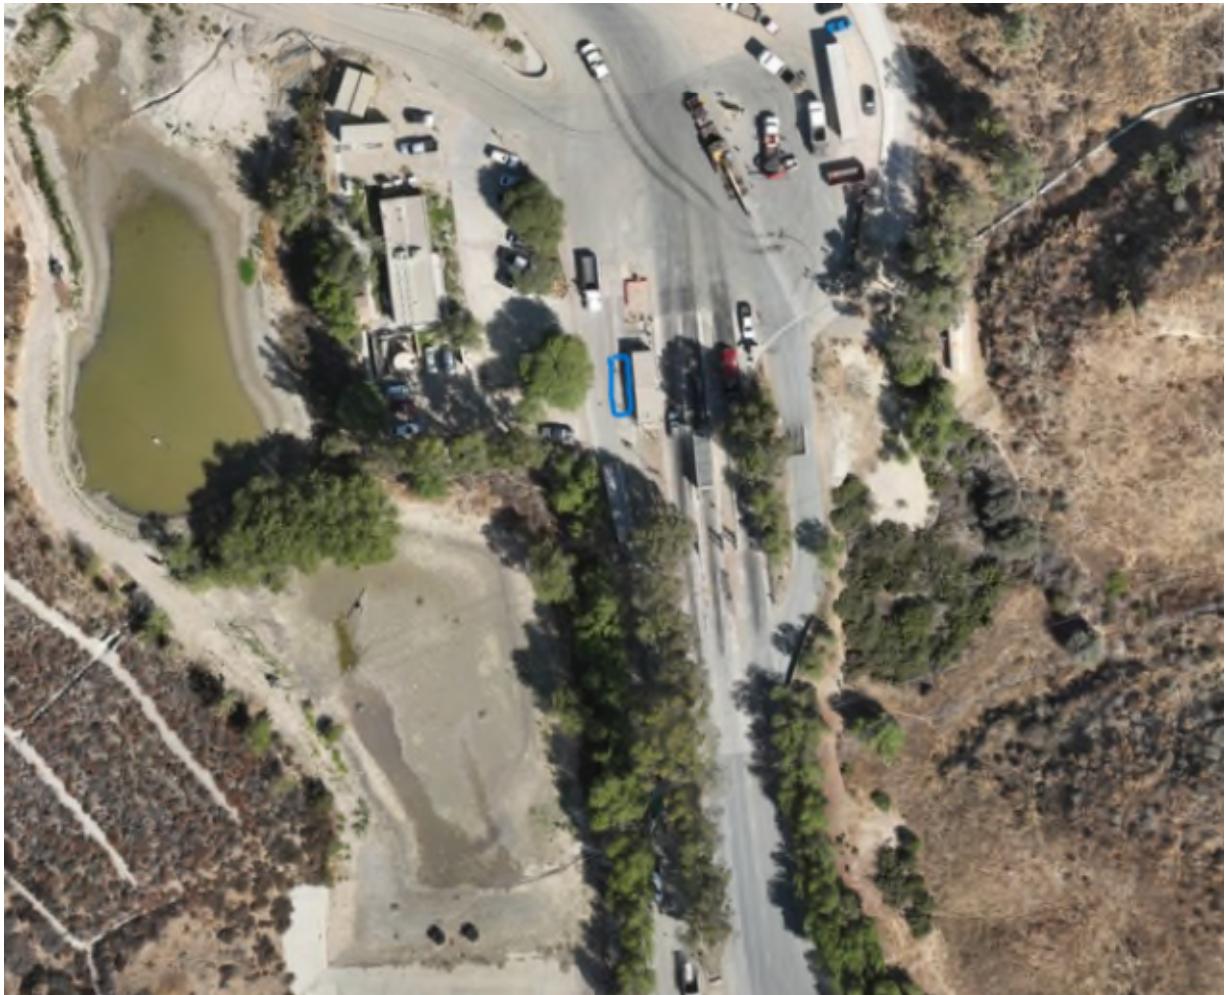
Attachments: Attachment A – Map depicting the location of the spill

The spill occurred at outbound scale near the scale house – as depicted in Attachment A.
