**CHIQUITA CANYON**  
*A Waste Connections Company*

**Re: Chiquita Canyon, LLC's Weekly Report on the Documentation and Tracking of Cover Issues**

# 4050 - Chiquita Reaction Area Tracking of Fissures and Tension Cracks

# 4050 - Geosynthetic Cover Inspection

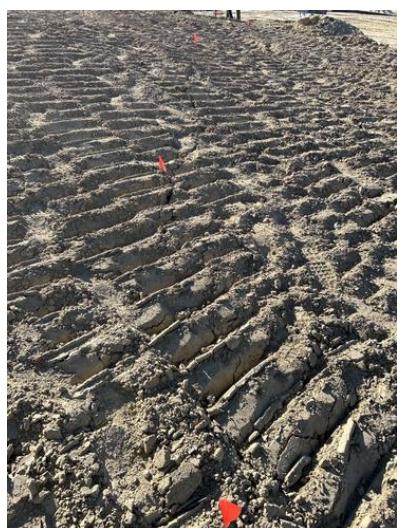
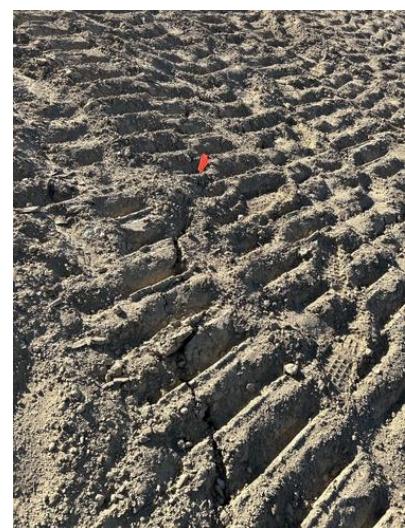
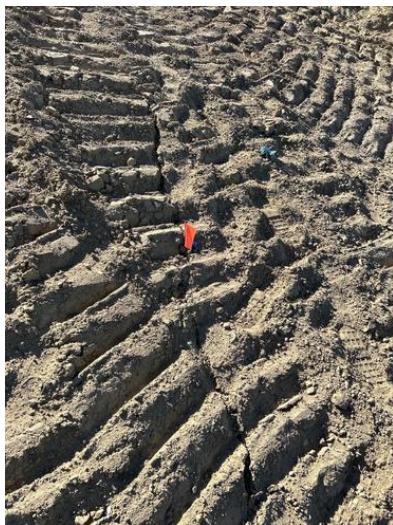
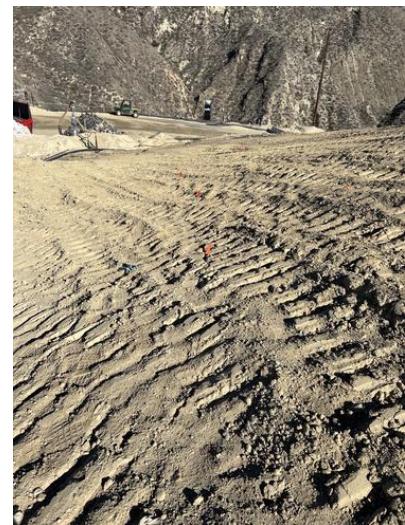
**Grid Location**

146

40ft x 15ft

Small 0.5-2" in width

Extra small <0.5" in height

N to S

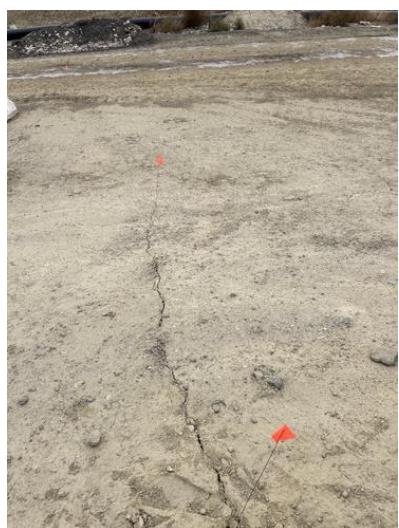
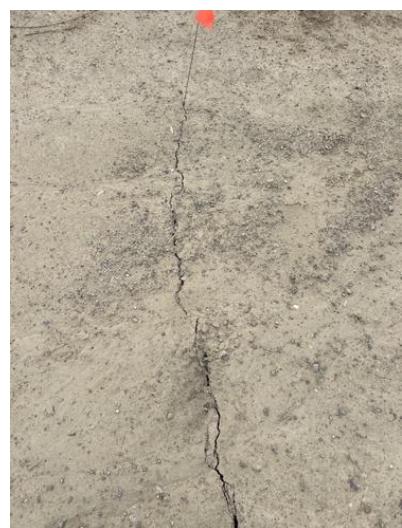
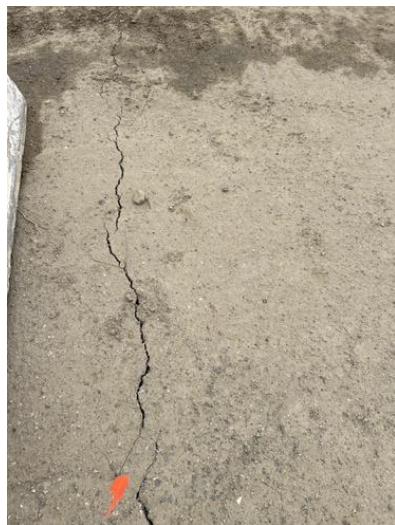
**Grid Location**

146

8ft x 25ft

Small 0.5-2" in width

Extra small <0.5" in height

NW to SE

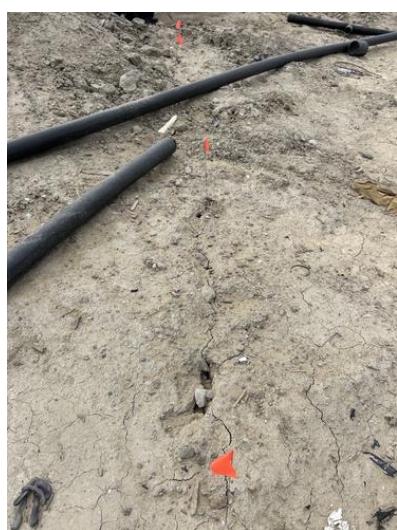
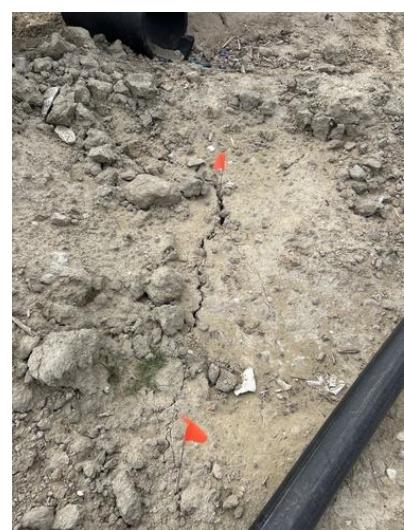
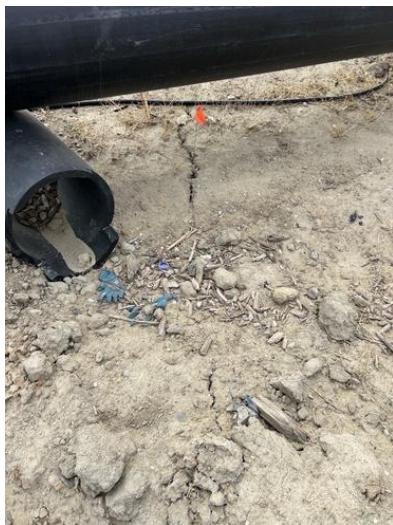
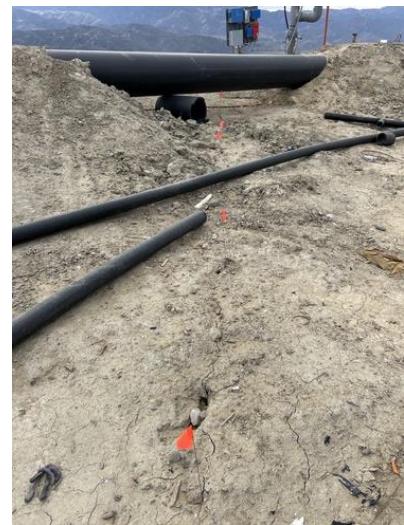
## Grid Location

89

25ftx4ft area

Small 0.5-2" in width

Extra small <0.5" in height

NE to SW

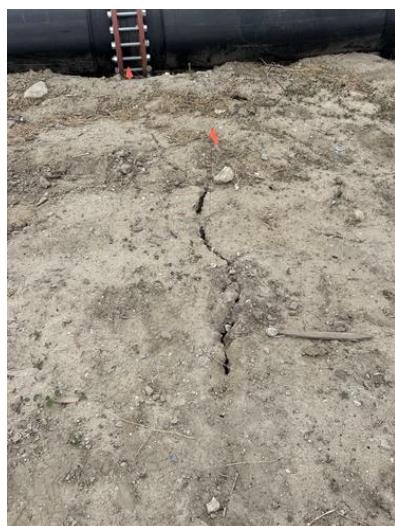
Photo 6

**Grid Location**

90

9ft

Small 0.5-2" in width

Extra small <0.5" in height

N to S

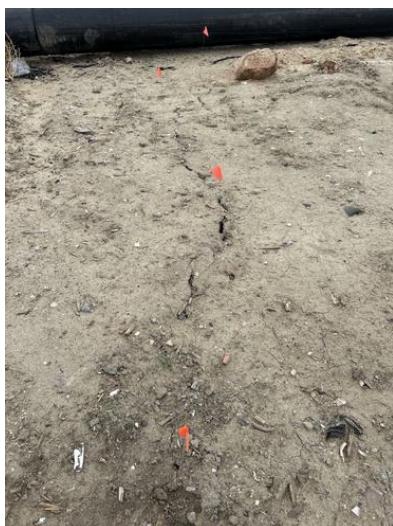
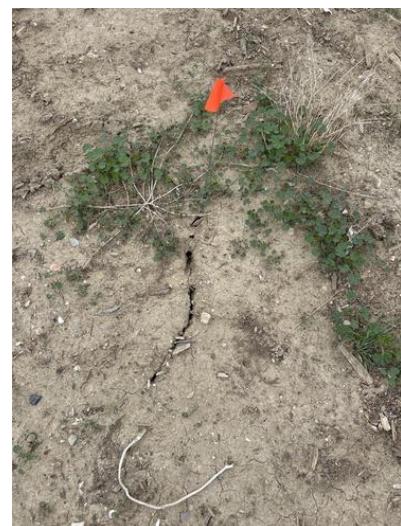
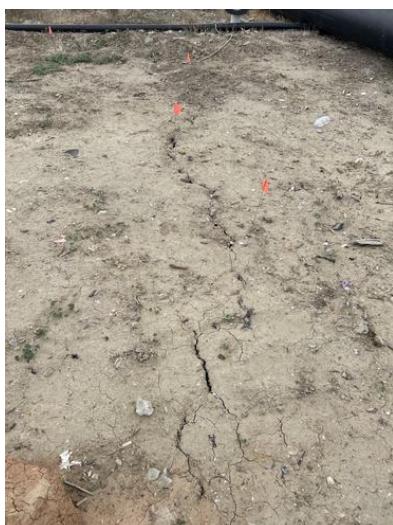
**Grid Location**

90

17ftx6ft area

Small 0.5-2" in width

Extra small <0.5" in height

E to W
