Re: Chiquita Canyon, LLC's Weekly Report on the Documentation and Tracking of Cover Issues

4050 - Chiquita Reaction Area Tracking of Fissures and Tension Cracks

4050 - Geosynthetic Cover Inspection

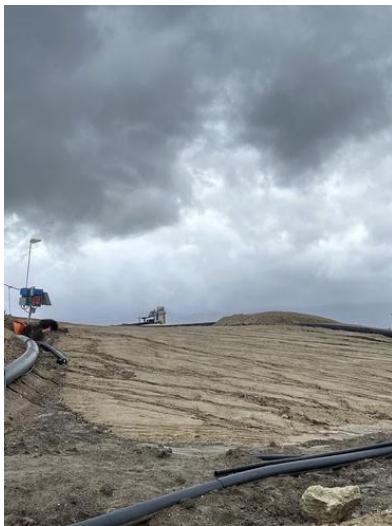
Photo 1

Fissure or Tension Crack Found?

No

Grid 147

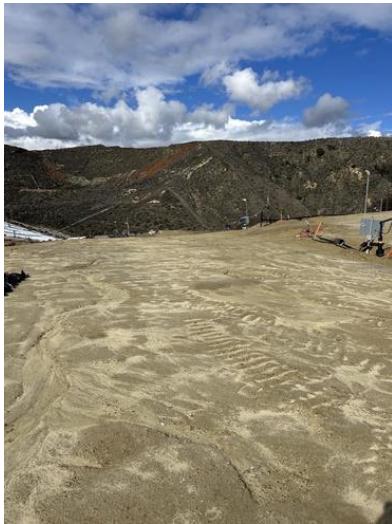
Photo 1

Fissure or Tension Crack Found?

No

Grid 147

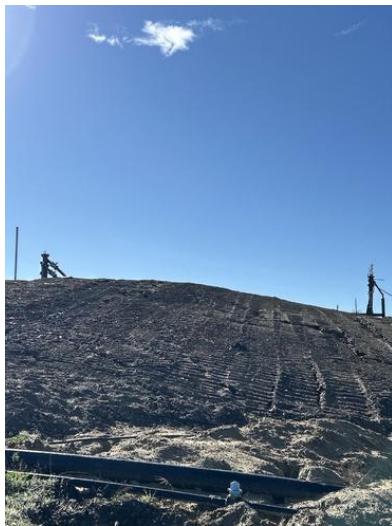
Photo 1

Fissure or Tension Crack Found?

No

Grid 146

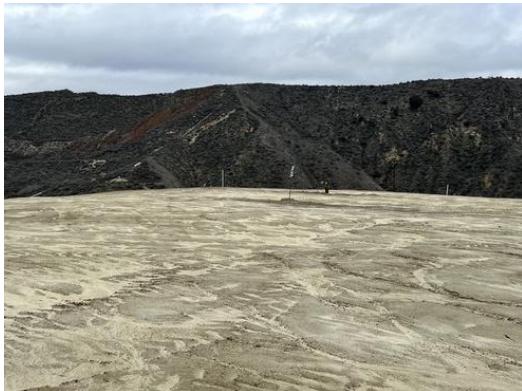
Photo 1

Fissure or Tension Crack Found?

No

Grid 147

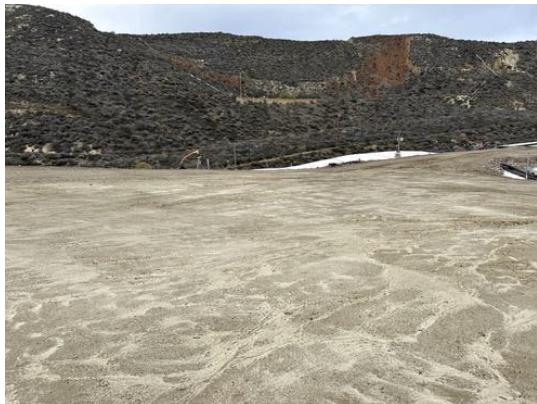
Photo 1

Fissure or Tension Crack Found?

No

Grid 147

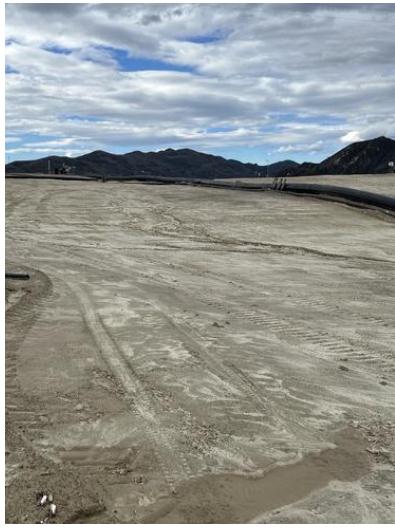
Photo 1

Fissure or Tension Crack Found?

No

Grid 148

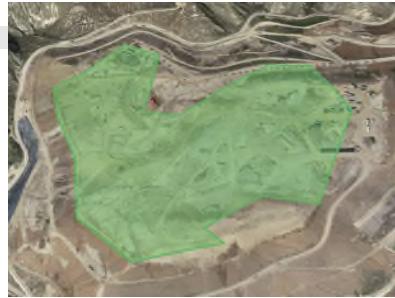
Location 1

- The charts on the following page show the settlement in cubic yards measured at a fixed location.
 - Chiquita restaked the survey benchmarks between July 31, 2025 and August 13, 2025 to maintain accuracy. After performing additional surveys, Chiquita has confirmed that the restaking caused the data to show an inflated amount of settlement, which does not accurately convey the true rate of settlement.

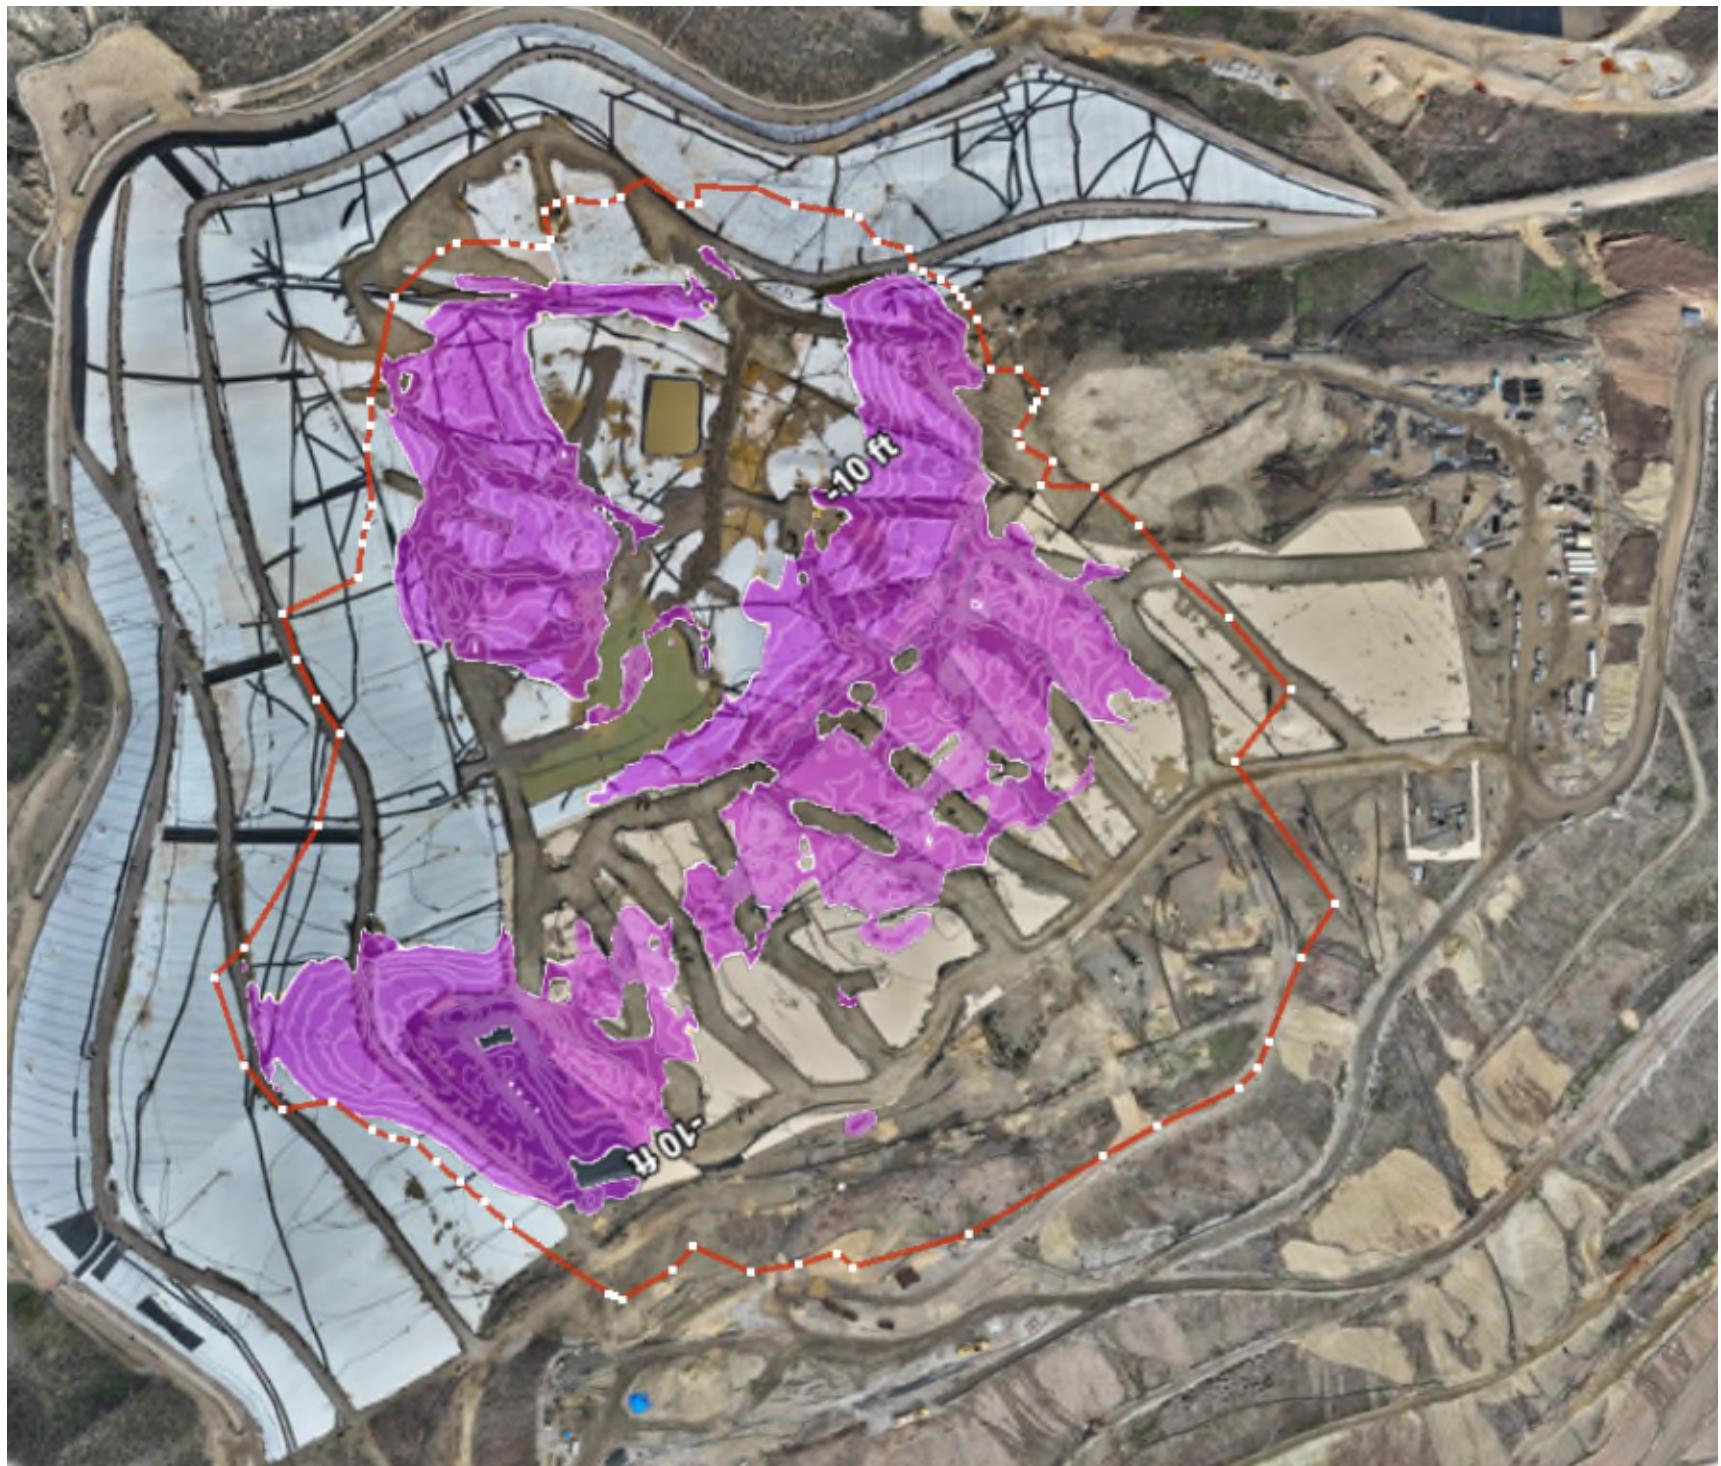
- The map shows the area between 11/20/2024 and 11/19/2025 where the grades have changed more than 10 feet. A typical MSW strain rate is 3% per year - for a landfill with a 300-foot waste column, this would be 9 feet per year.

- Note that at the time of the most recent flyover, on November 19, 2025, landfill gas piping was temporarily offline in certain areas to perform tie in work as part of the EVOH/HDPE geomembrane cover deployment work. Taking the piping offline caused a small amount of landfill gas to temporarily accumulate under the geomembrane cover. As a result, the image gives the impression of more settlement than what actually occurred. The piping has since been reinstalled and is back online, and the landfill gas bubbles are no longer present.

- During normal site operations before site closure, large stockpiles of rock materials were maintained, and sometimes moved as other operations necessitated. The areas used for these material stockpiles were south and east of the lined area. There is not a way to differentiate between settlement and stockpile movements.

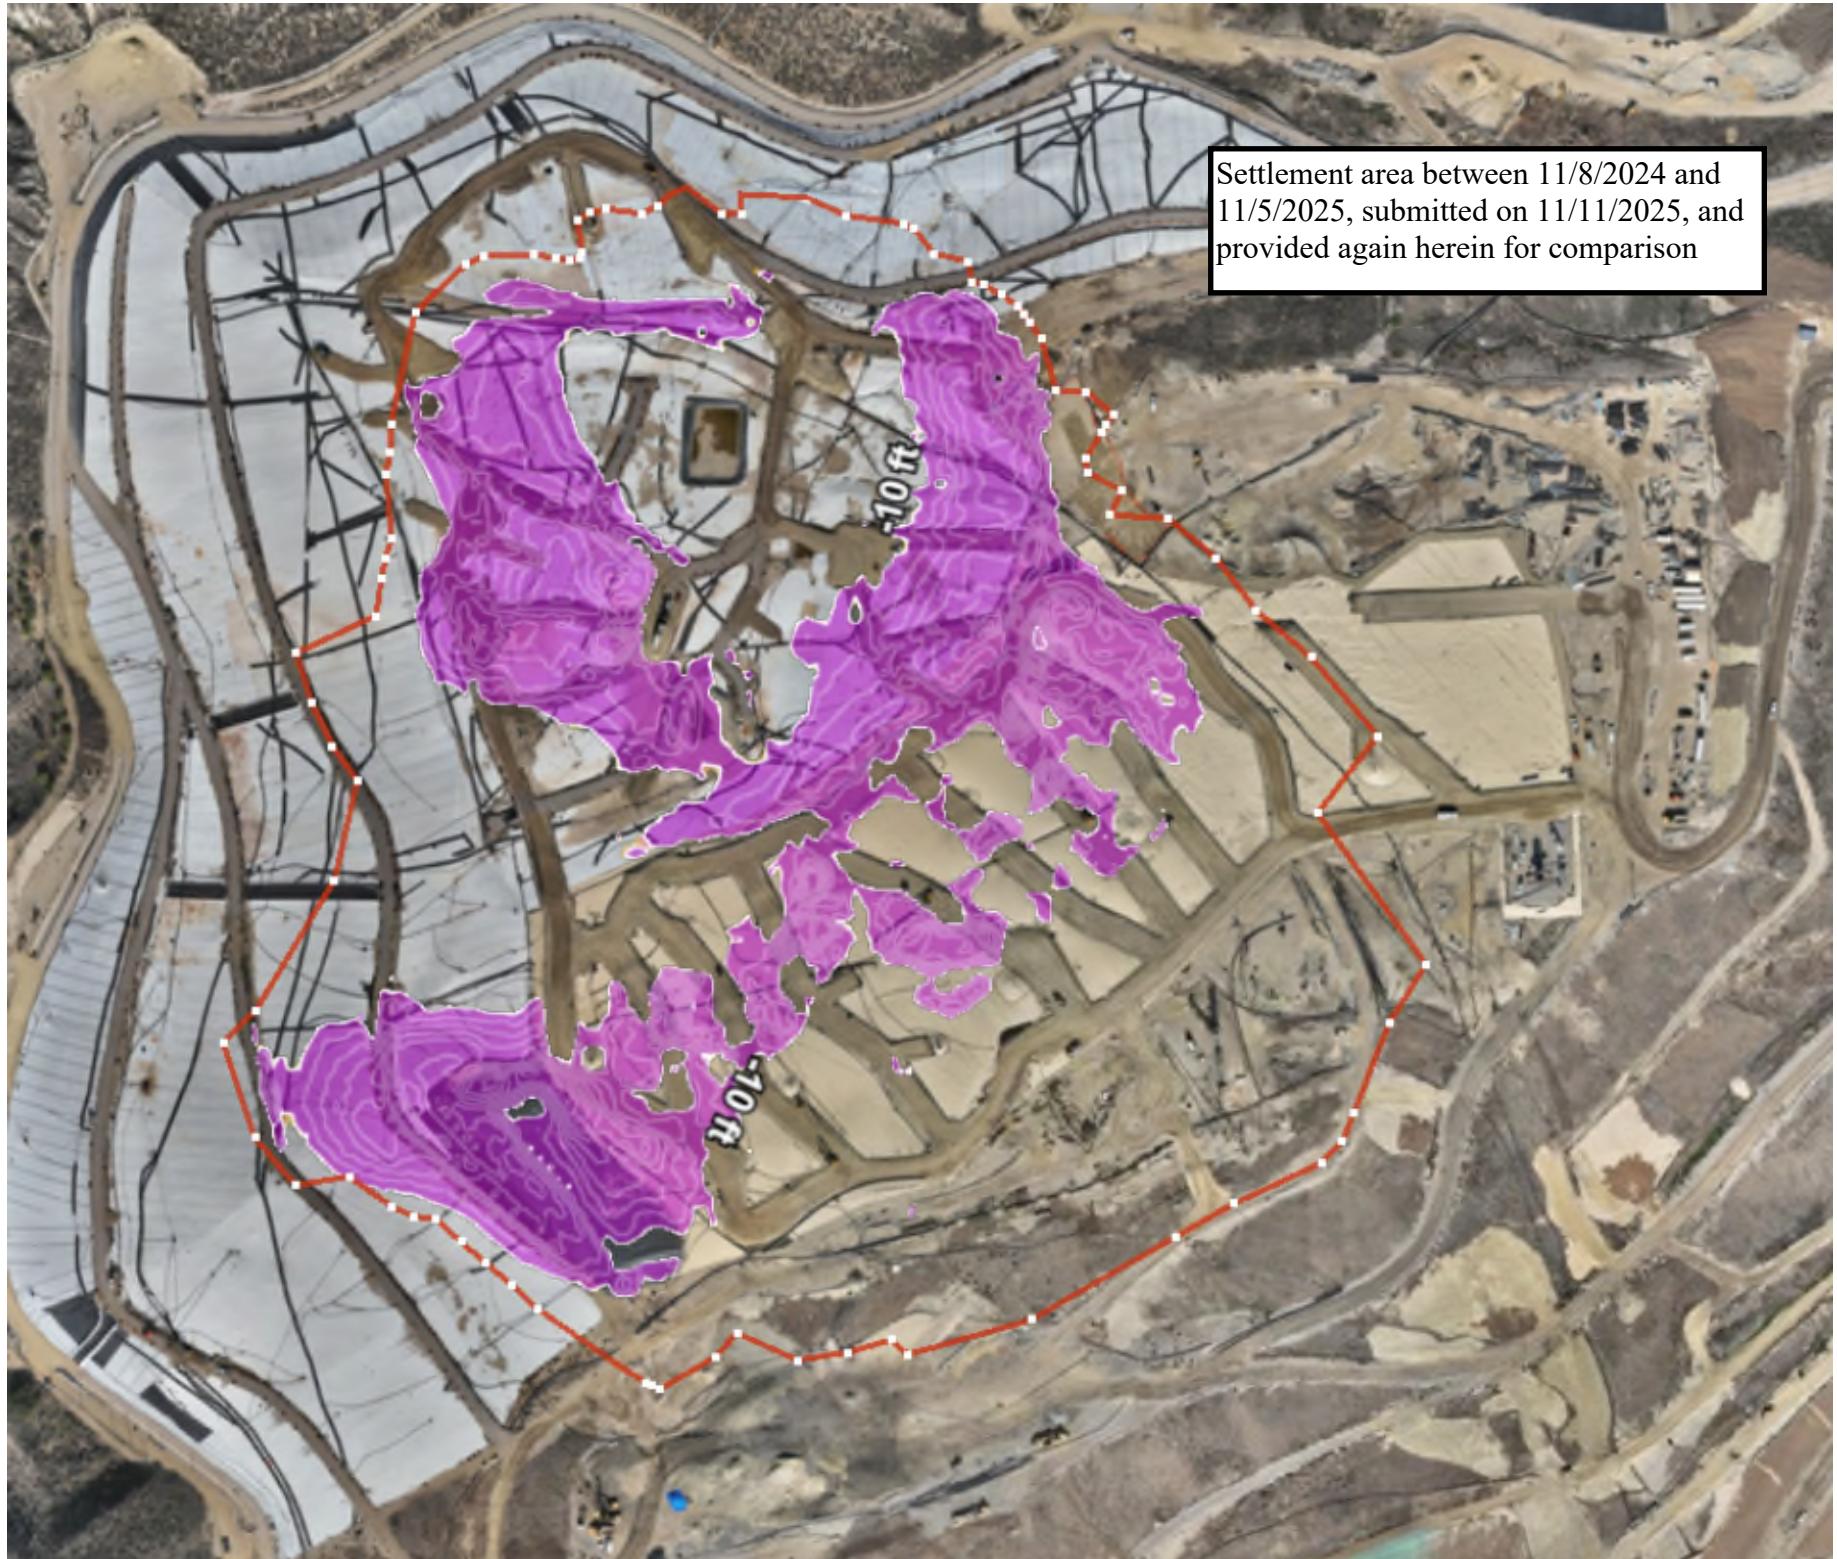
Settlement area between 11/8/2024 and 11/5/2025, submitted on 11/11/2025, and provided again herein for comparison
