CHIQUITA CANYON
A Waste Connections Company

Re: Chiquita Canyon, LLC's Weekly Report on the Documentation and Tracking of Cover Issues

4050 - Chiquita Reaction Area Tracking of Fissures and Tension Cracks

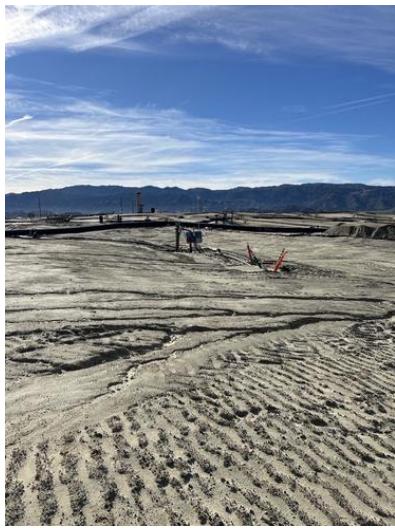
Photo 1

Fissure or Tension Crack Found?

No

Grid 147

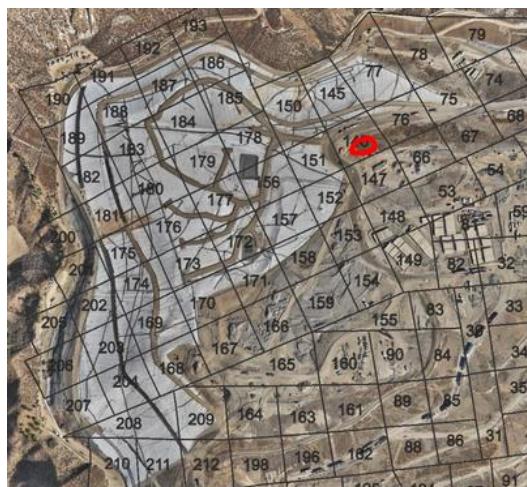
Using the attached image, annotate all areas where inspectors identified a fissure or tension crack.

146

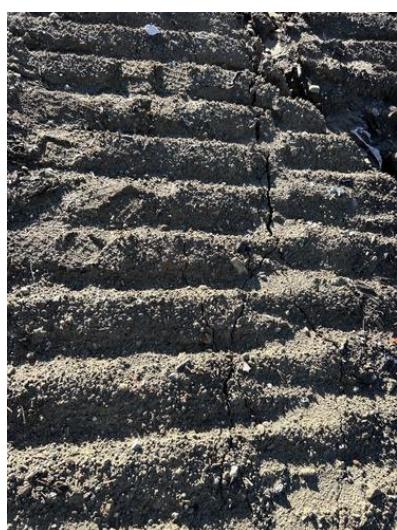
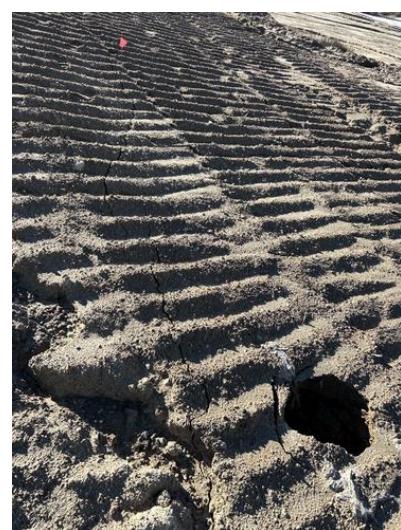
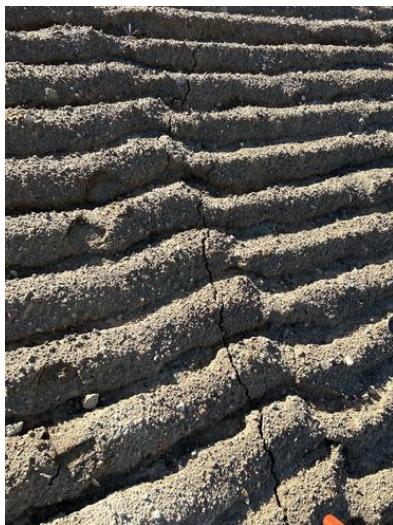
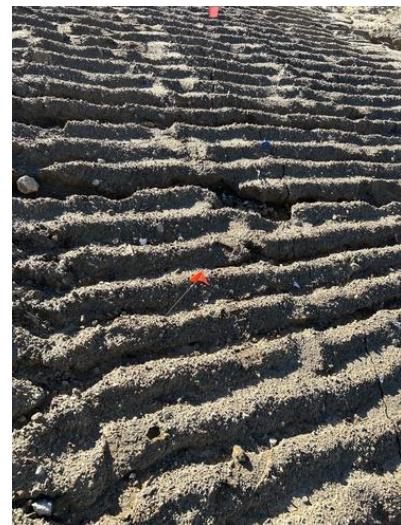
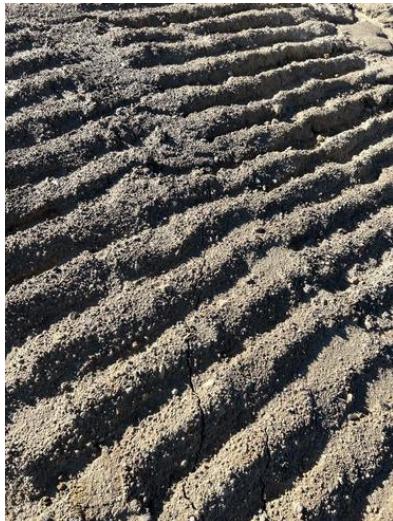
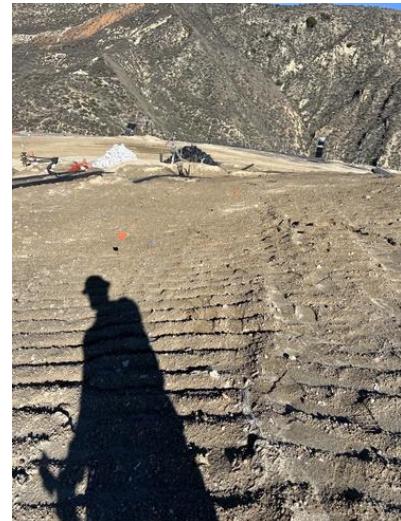
Yes

45ft x 15ft

Large >4" in width

Extra small <0.5" in height

N to S

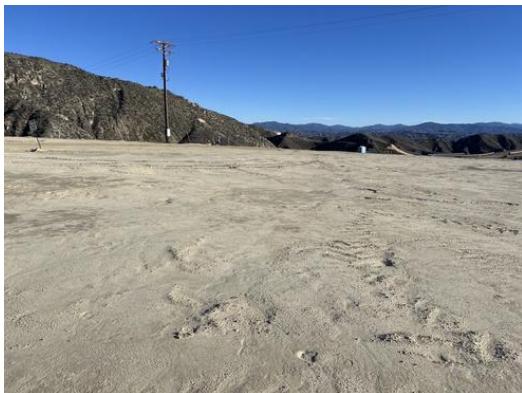
Photo 1

Fissure or Tension Crack Found?

No

Grid 147

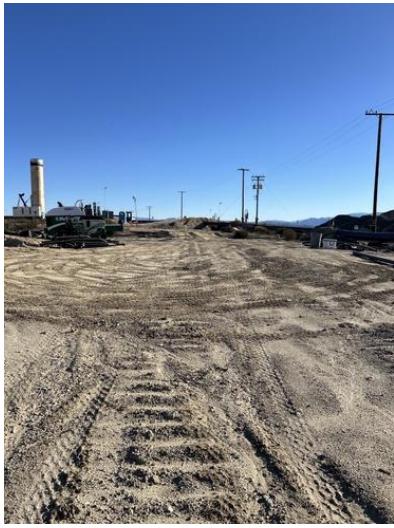
Photo 1

Fissure or Tension Crack Found?

No

Grid 160

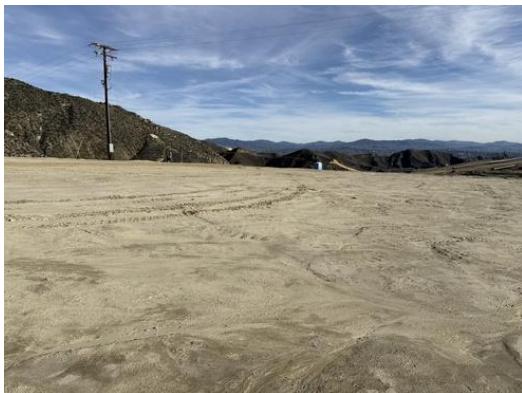
Photo 1

Fissure or Tension Crack Found?

No

Grid 147

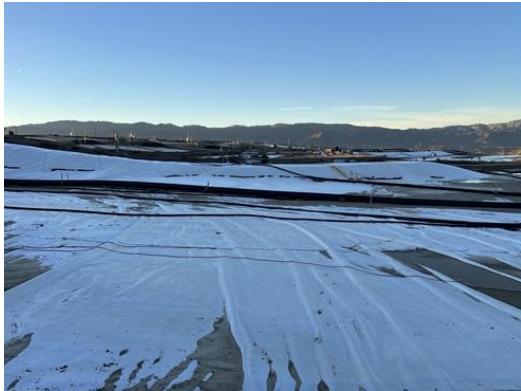
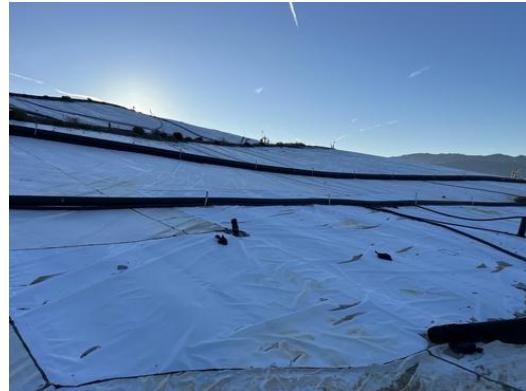
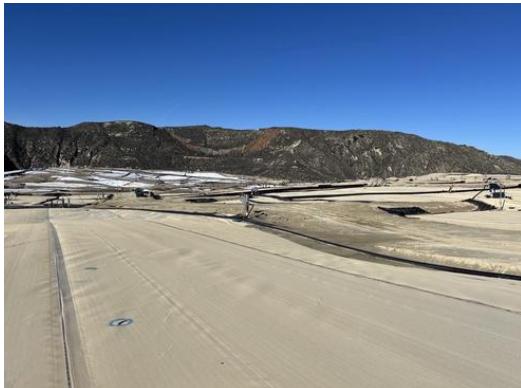
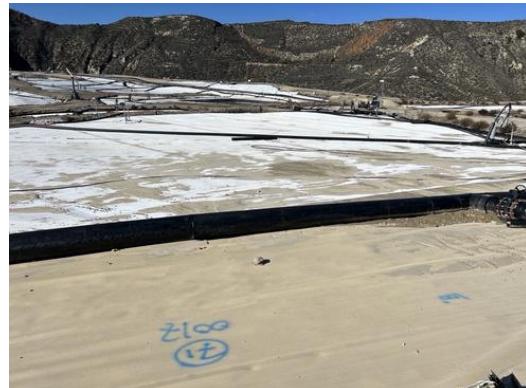
Are there any issues with the geosynthetic cover?

No

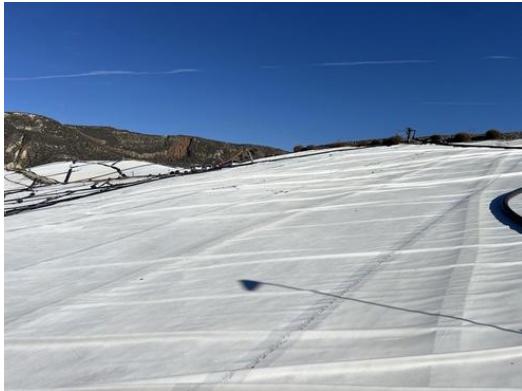
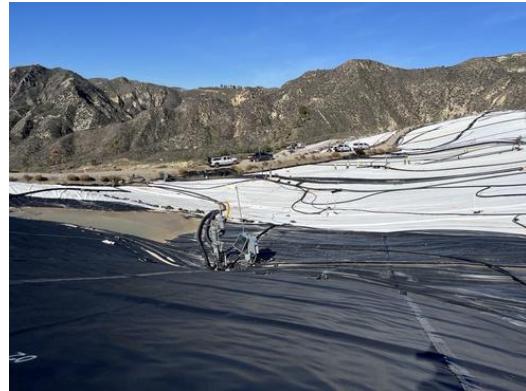
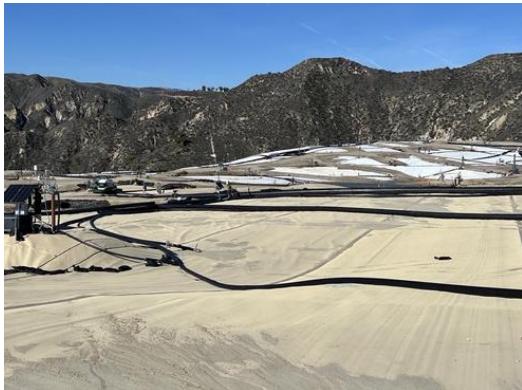
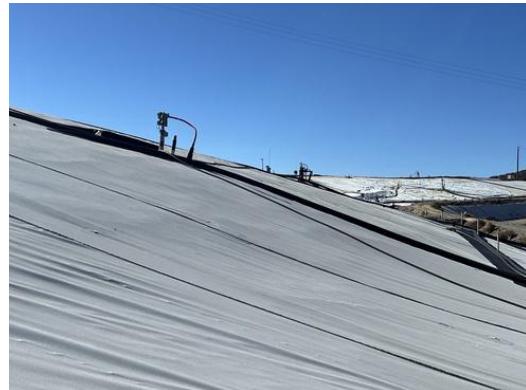
Are there any issues with the geosynthetic cover?

No

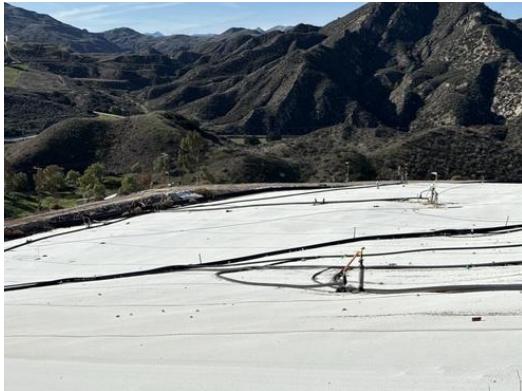
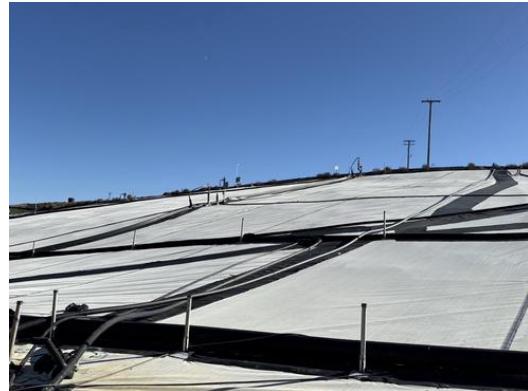
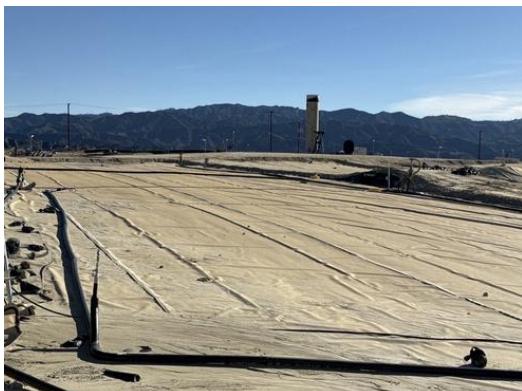
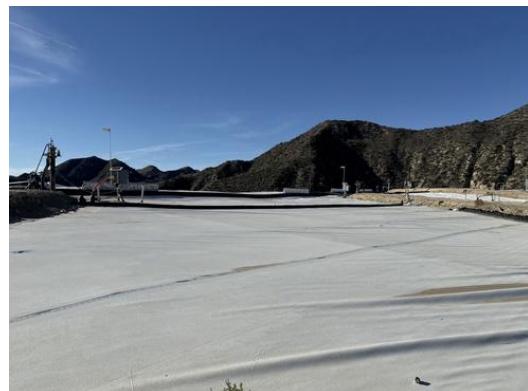
Are there any issues with the geosynthetic cover?

No

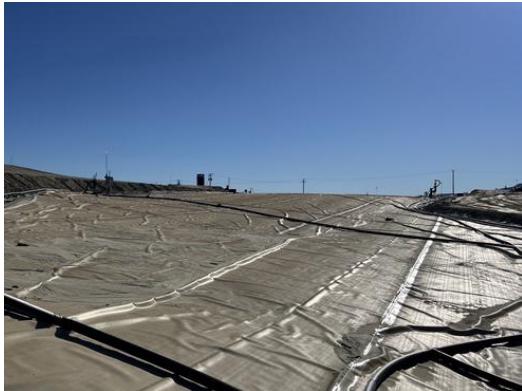
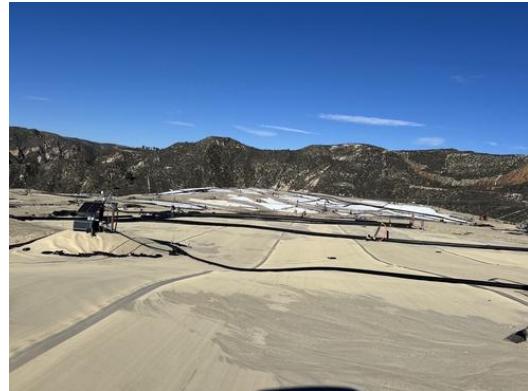
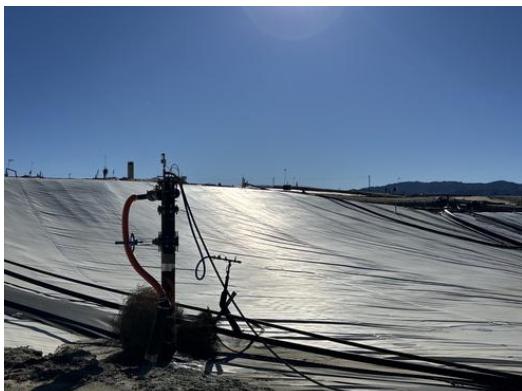
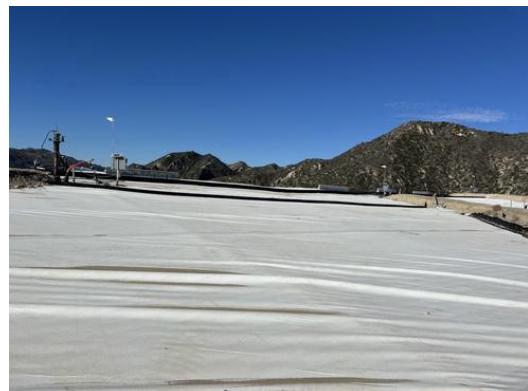
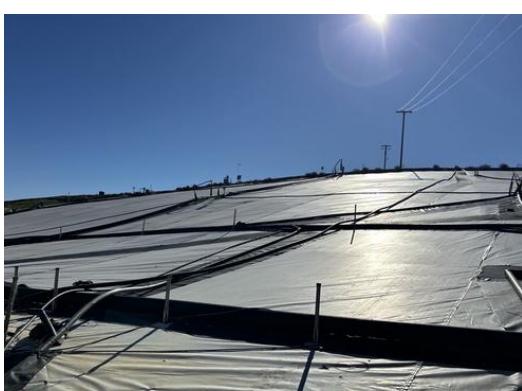
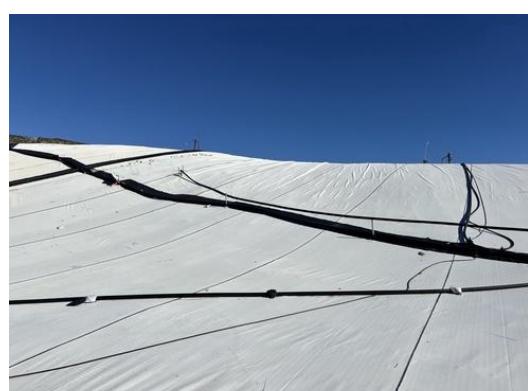
Are there any issues with the geosynthetic cover?

No

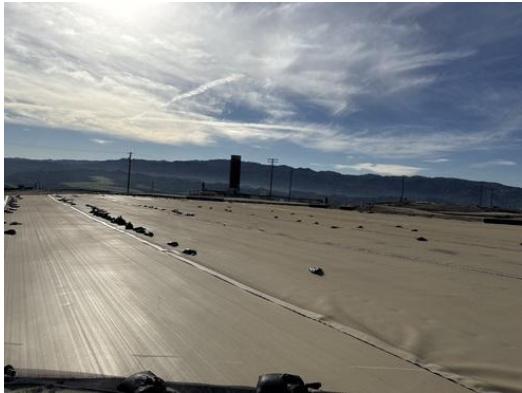
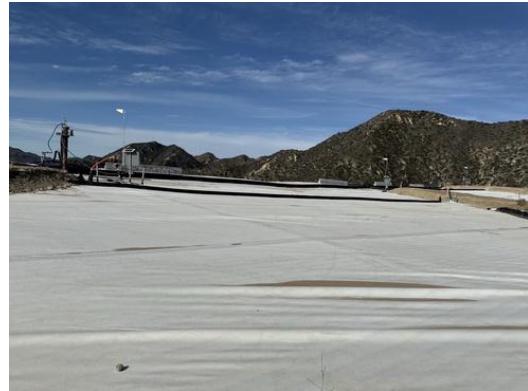
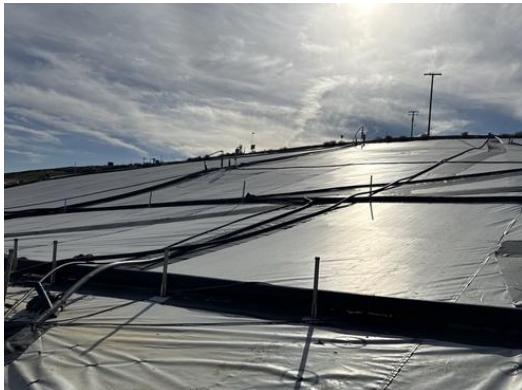
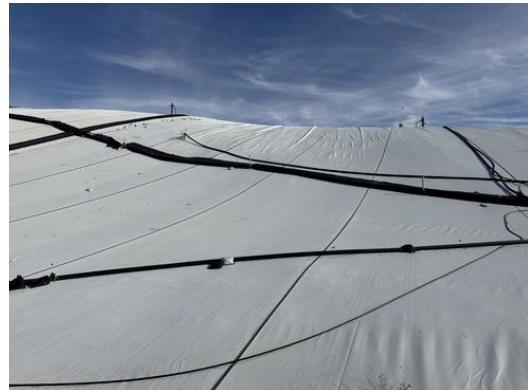
Are there any issues with the geosynthetic cover?

No
