**CHIQUITA CANYON**  
*A Waste Connections Company*

**Re: Chiquita Canyon, LLC's Weekly Report on the Documentation and Tracking of Cover Issues**

Attachment: December 16, 2025 Weekly Cover Issues Report

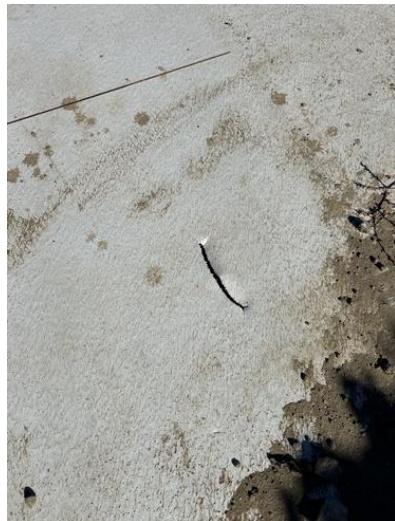
Photo 1

Tear in liner needs to be extrusion welded.
