Re: Chiquita Canyon, LLC's Weekly Leachate Inspection Report for Stipulated Order for Abatement (Case No. 6177-4), Condition 27(c)

Attachment: Leachate Inspection Logs from December 8 – December 14, 2025

4050 - Chiquita Leachate Seep/Pooling Inspection

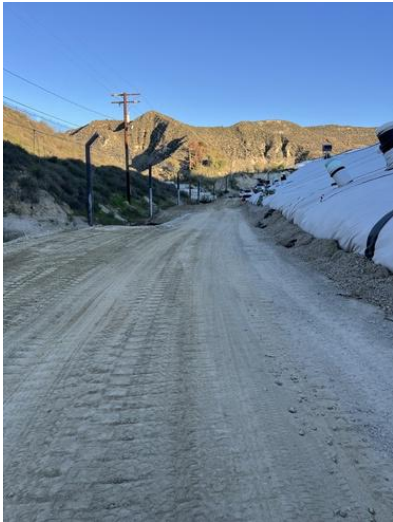
Photo 1

No

Westside perimeter road.

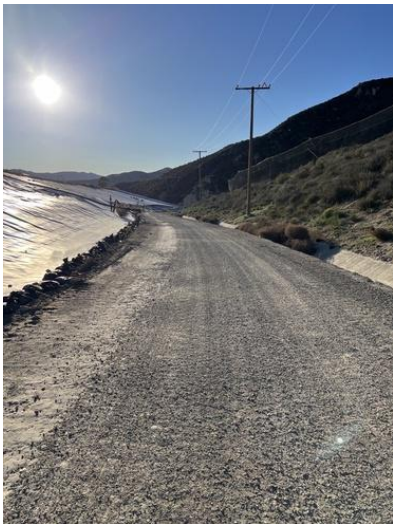
Photo 1

No

North perimeter road.

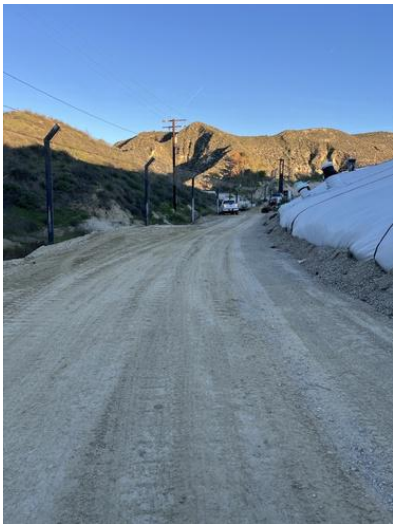
Photo 1

No

Westside perimeter road.

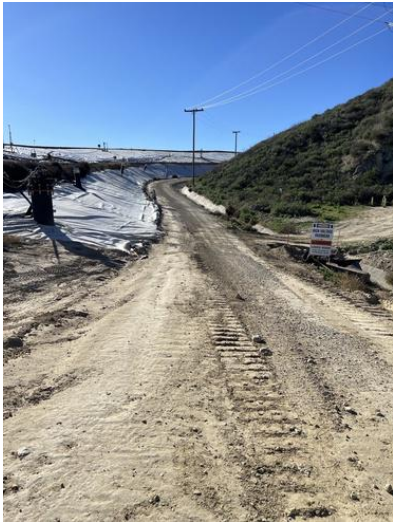
Photo 1

No

North perimeter road.

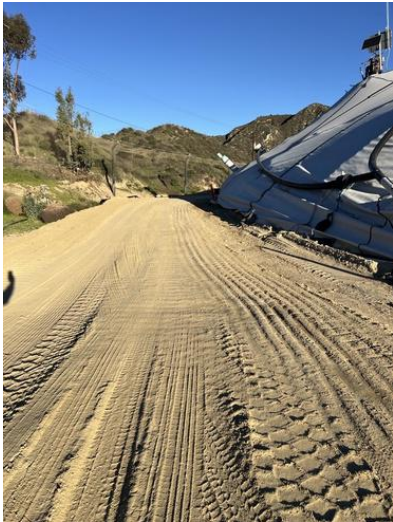
Photo 1

No

Westside perimeter road.

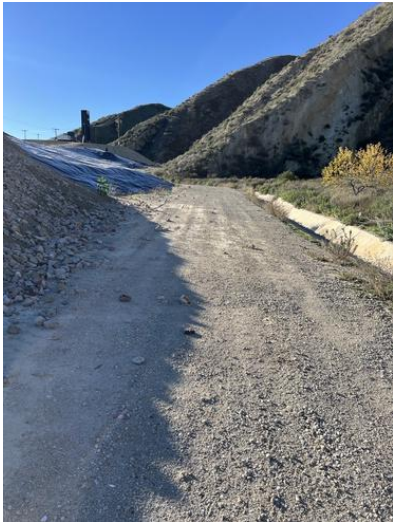
Photo 1

No

North perimeter road.

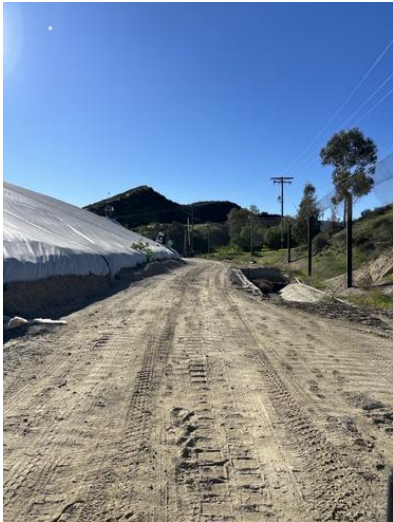
Photo 1

No

West side perimeter road

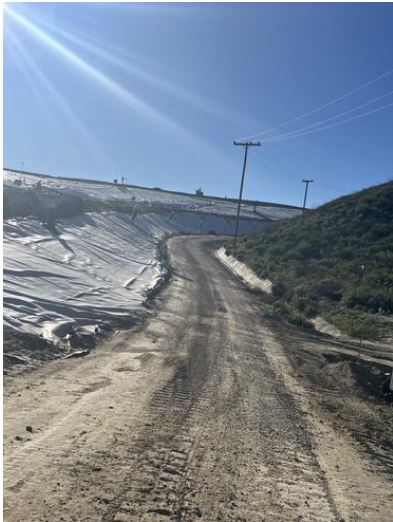
Photo 1

No

North side perimeter road

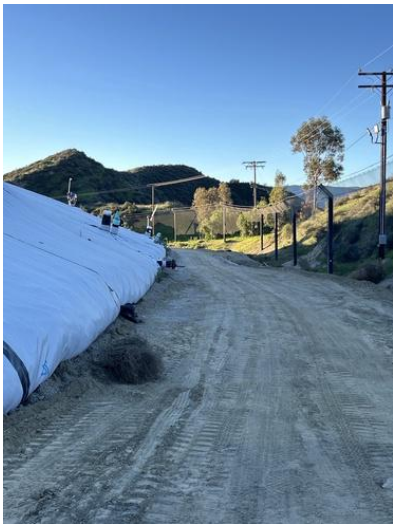
Photo 1

No

West side perimeter road

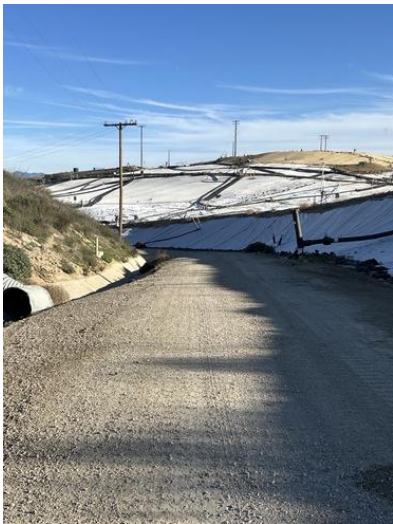
Photo 1

No

North side perimeter road

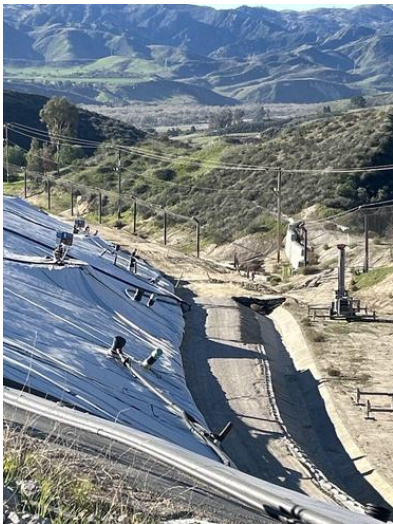
Photo 1

No

West side perimeter road

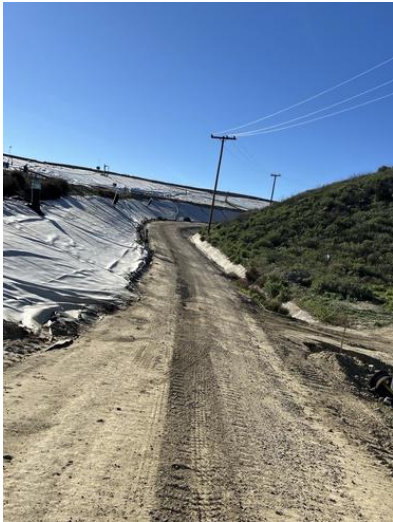
Photo 1

No

North side perimeter road

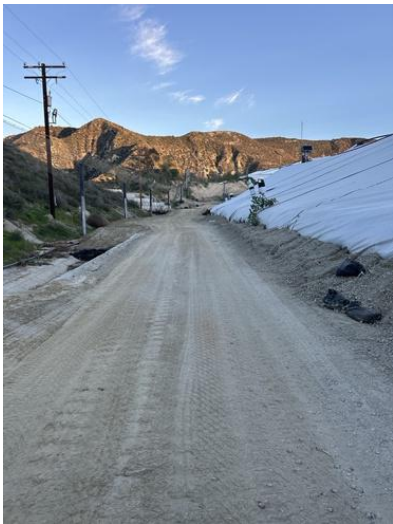
Photo 1

No

Westside perimeter road.

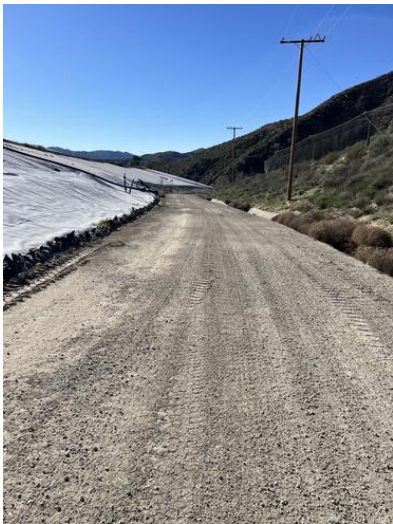
Photo 1

No

North perimeter road.
