CHIQUITA CANYON
A Waste Connections Company

**Re: Chiquita Canyon, LLC's Weekly Report on the Documentation and
Tracking of Cover Issues, Monthly Summary, and Monthly Isopach Map**

4050 - Chiquita Reaction Area Tracking of Fissures and Tension Cracks

**NOVEMBER 2025 FISSURE AND TENSION CRACK MONITORING SUMMARY
CHIQUITA CANYON LANDFILL
CASTAIC, CALIFORNIA**

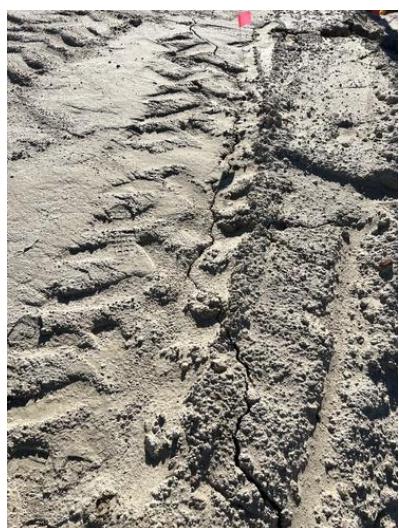
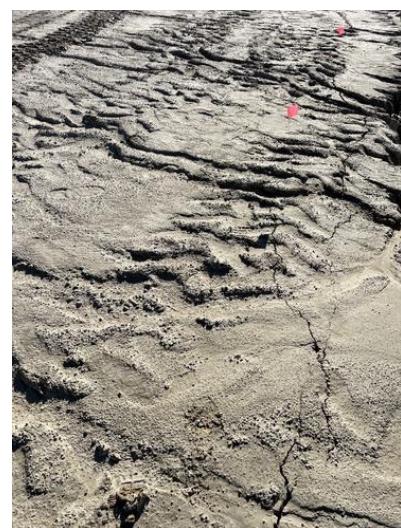
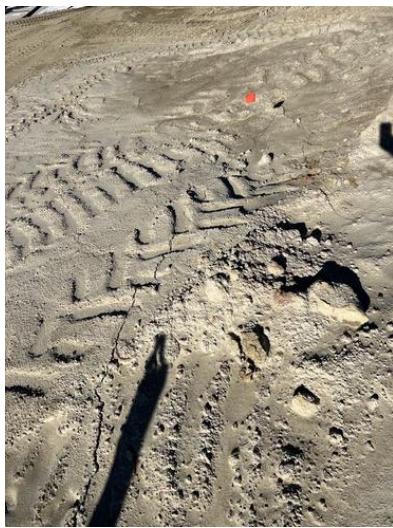
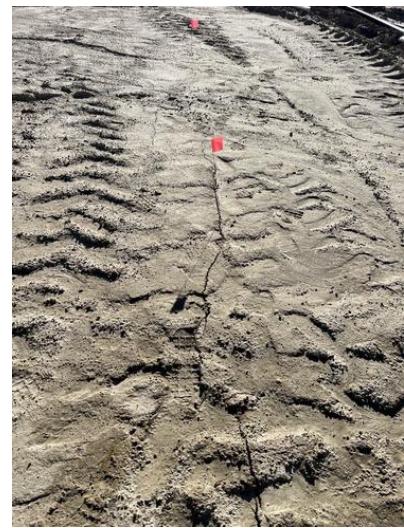
147

65ft x 6ft

Longest crack approximately 25ft

Small 0.5-2" in width

Extra small <0.5" in height

NE to SW

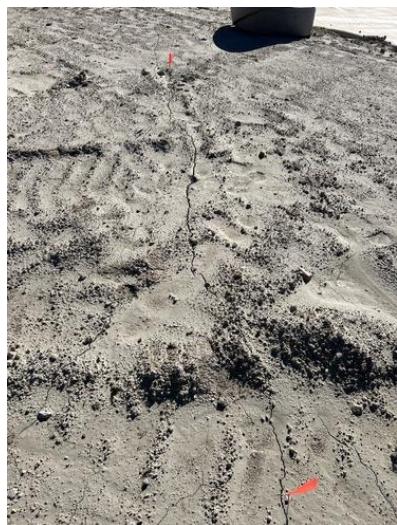
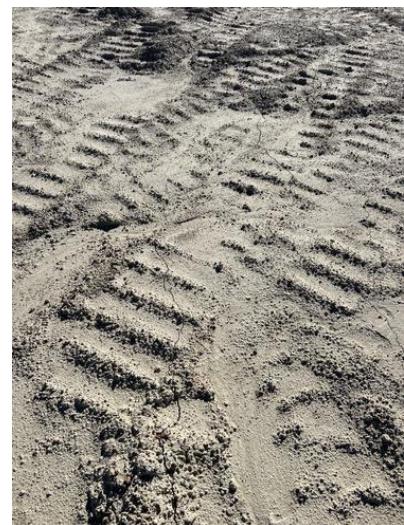
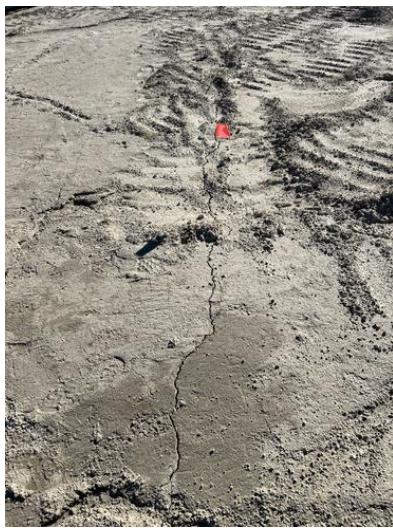
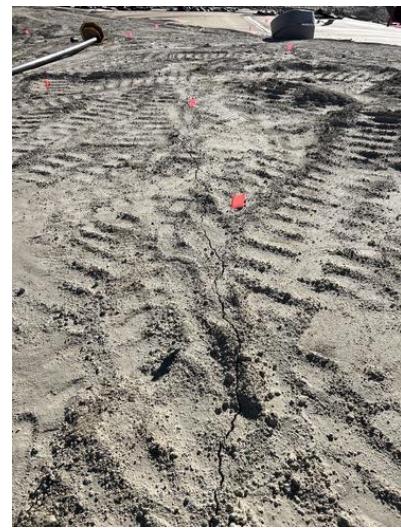
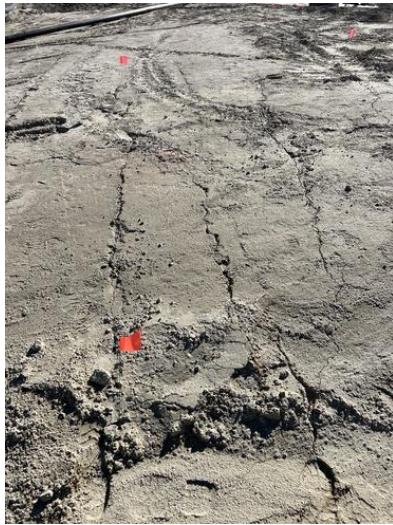
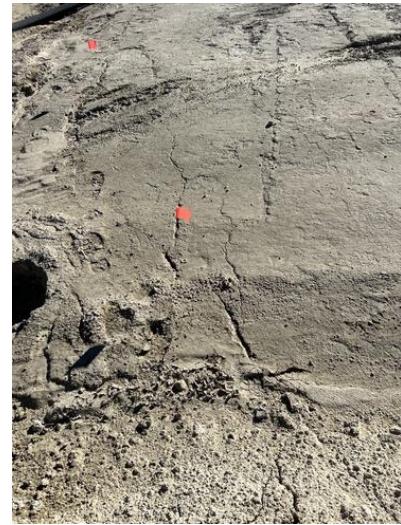
148

20ft x 40ft area

Extra Small <0.5 in width

Extra small <0.5" in height

NW to SE

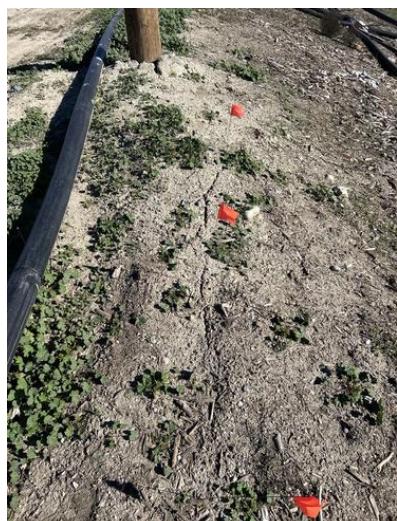
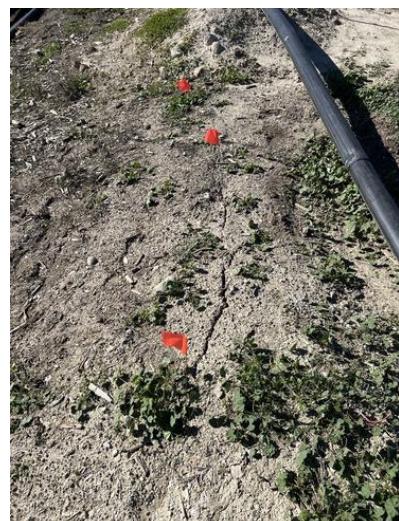
161

6ft

Small 0.5-2" in width

Extra small <0.5" in height

E to W

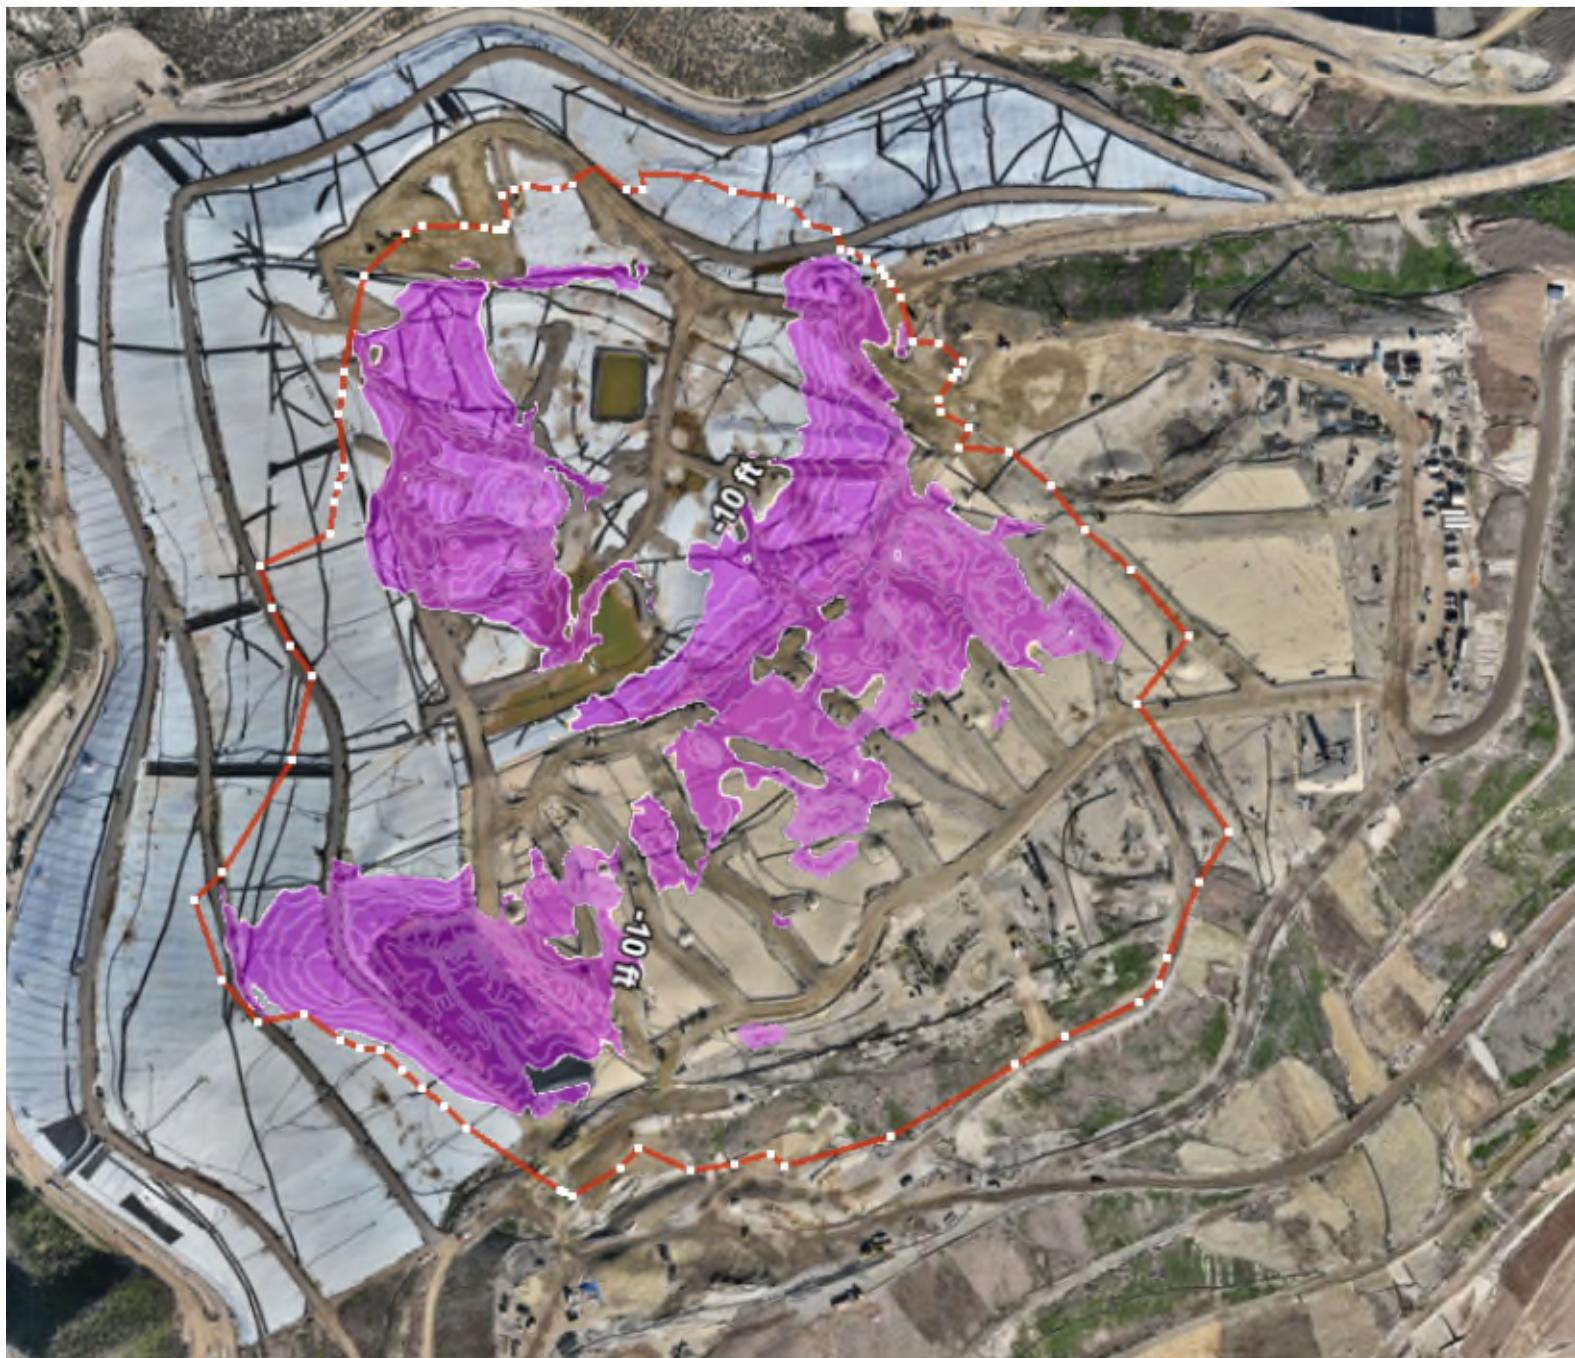
- The map shows the area between 12/4/2024 and 12/5/2025 where the grades have changed more than 10 feet. A typical MSW strain rate is 3% per year - for a landfill with a 300-foot waste column, this would be 9 feet per year.

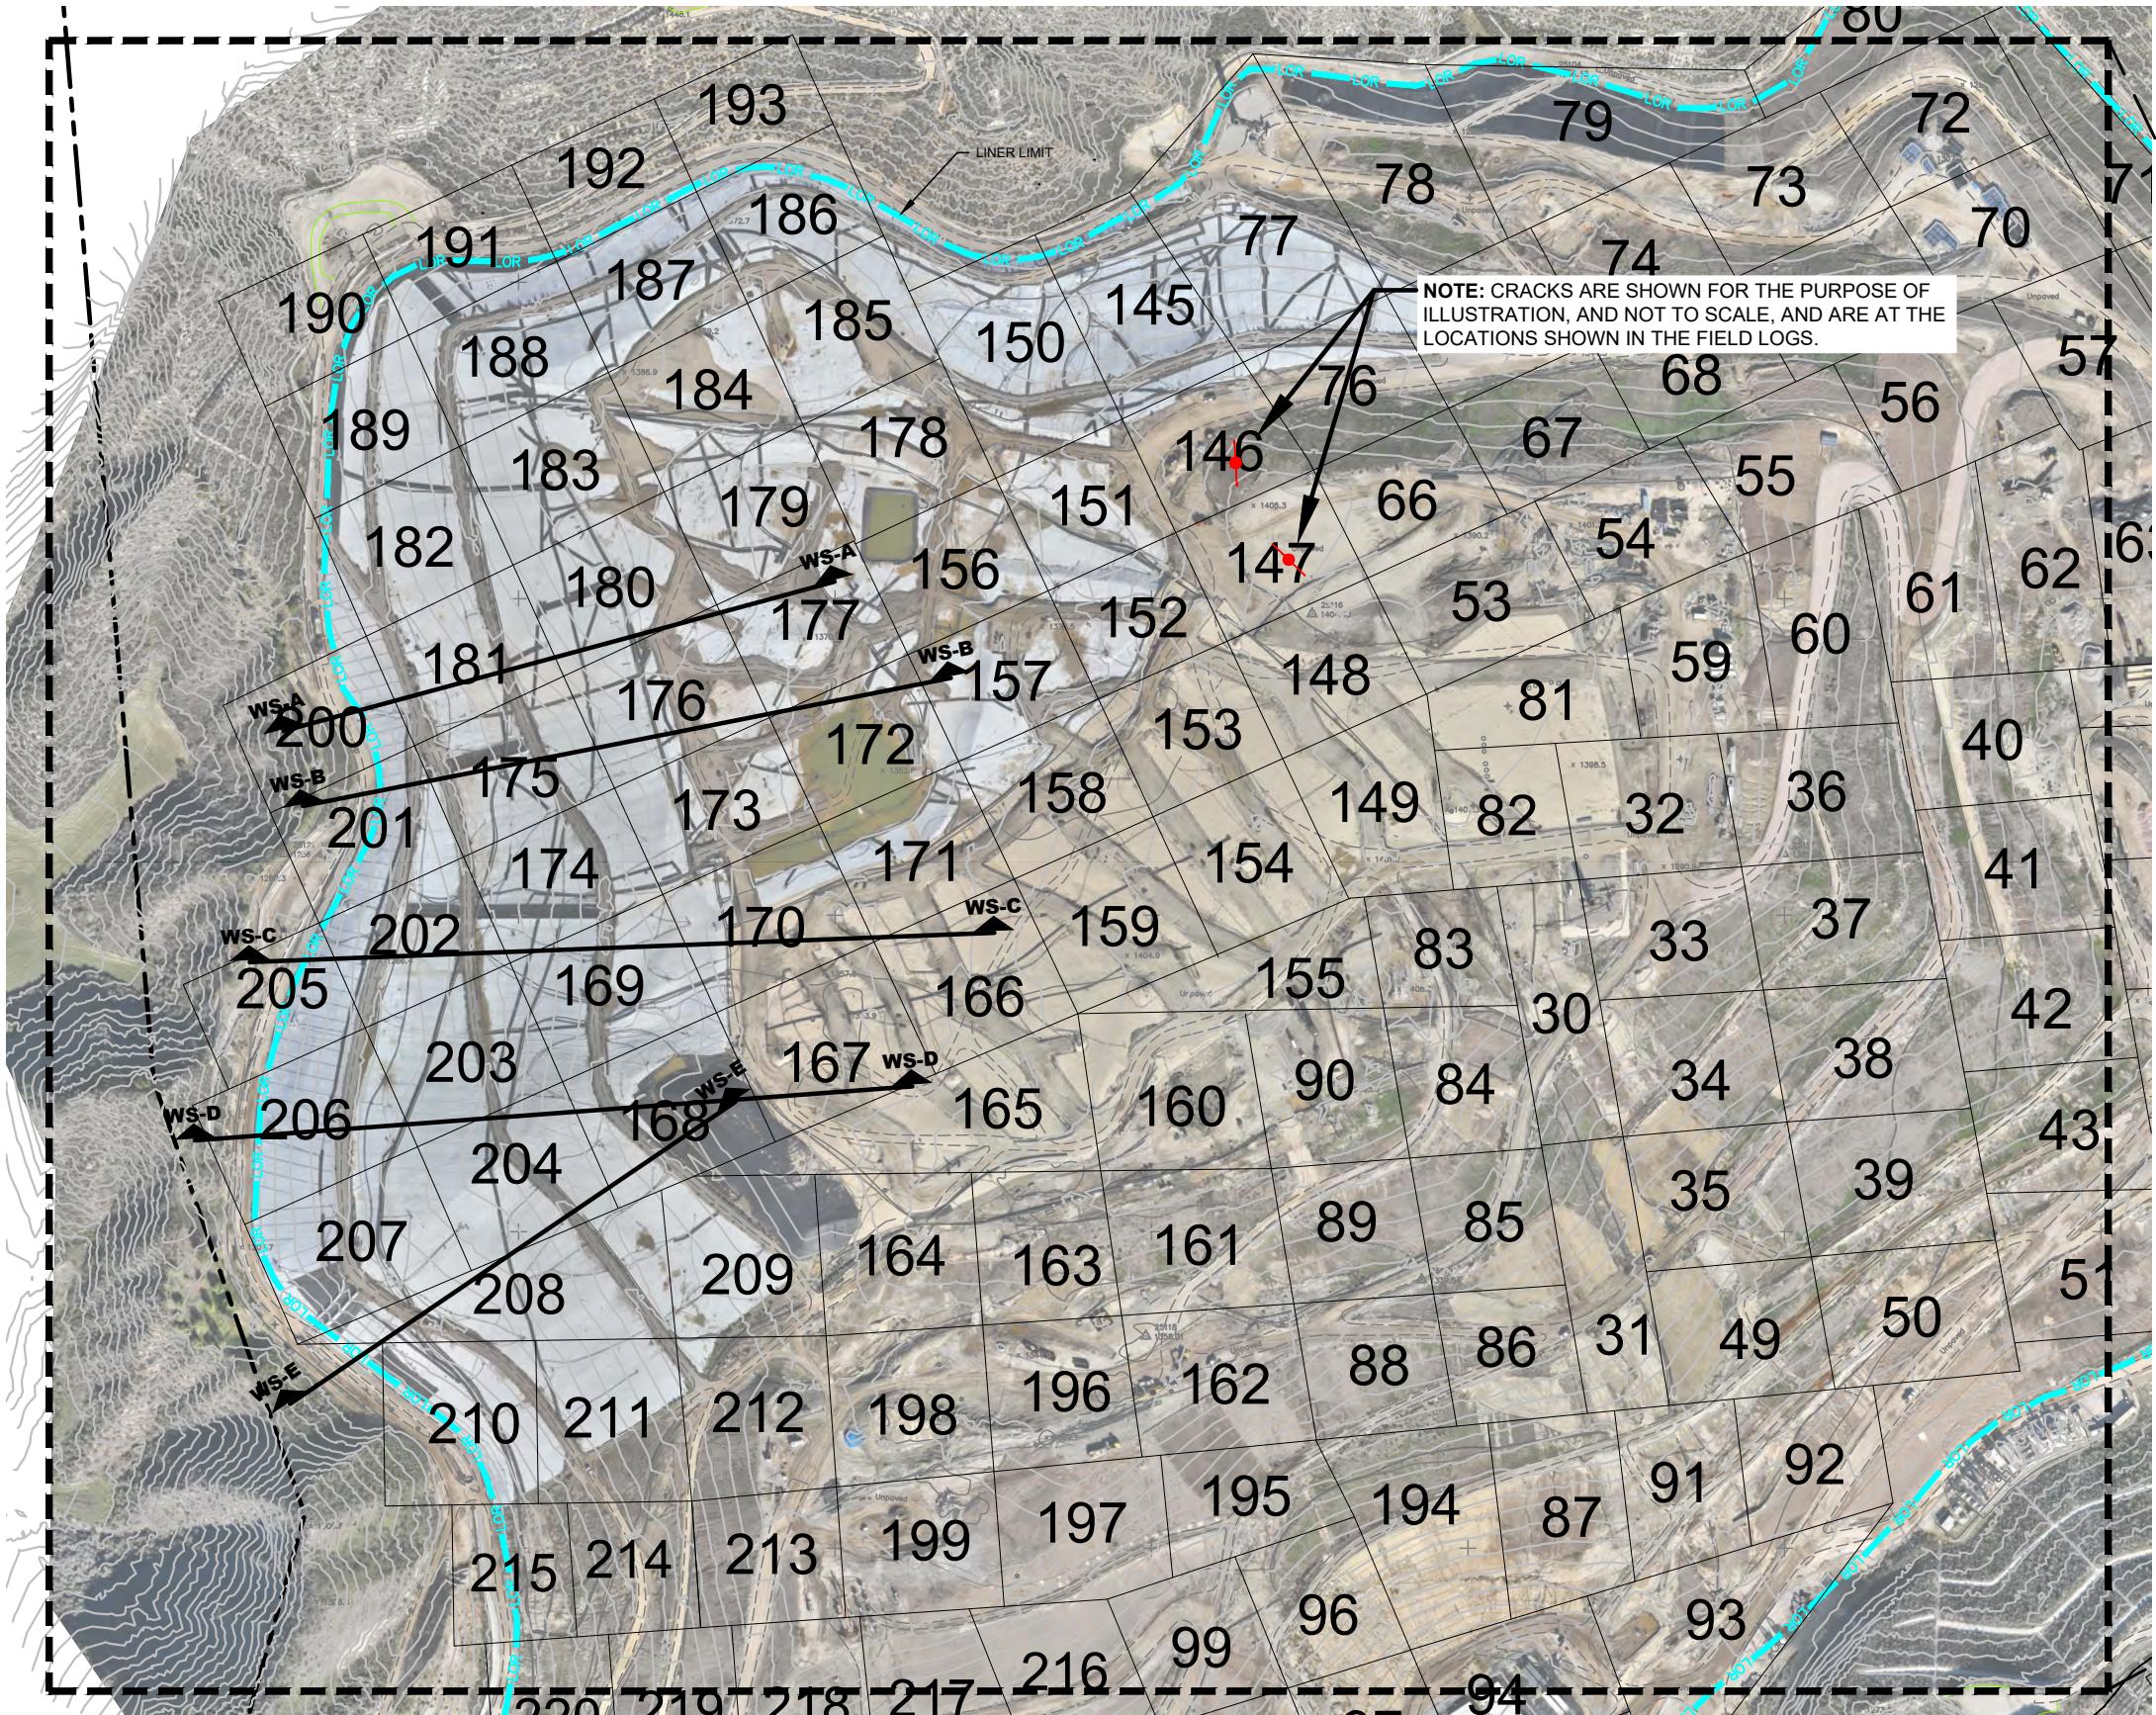
Although not “significant,” two cracks or fissures with “large” horizontal offset were observed at the approximate locations shown in Figure 1. The observation of these cracks does not indicate slope instability or possible impacts to the landfill’s containment system; rather, they were identified during routine inspection and are reported for consistency with prior documentation of all cracks or fissures with medium or greater horizontal and/or vertical offsets. These cracks and fissures include:

- An approximately 40 ft x 15 ft area with a crack showing evidence of “large” displacement was identified in Grid 147 on November 5, 2025. Review of the photographs on the field data record indicate this “large” displacement was a small, near-surface hole that was likely associated with settlement.
- An approximately 45 ft x 15 ft area with a crack showing evidence of “large” displacement was identified in Grid 146 on November 24, 2025. Review of the photographs associated with this feature does not show evidence of large displacement along the cracks. There is evidence of a hole that appears be a “collapse” feature associated with settlement.

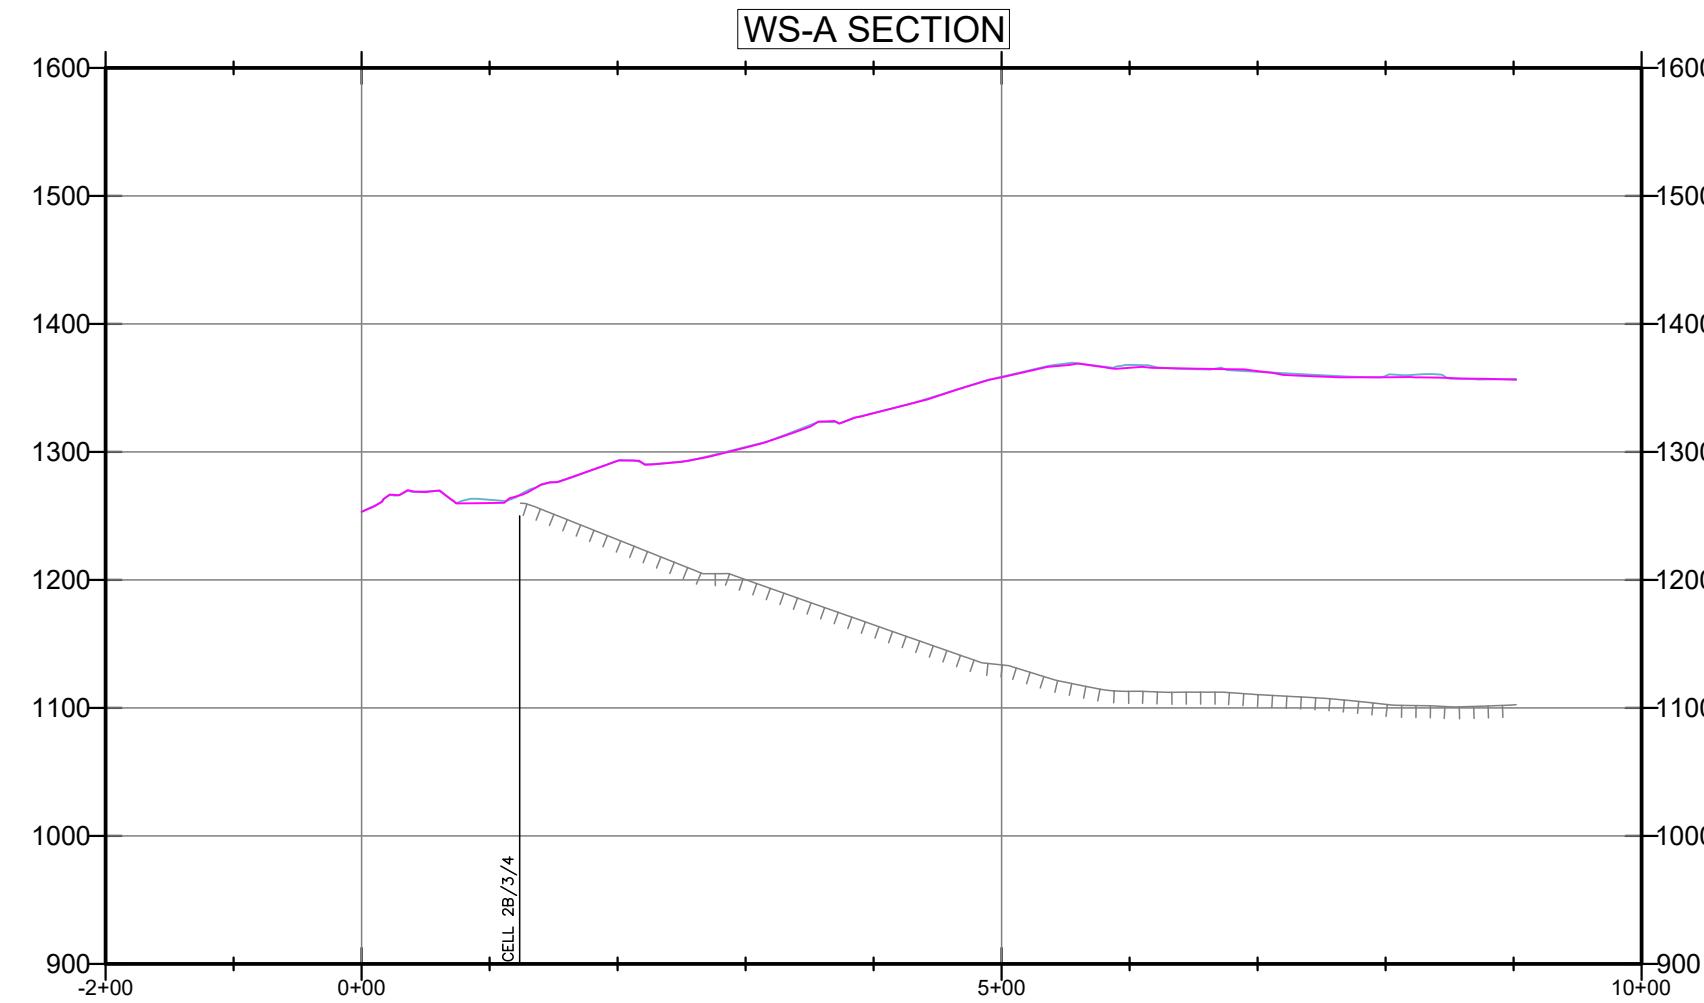
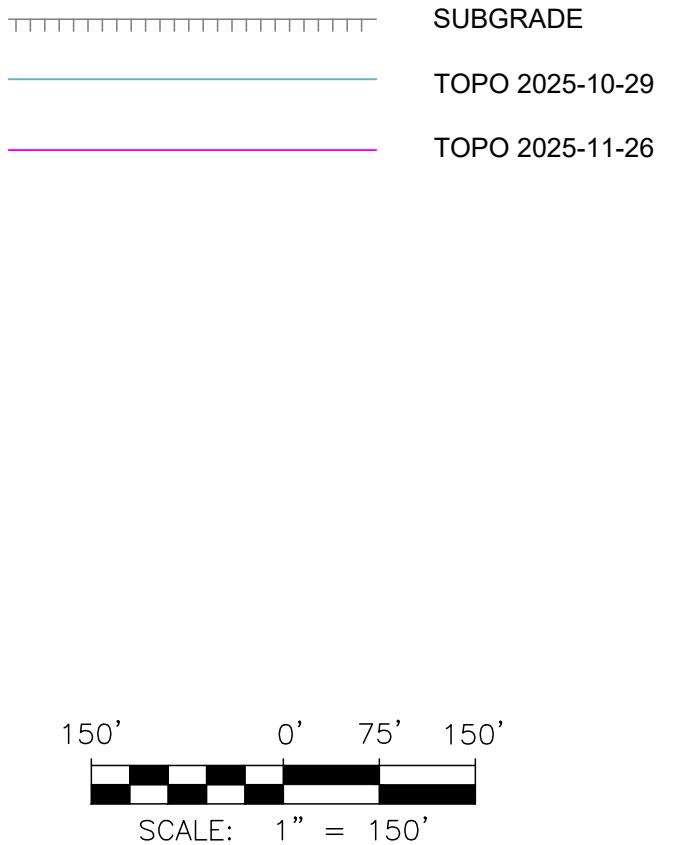
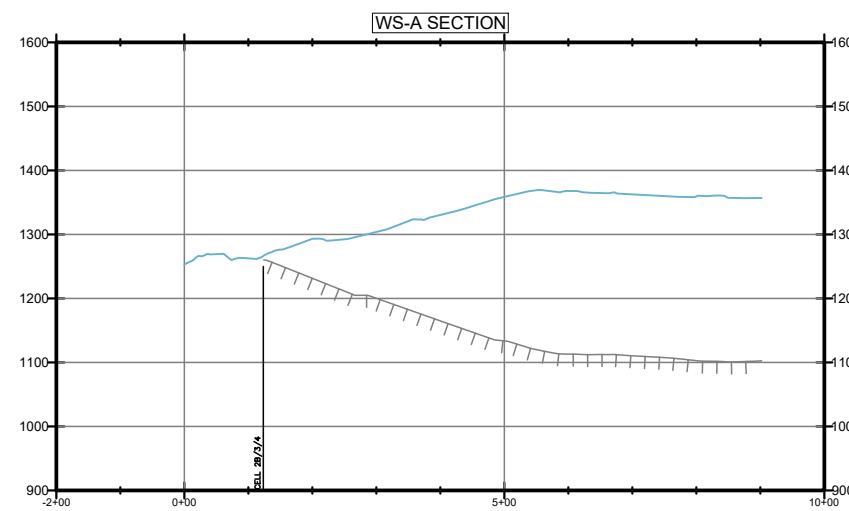
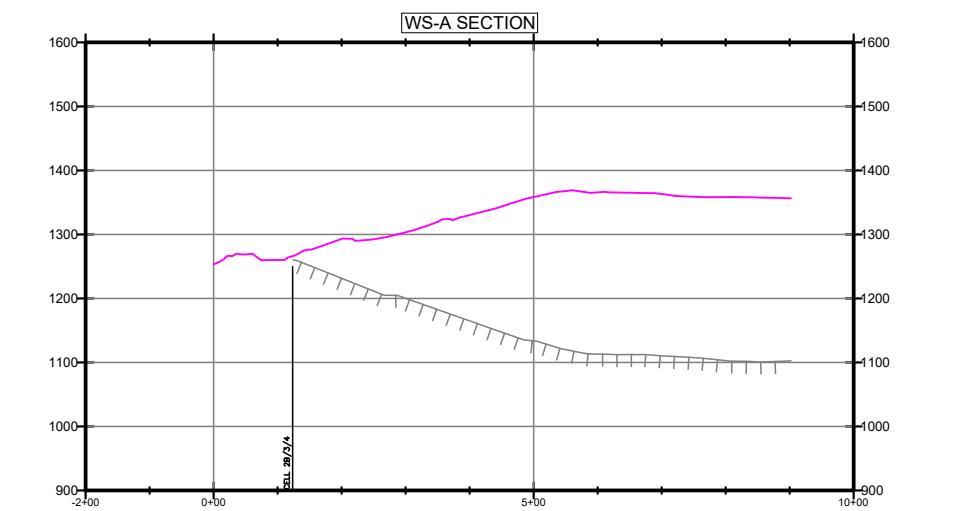
FIGURE 2A
WESTERN SLOPE CROSS SECTION A
NOVEMBER 2025 MONITORING SUMMARY
CHIQUITA CANYON LANDFILL
COUNTY OF LOS ANGELES, CA

All the cracks identified in Table 1 were repaired. Cross sections that compare October 29, 2025 and November 26, 2025 topography are shown in Figures 2A through 2E. The locations of these cross sections are shown in Figure 1. The sections show no significant differences in slope or evidence of instability between the October 2025 and November 2025 profiles, which is consistent with the observational records summarized in Tables 1 and 2.
