CHIQUITA CANYON
A Waste Connections Company

Re: Chiquita Canyon, LLC's Weekly Report on the Documentation and Tracking of Cover Issues

Attachment: December 23, 2025 Weekly Cover Issues Report

4050 - Chiquita Reaction Area Tracking of Fissures and Tension Cracks

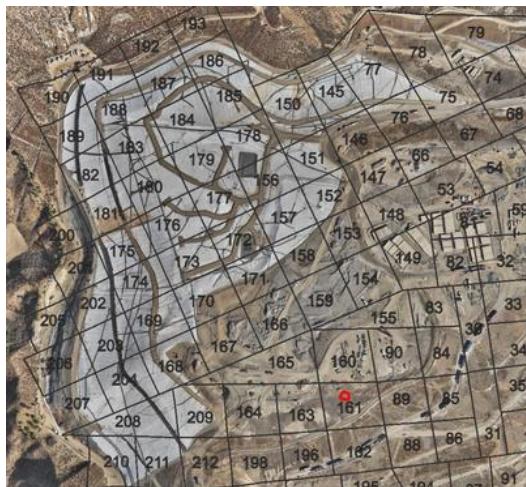
161

Using the attached image, annotate all areas where inspectors identified a fissure or tension crack.

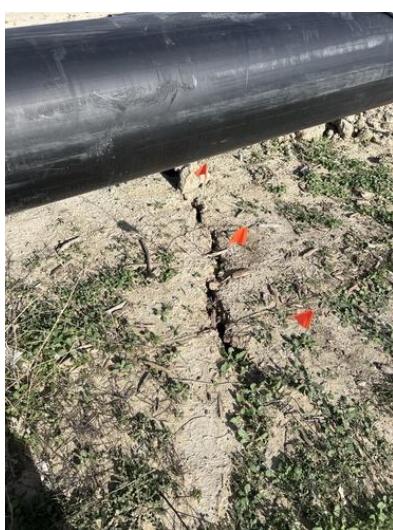
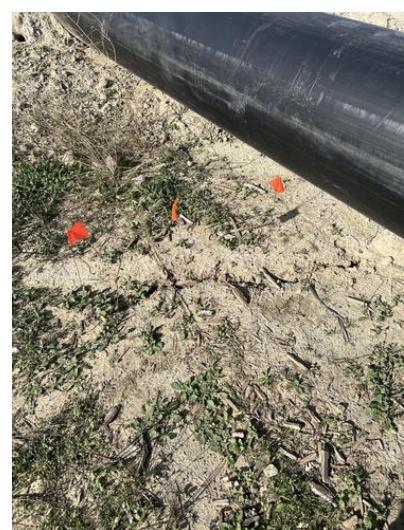
4ft

Horizontal Offset (width)	Medium 2-4" in width
Vertical Offset (height)	Extra small <0.5" in height
Orientation (direction)	NE to SW

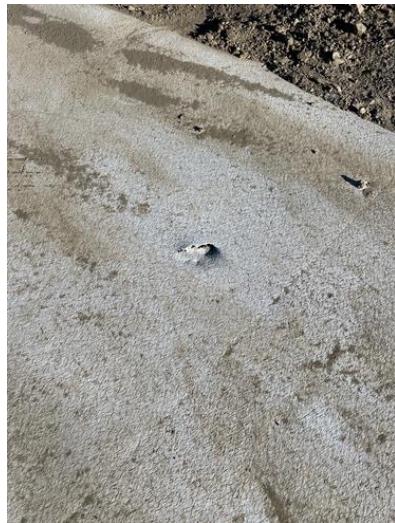
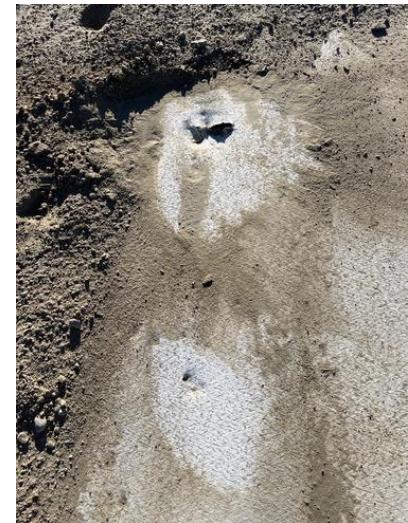
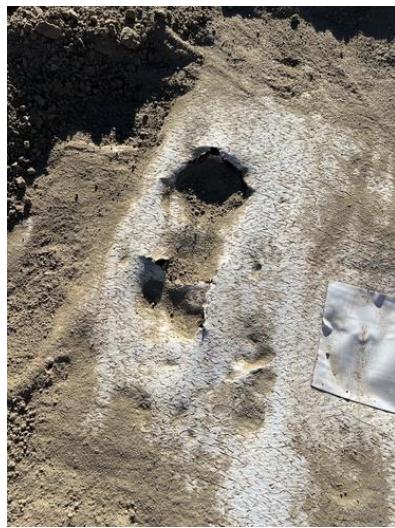
A few small tears need to be patched/extrusion welded.

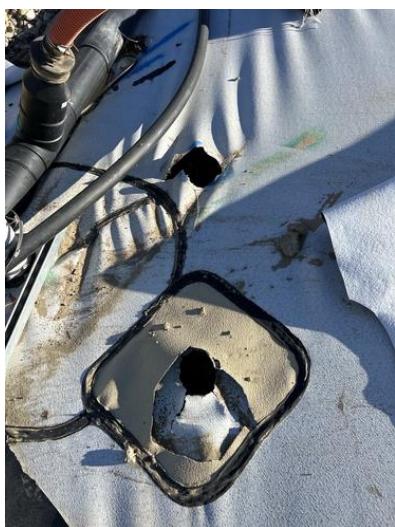
Photo 8

Two holes need to be patched and extrusion welded.
