December 29, 2025

Mr. Stephen Dutz
South Coast Air Quality Management District
21865 Copley Drive
Diamond Bar, California 91765

POST-EXCEEDANCE AIR MONITORING INVESTIGATION MS-04, DECEMBER 22-23, 2025 – STIPULATED ORDER FOR ABATEMENT CONDITION NO. 34(d)

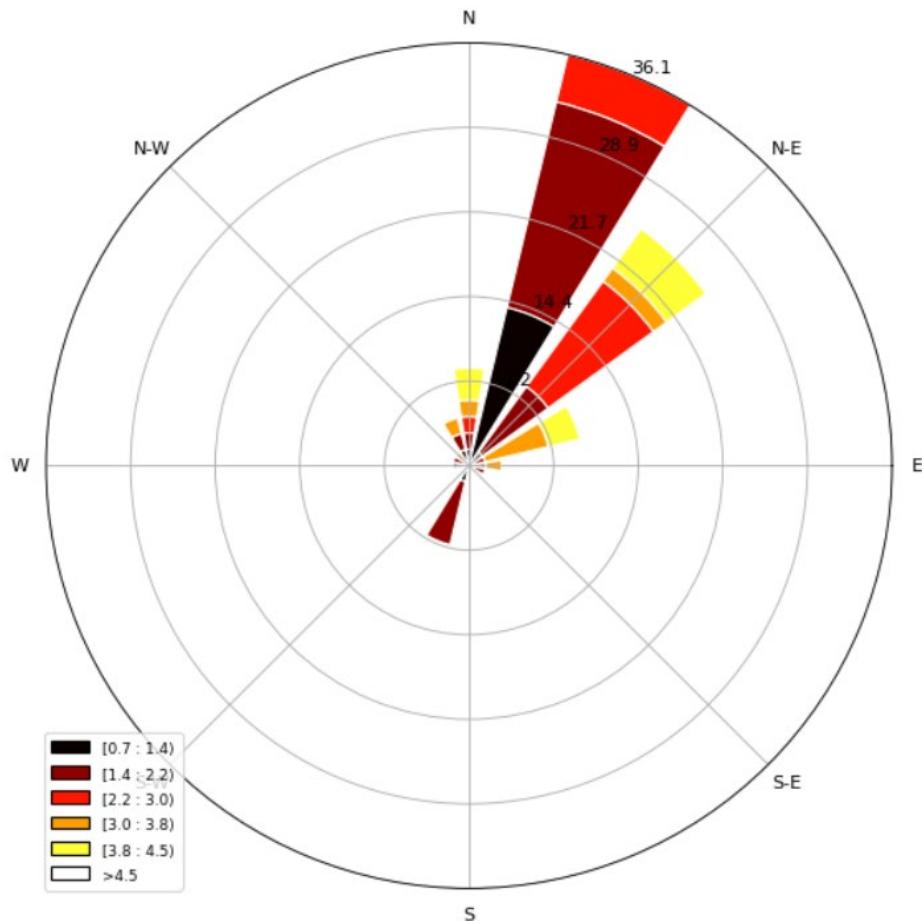
Figure 2. Wind Rose for MS-04, December 22-23, 2025, 8 PM through 4 AM

Wind data suggests that the air monitoring unit was not directly downwind from the Landfill during the time prior to and during the exceedance event although wind speeds were generally very low, indicating limited air mixing and dispersion likely occurred.

As shown in **Figure 2** above, winds were generally observed to be coming from the northwest and north-northwest. As such, additional data review was conducted at MS-07, located south-west of MS-04. Analysis indicates no strong trend observed at MS-07 during the time of the REL exceedance. This suggests that the measured constituents were mainly located near MS-04, which is the nearest station to the reaction area.

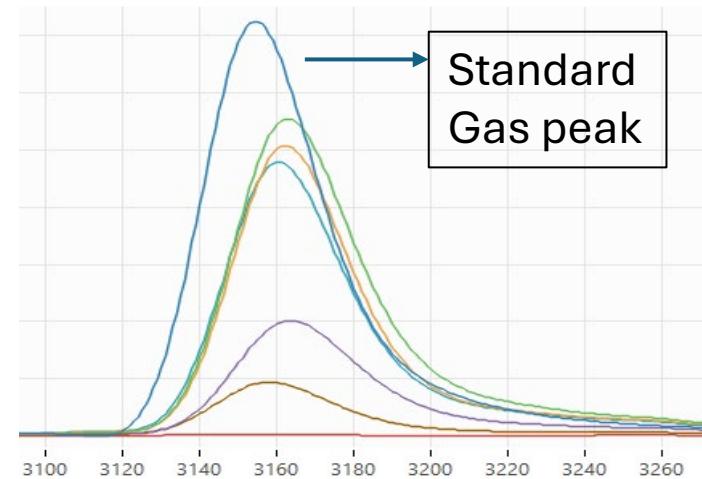
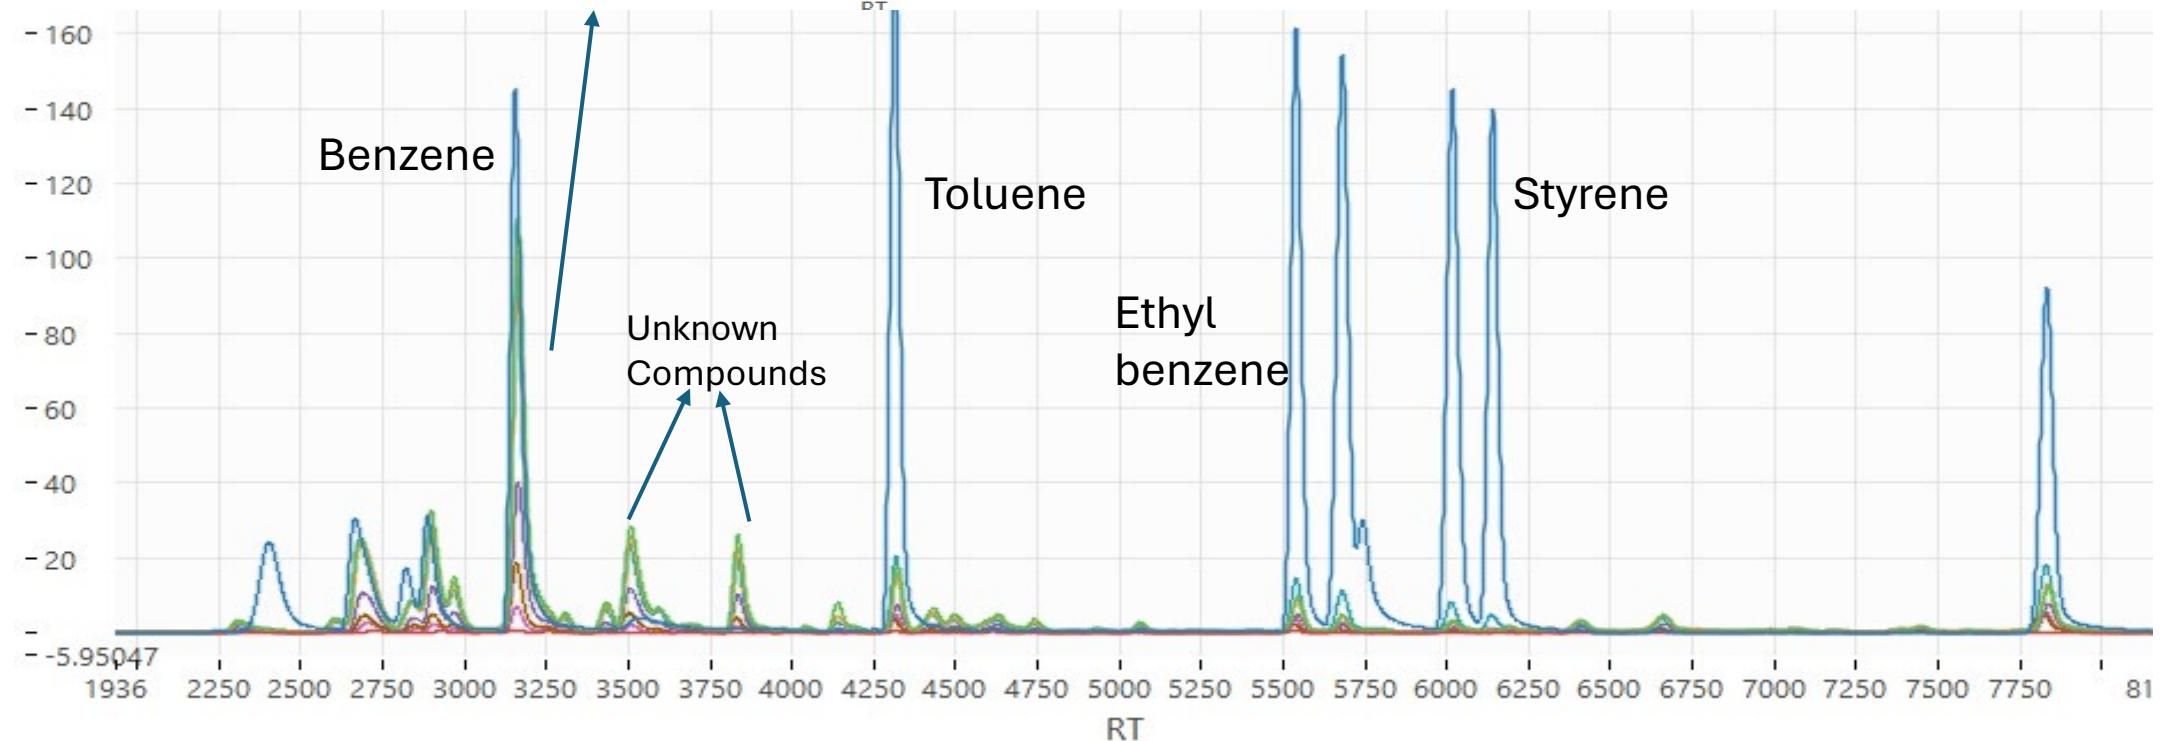
Dec 22 , MS04 – Benzene reading

Benzene concentrations at MS04 exceeded the REL on 22 December.

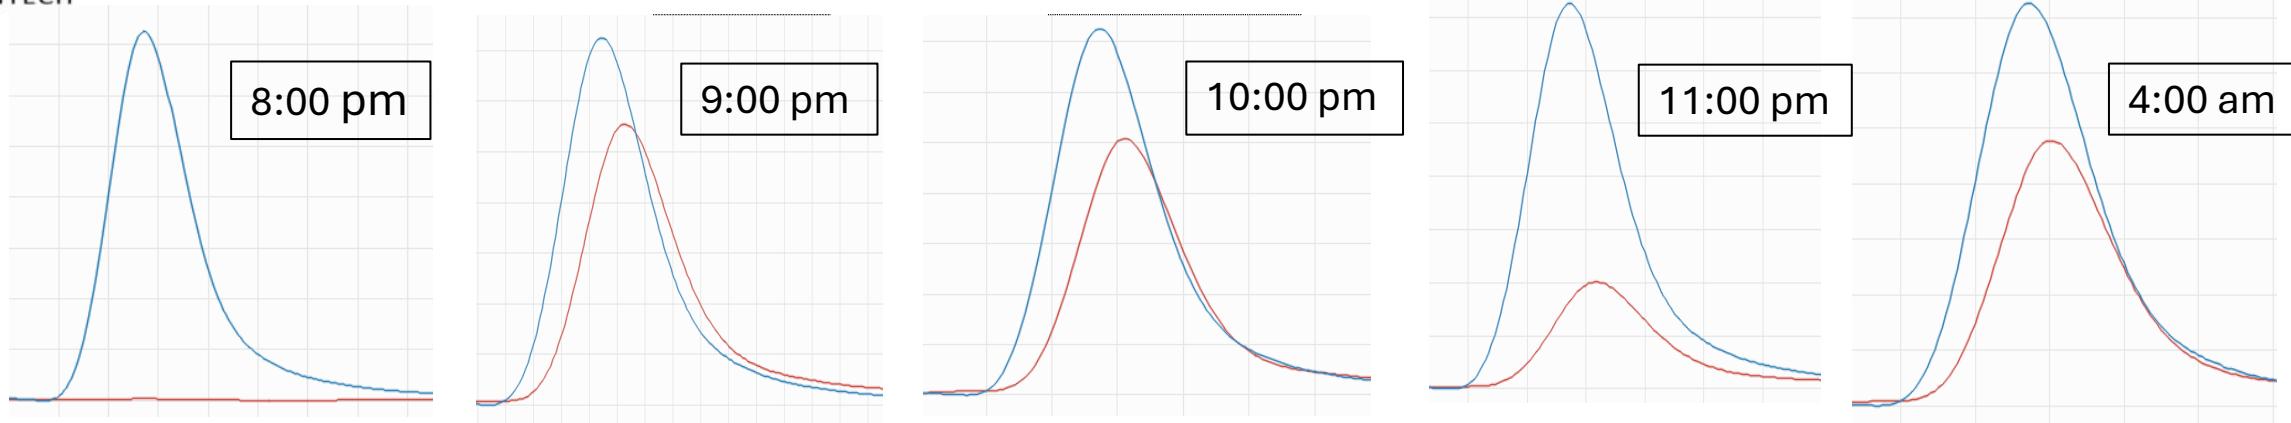
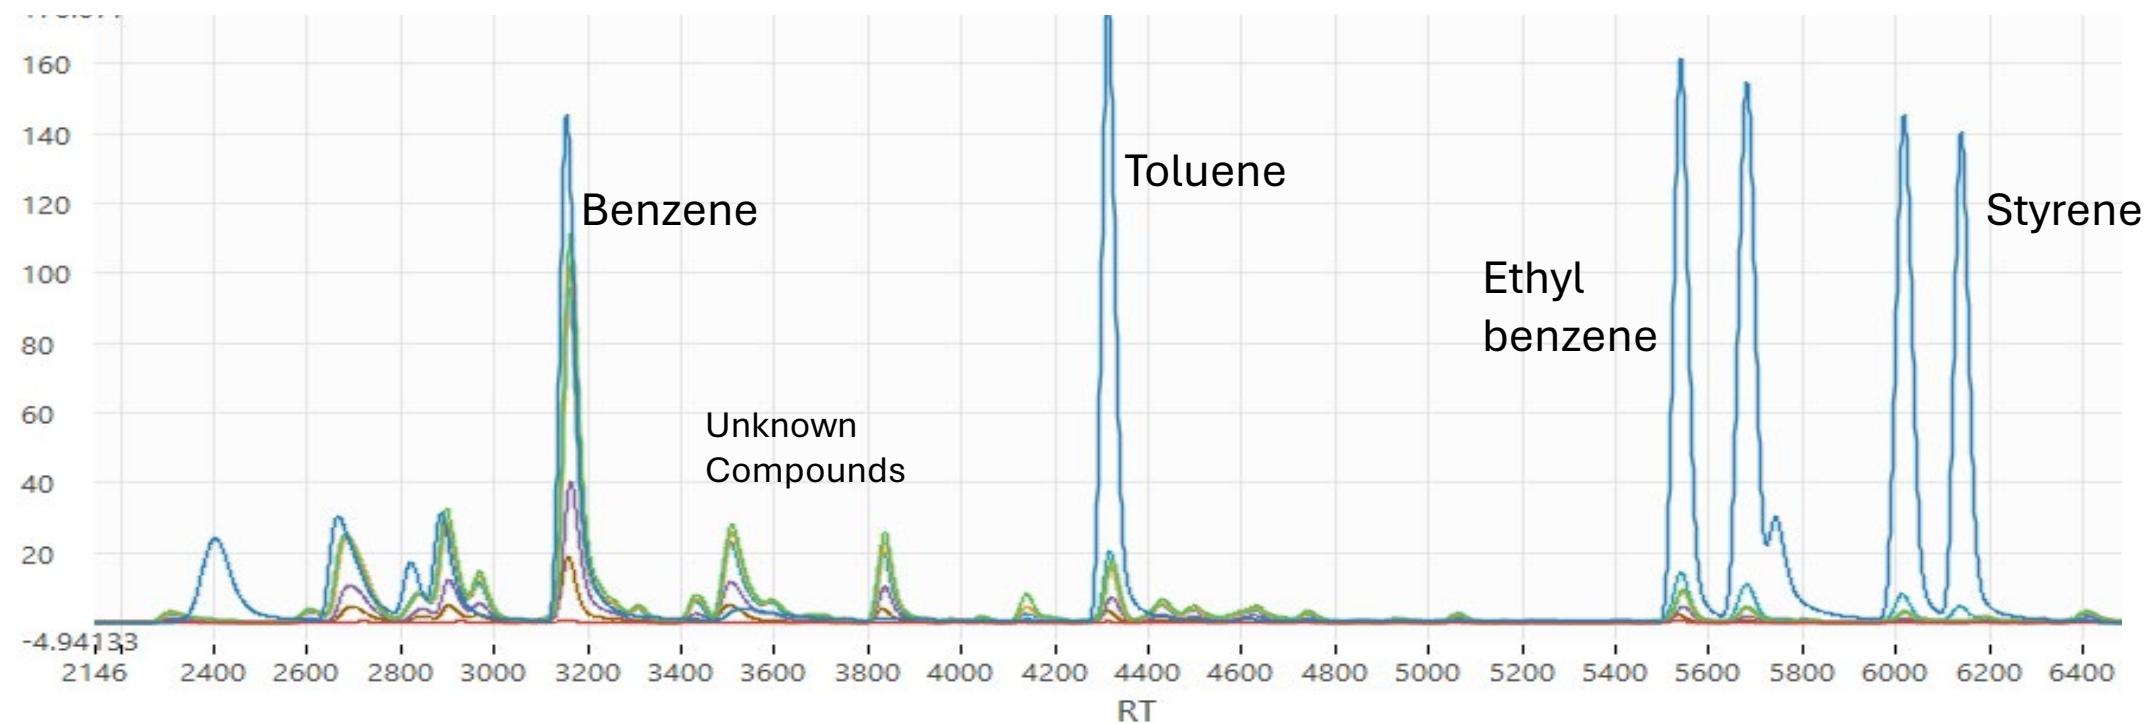
MS04 – Benzene Environmental sample signals

Hourly environmental benzene responses show strong correlation with recent calibration standards.

Chromatographic retention and peak characteristics are consistent with calibration benchmarks.

All measured concentrations fall within the validated calibration range.

All benzene data recorded at MS04 are valid, reliable, and representative of environmental conditions, with no evidence of analytical or operational anomalies.
