**CHIQUITA CANYON**  
*A Waste Connections Company*

**Re: Chiquita Canyon, LLC's Weekly Report on the Documentation and Tracking of Cover Issues**

# 4050 - Chiquita Reaction Area Tracking of Fissures and Tension Cracks

# 4050 - Geosynthetic Cover Inspection

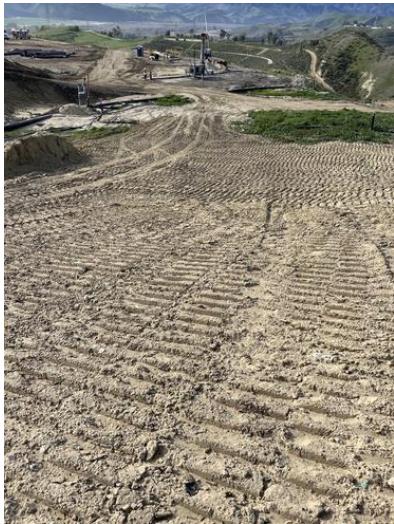
Photo 1

**Fissure or Tension Crack Found?**

No

Grid 164

**Are there any indications of slope stability concerns?**

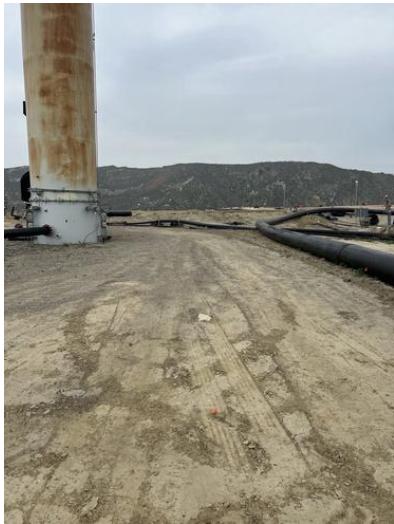
Photo 1

**Fissure or Tension Crack Found?**

No

Grid 90

**Are there any indications of slope stability concerns?**

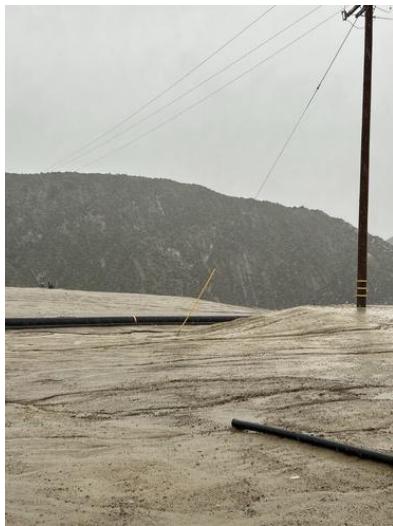
Photo 1

**Fissure or Tension Crack Found?**

No

Grid 66

**Are there any indications of slope stability concerns?**

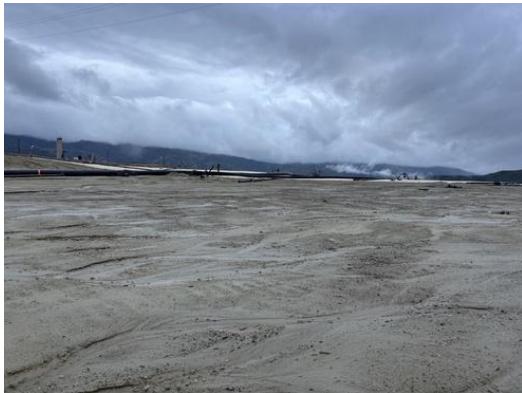
Photo 1

**Fissure or Tension Crack Found?**

No

Grid 66

**Are there any indications of slope stability concerns?**

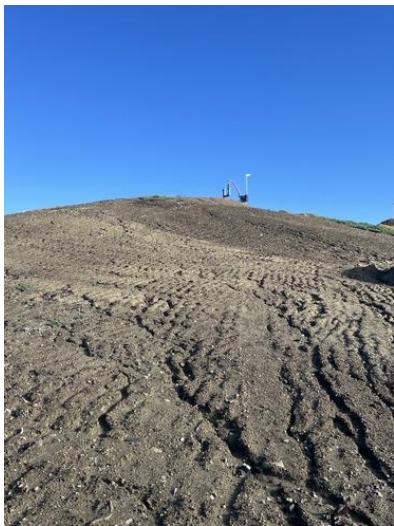
Photo 1

**Fissure or Tension Crack Found?**

No

Grid 164

**Are there any indications of slope stability concerns?**

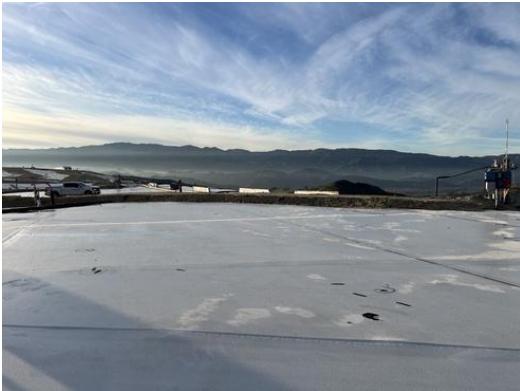
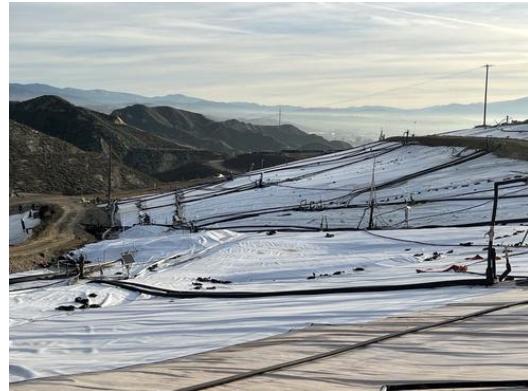
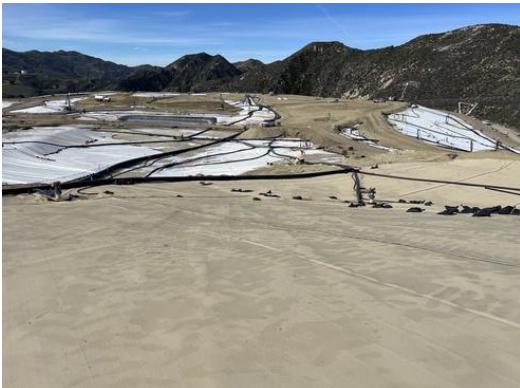
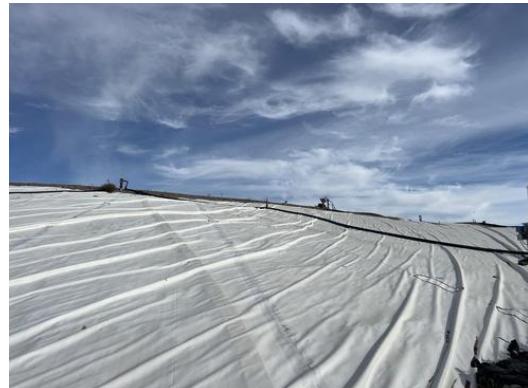
**Are there any issues with the geosynthetic cover?**

No

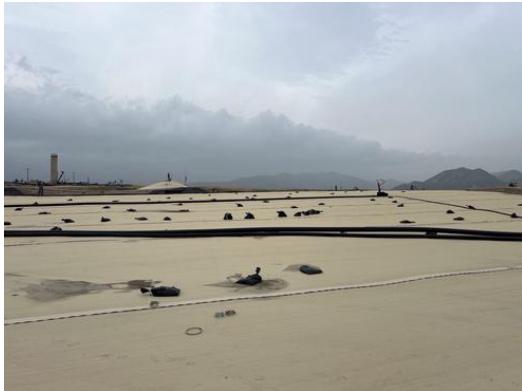
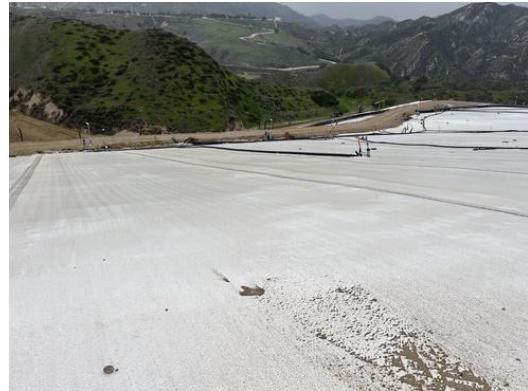
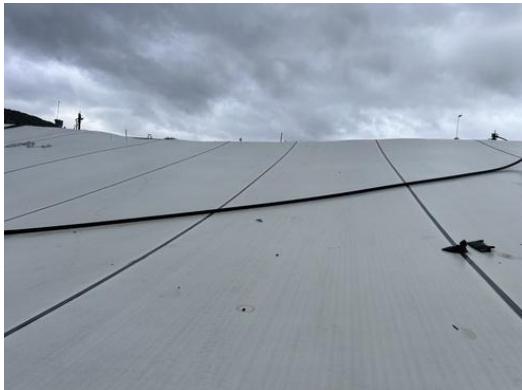
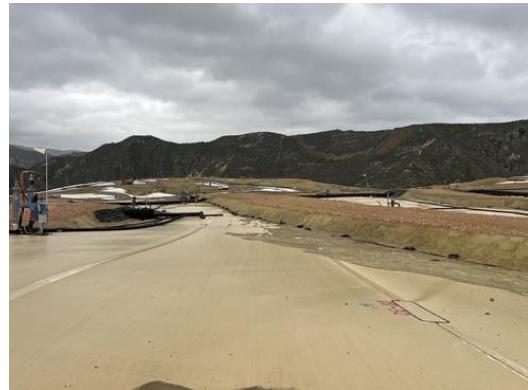
**Are there any issues with the geosynthetic cover?**

No

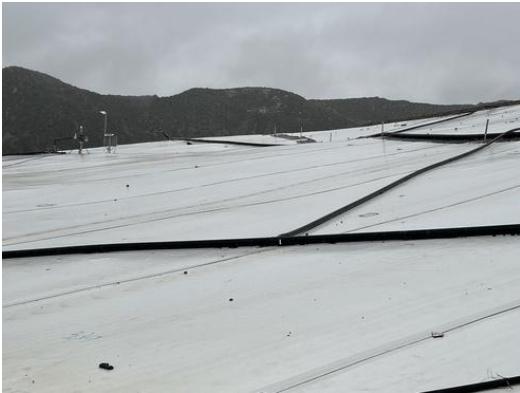
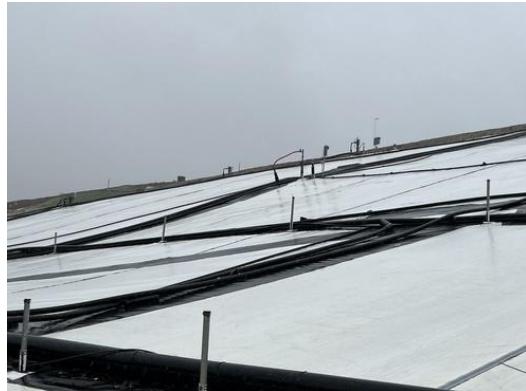
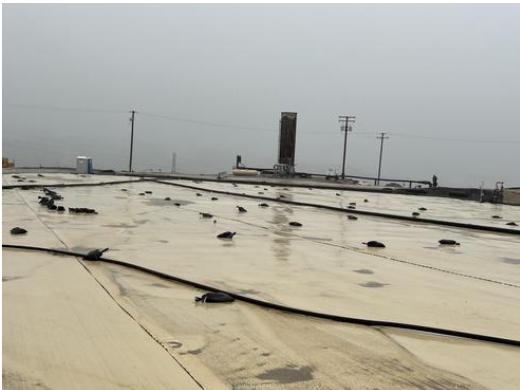
**Are there any issues with the geosynthetic cover?**

No

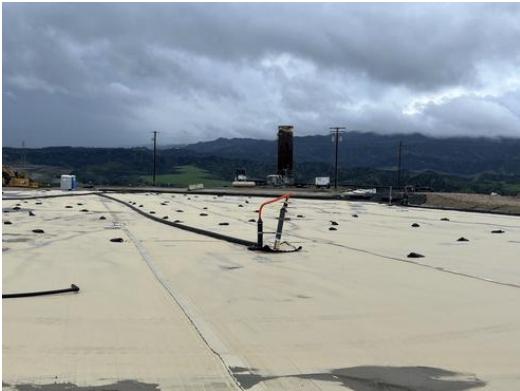
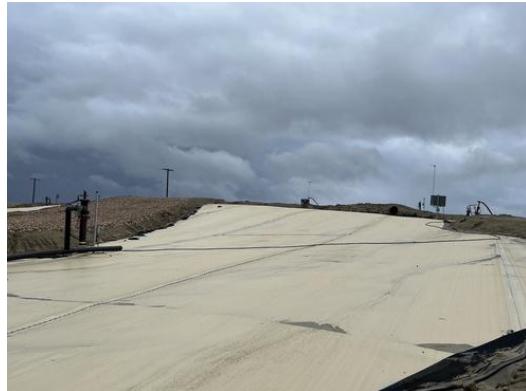
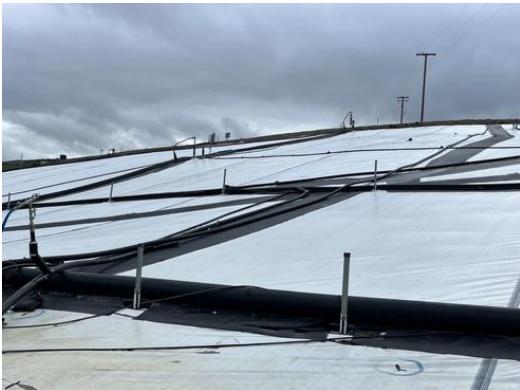
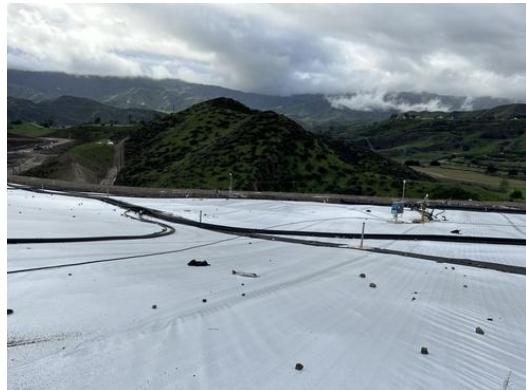
**Are there any issues with the geosynthetic cover?**

No

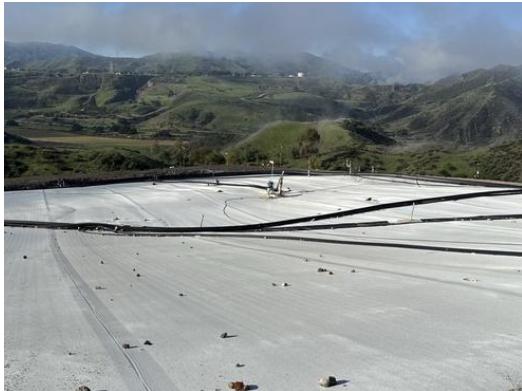
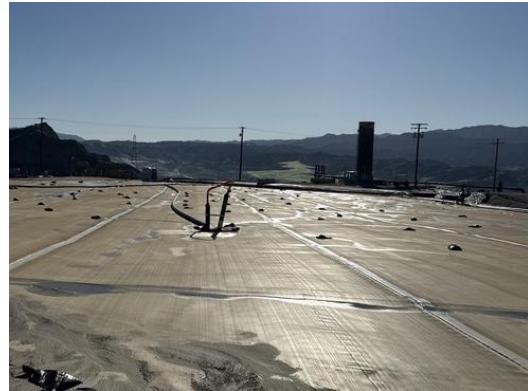
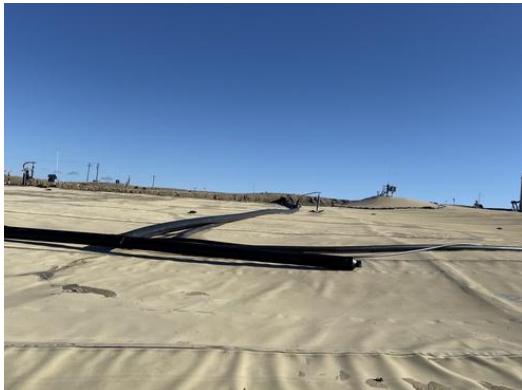
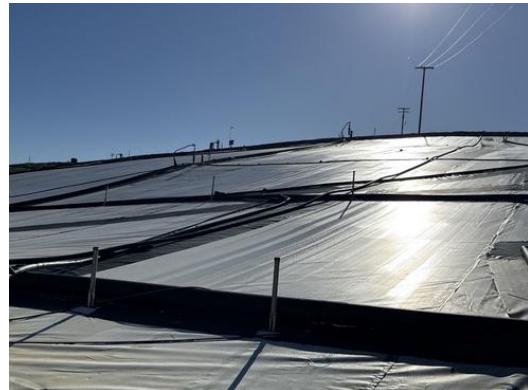
**Are there any issues with the geosynthetic cover?**

No
