Informe de Aseguramiento de la Calidad de la Construcción del Vertedero de Chiquita Canyon Proyecto de Construcción de Barrera de Tierra

01204123.41 | Mayo de 2025
Revisado en enero de 2026

Informe de Aseguramiento de la Calidad de la Construcción

Proyecto de Construcción de Barrera de Tierra

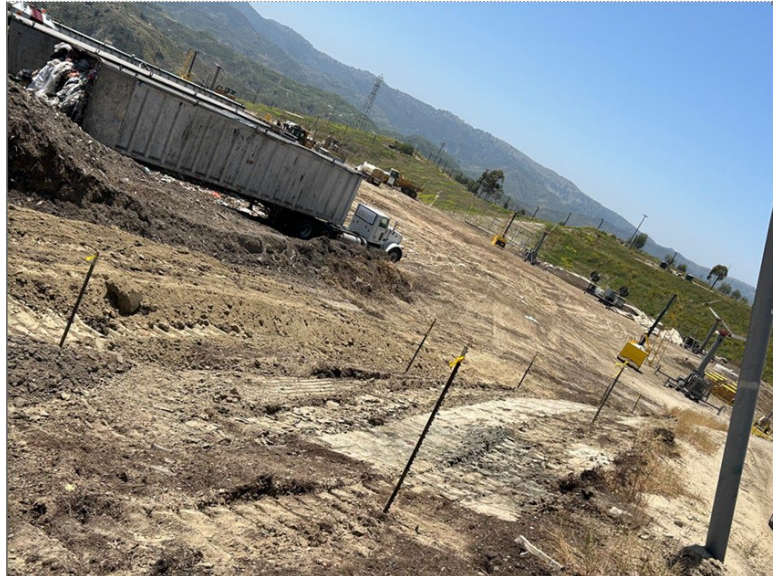
Description: Staking for placement of 5 ft soil barrier.

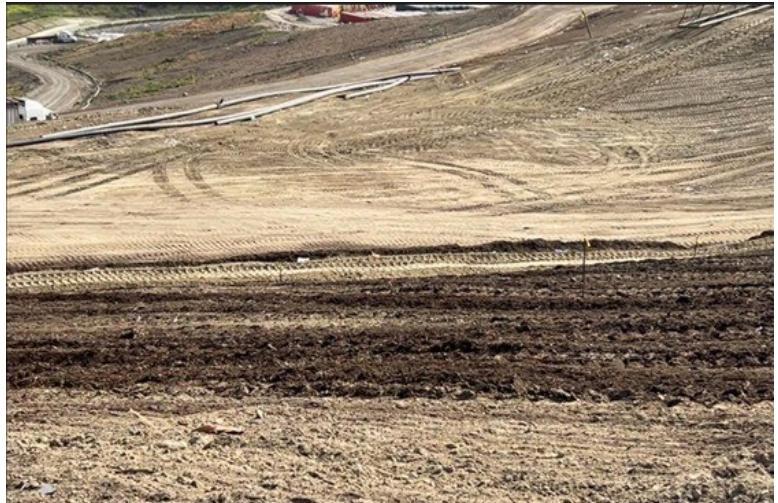
Photo #4

Description: In progress placement of soil barrier.

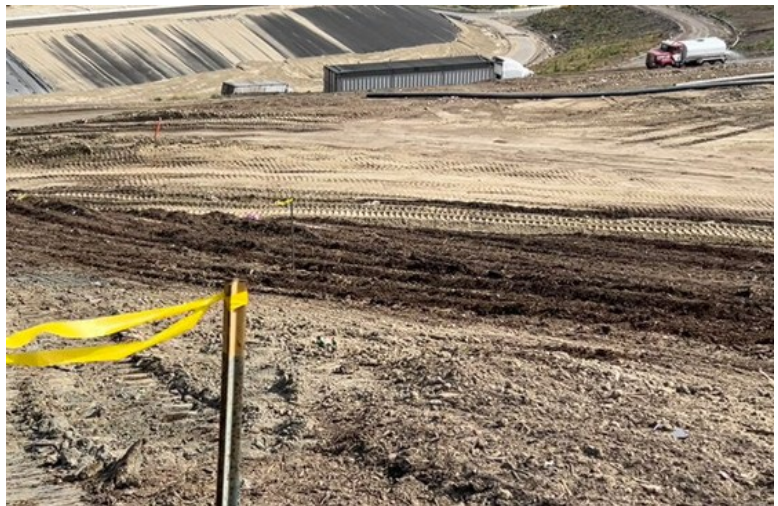
Photo #5

Description: In progress placement of soil barrier.

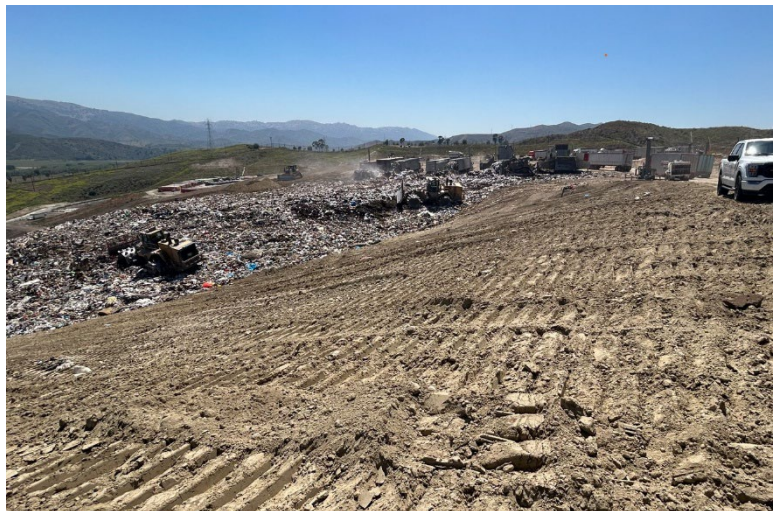
Photo #6

Description: Finished grade of soil barrier.

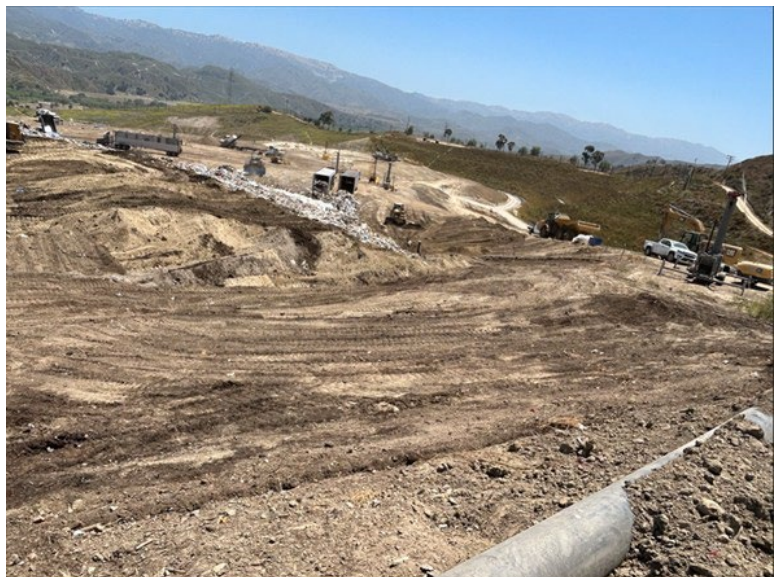
Photo #9

Description: Finished grade of soil barrier.

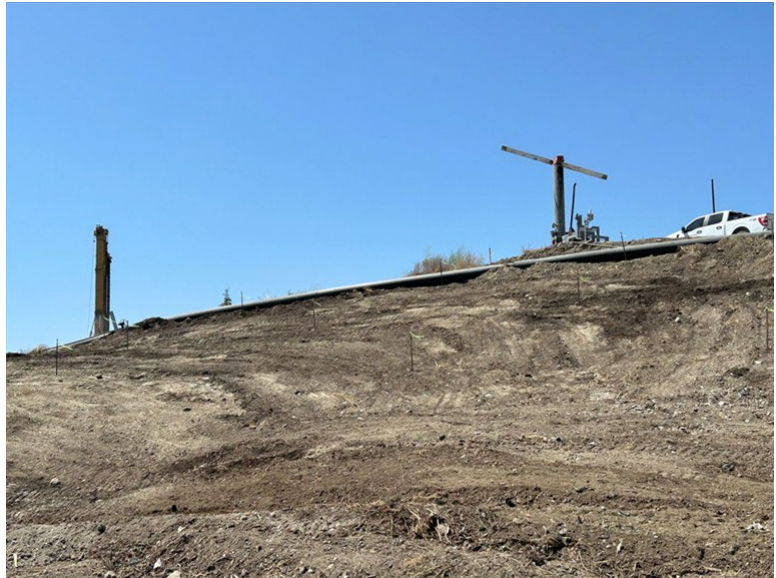
Photo #10

Description: Staking northeast slope for 5 feet of soil barrier.

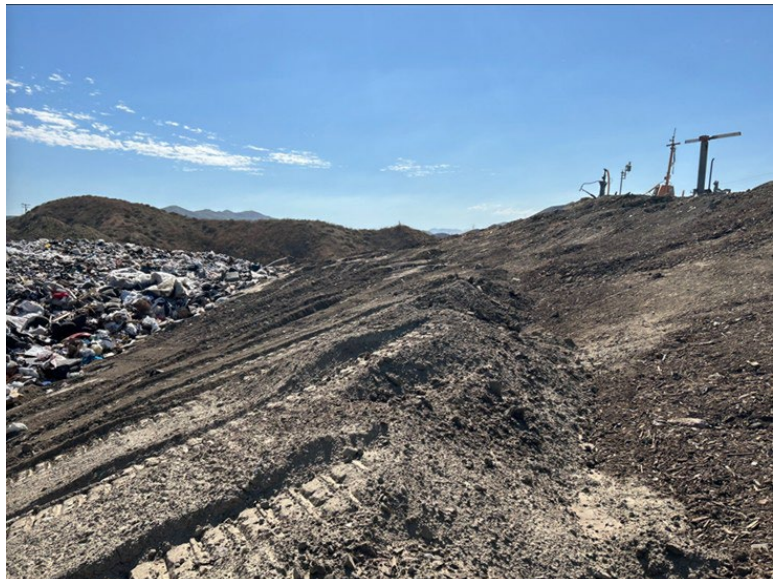
Photo #11

Description: In progress of soil barrier being placed on the northeast slope

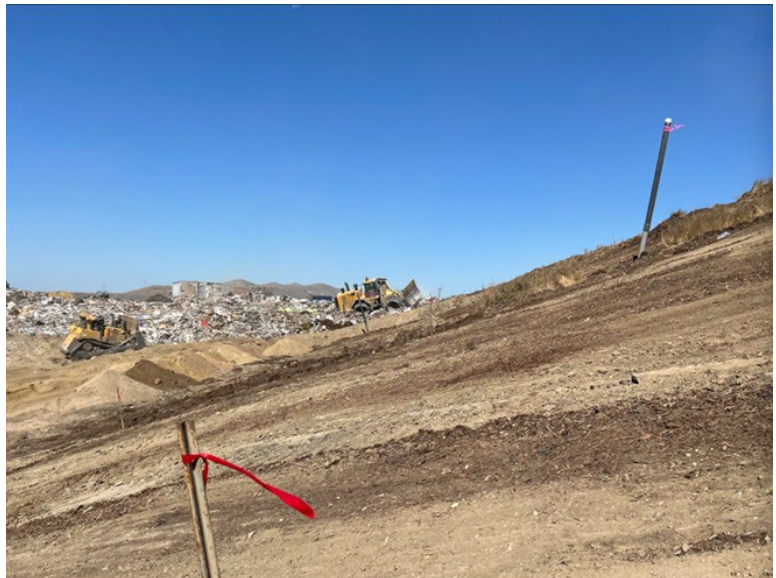
Photo #12

Description: Staking for placement of soil barrier.

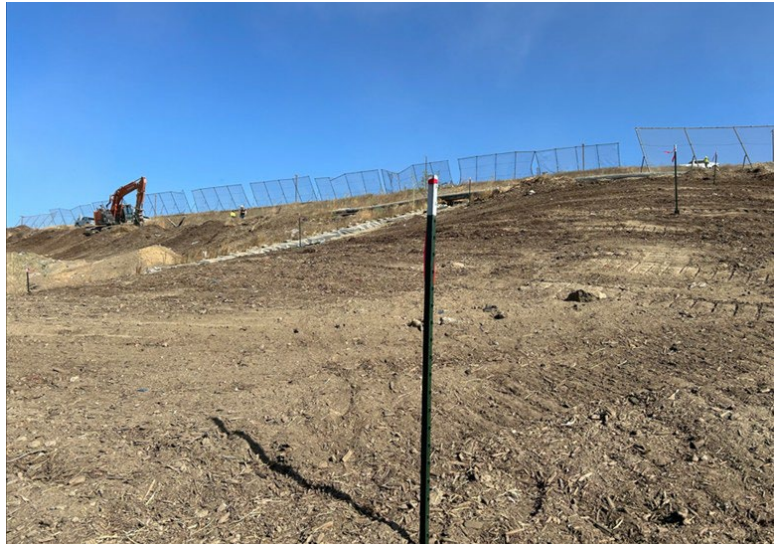
Photo #13

Description: Staking for placement of soil barrier.

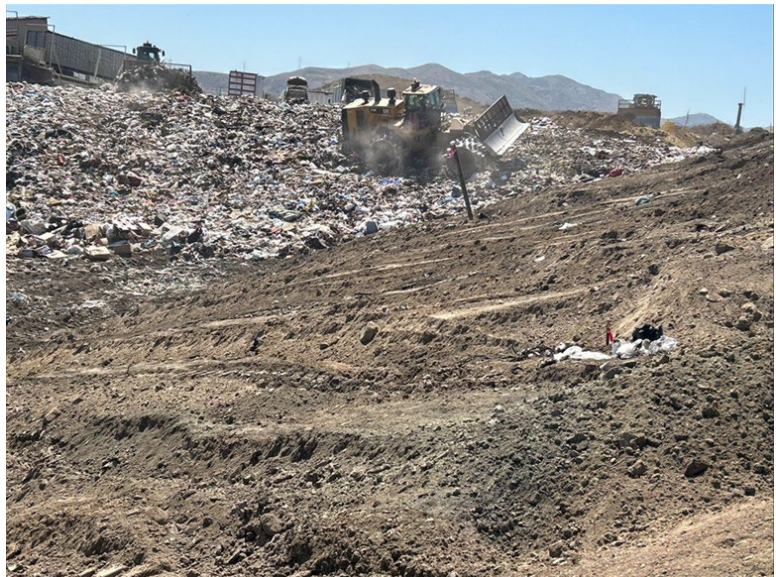
Photo #14

Description: In progress placement of soil barrier. Active waste cell pictured in the background placed over the already in place soil barrier.

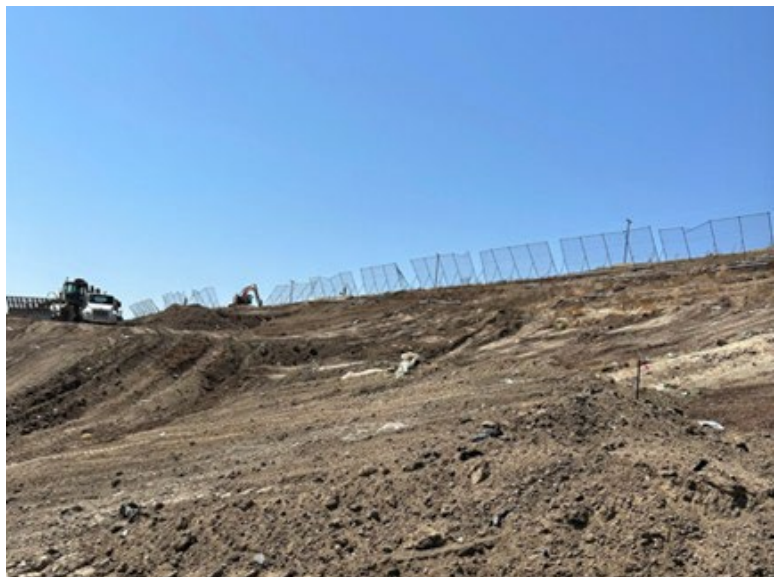
Photo #15

Description: In progress placement of soil barrier.

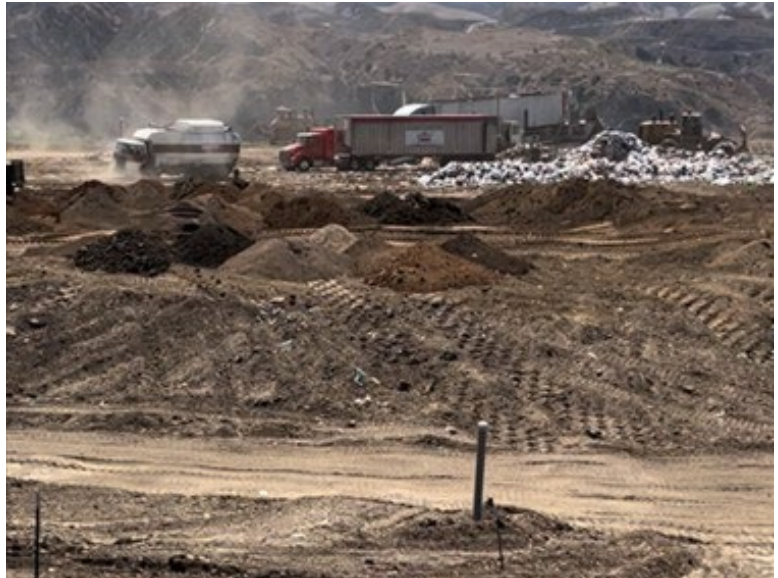
Photo #16

Description: Staking for soil barrier.

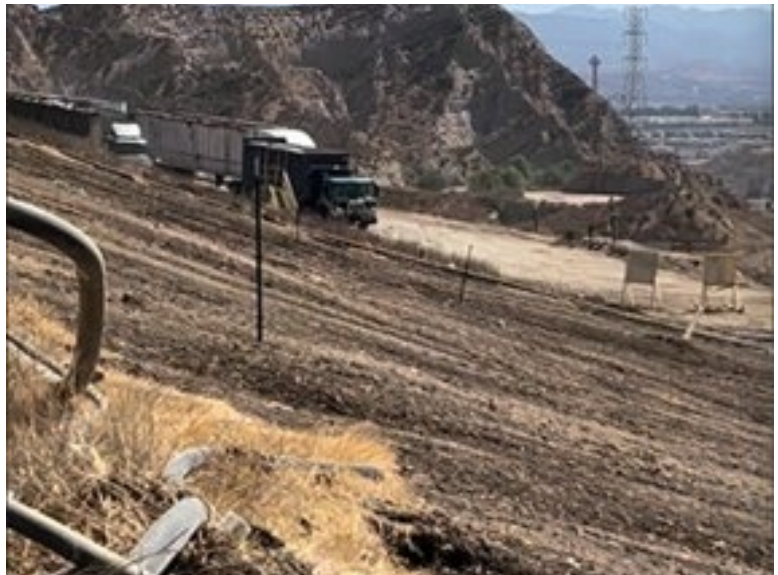
Photo #17

Description: Staking for soil barrier.

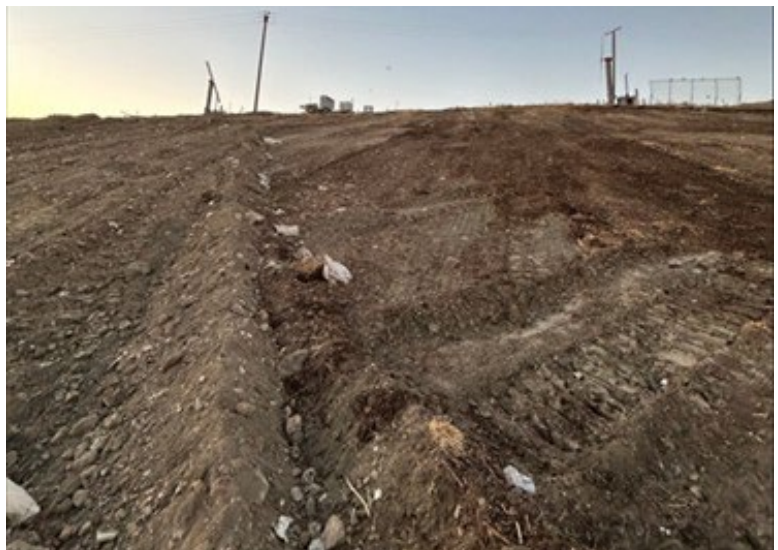
Photo #18

Description: In progress filling of soil barrier.

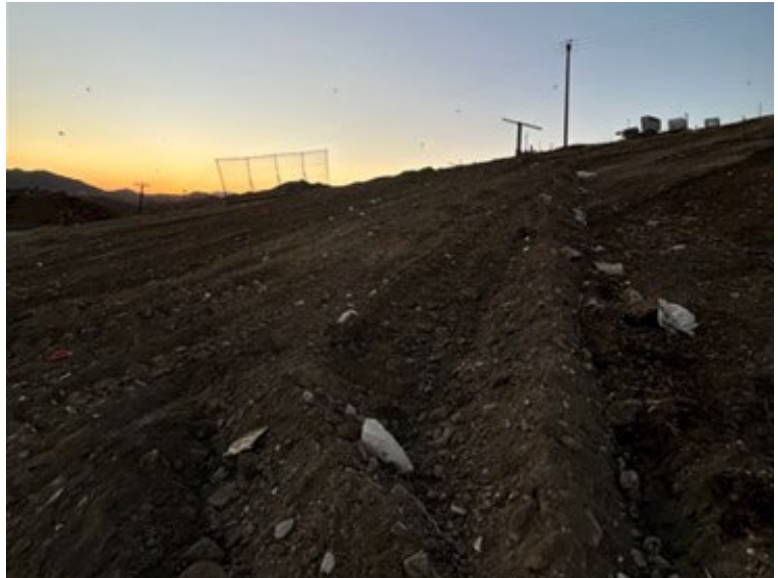
Photo #19

Description: In progress filling of soil barrier.

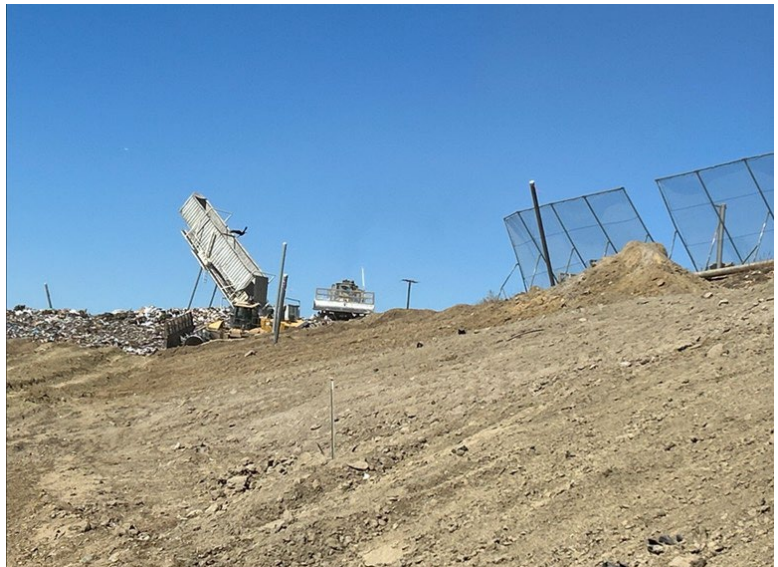
Photo #20

Description: Staking for soil barrier

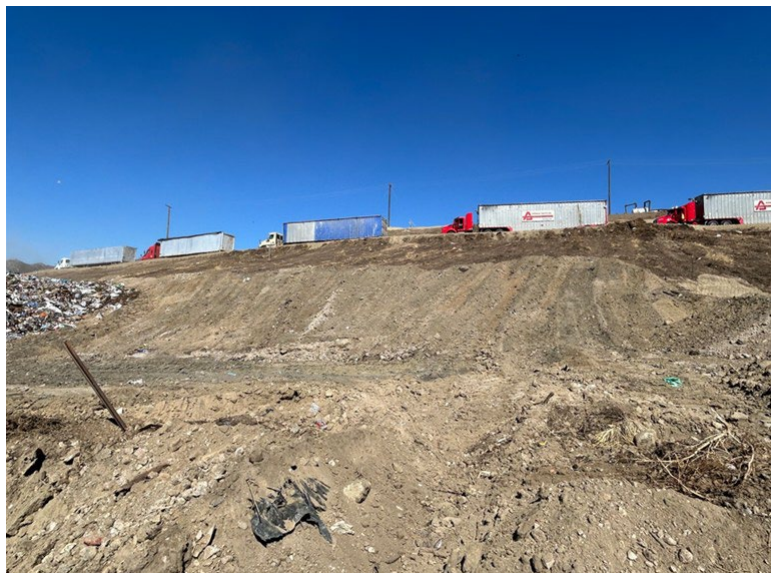
Photo #21

Description: Staking and placement of soil barrier.
