# Construction Quality Assurance Report Chiquita Canyon Landfill Soil Barrier Construction Project

01204123.41 | May 2025  
Revised January 2026

Construction Quality Assurance Report

Soil Barrier Construction Project

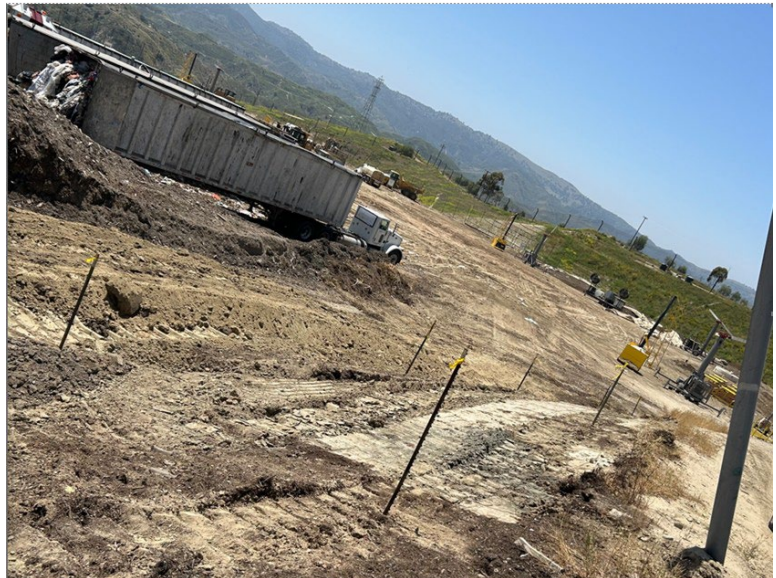
Description: Staking for placement of 5 ft soil barrier.

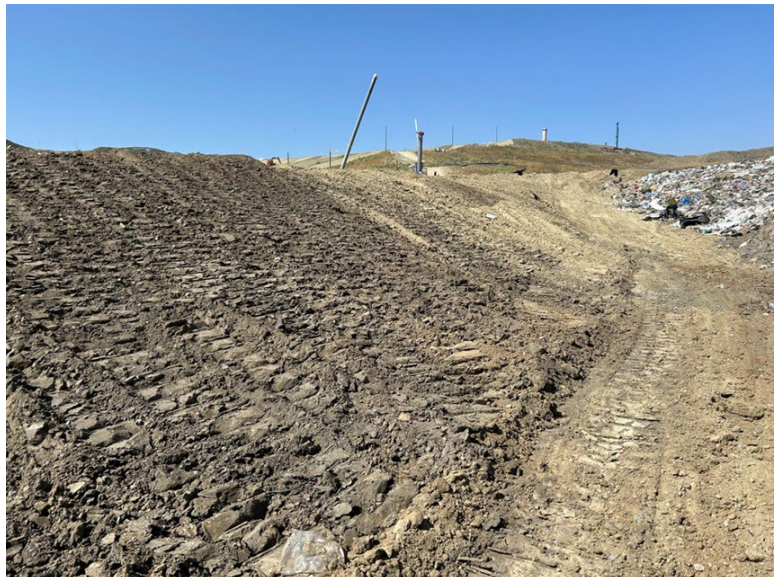
Photo #2

Description: 5 ft soil barrier placed to the top of the stakes.

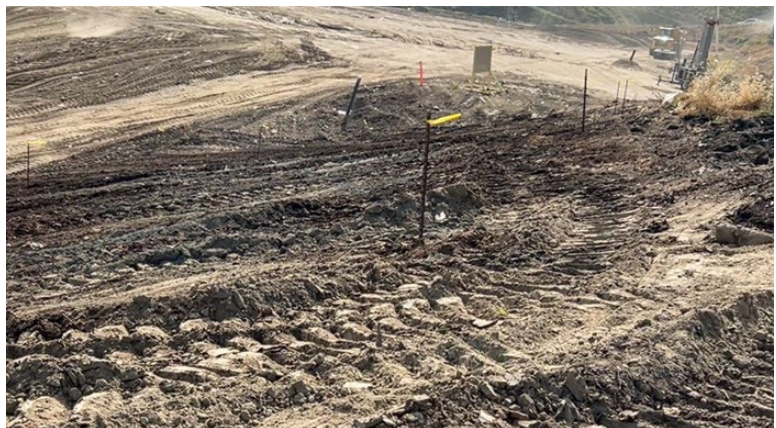
Photo #3

Description: Staking for placement of 5 feet soil barrier.

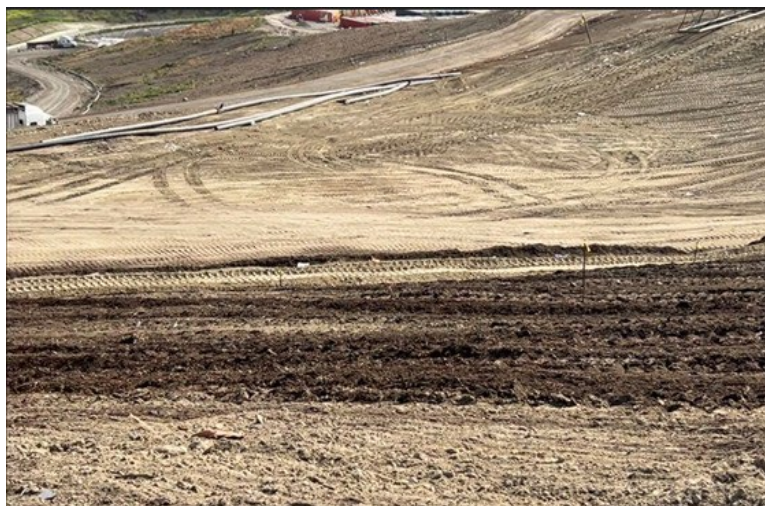
Photo #4

Description: In progress placement of soil barrier.

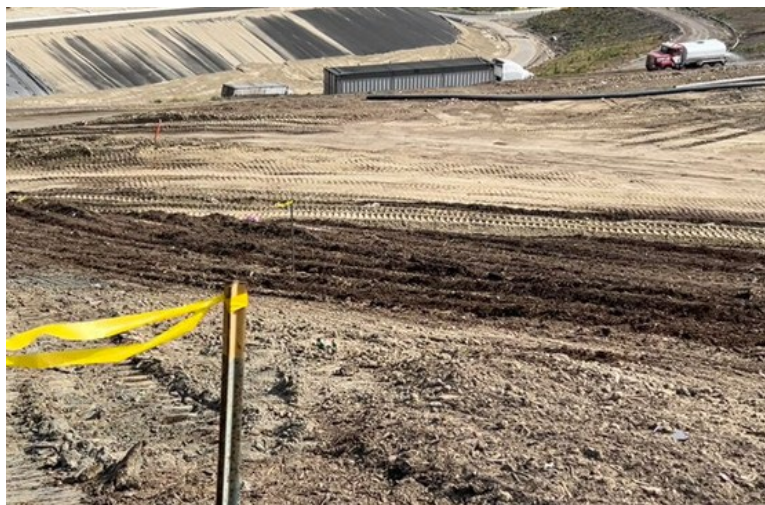
Photo #5

Description: In progress placement of soil barrier.

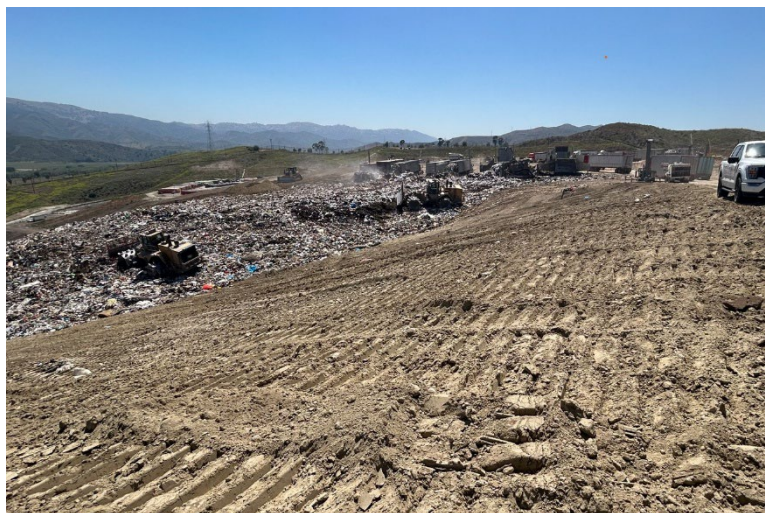
Photo #6

Description: Finished grade of soil barrier.

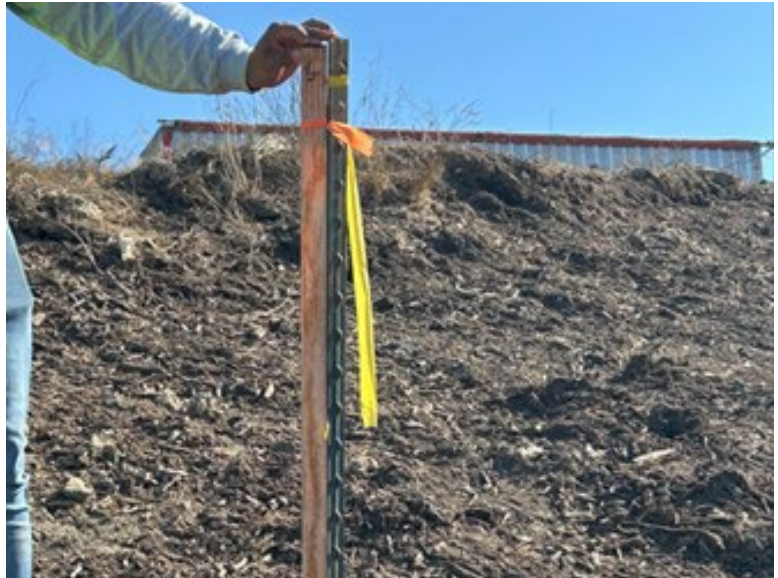
Photo #7

Description: Staking slope for 5 feet of soil barrier.

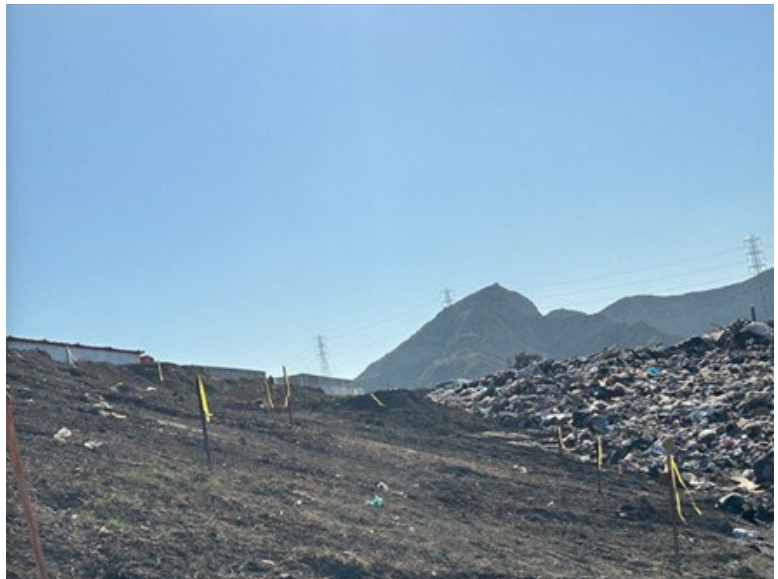
Photo #8

Description: Staking southwest slope for 5 feet of soil barrier.

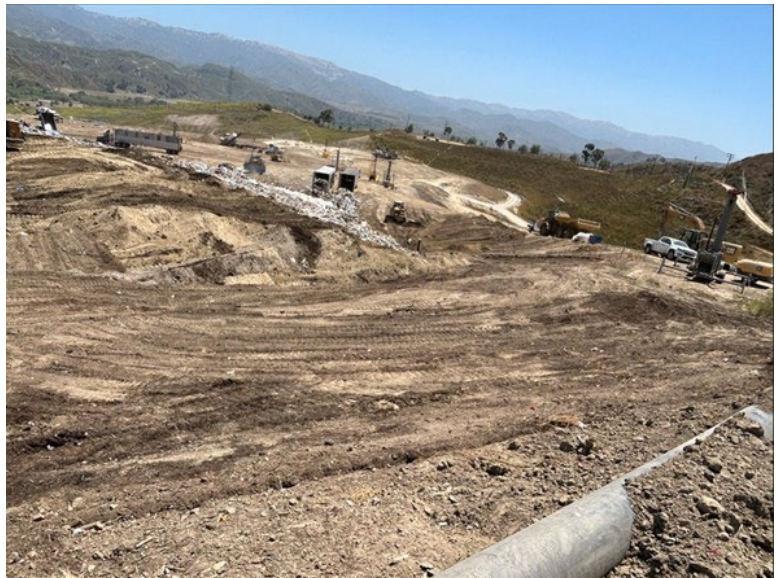
Photo #9

Description: Finished grade of soil barrier.

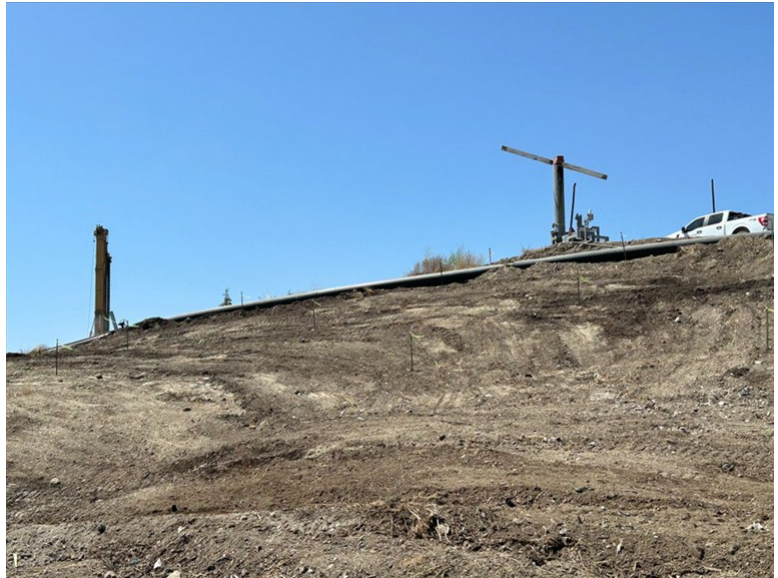
Photo #10

Description: Staking northeast slope for 5 feet of soil barrier.

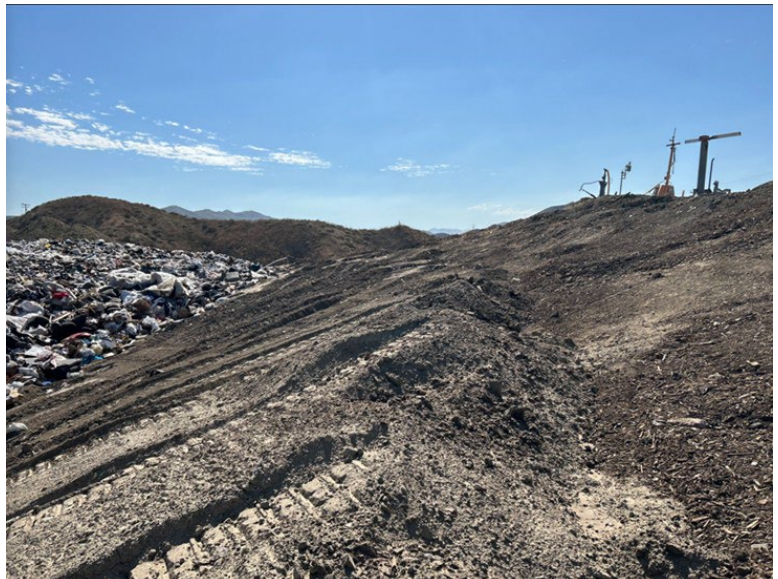
Photo #11

Description: In progress of soil barrier being placed on the northeast slope

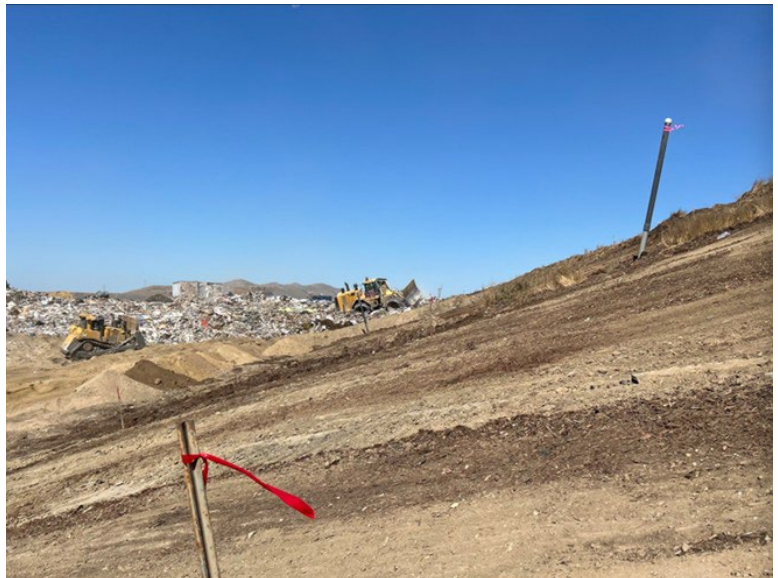
Photo #12

Description: Staking for placement of soil barrier.

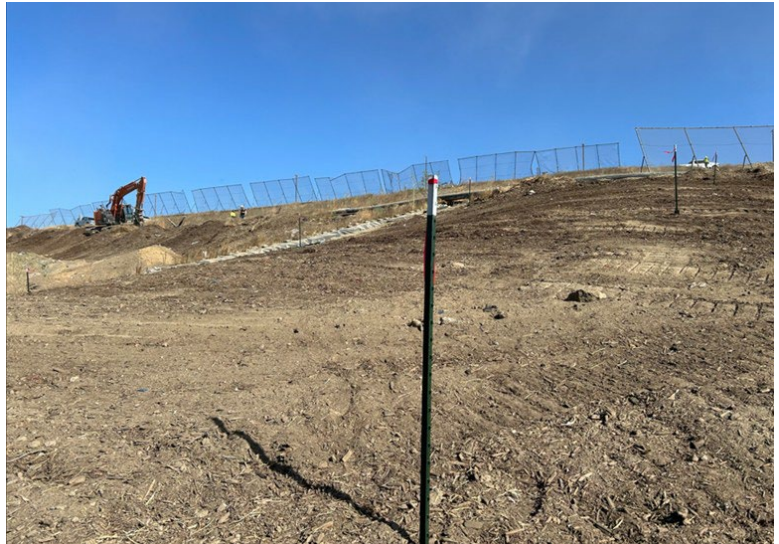
Photo #13

Description: Staking for placement of soil barrier.

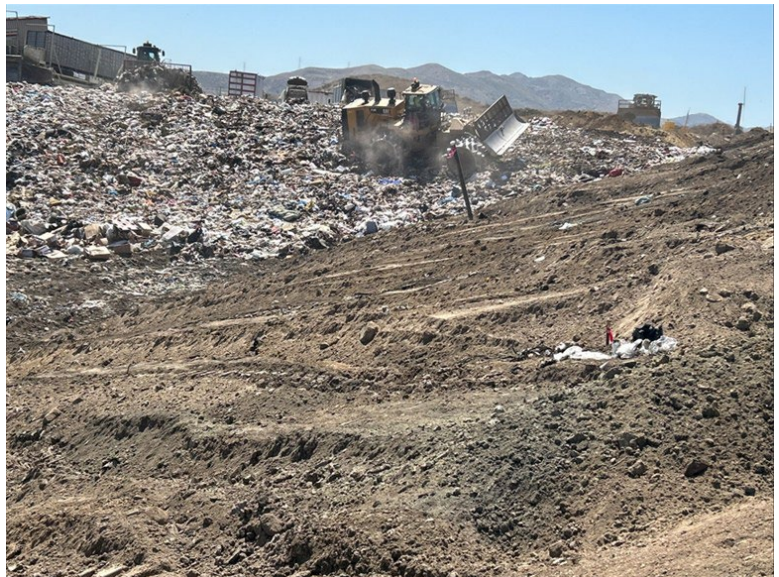
Photo #14

Description: In progress placement of soil barrier. Active waste cell pictured in the background placed over the already in place soil barrier.

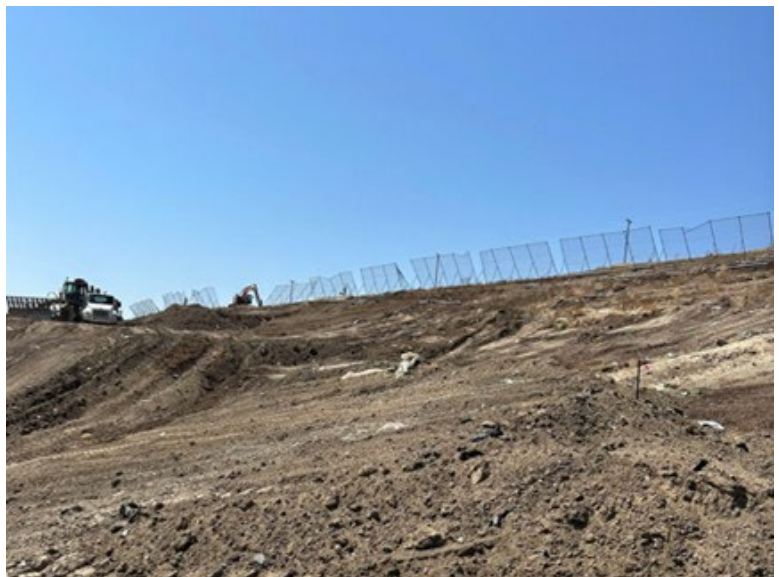
Photo #15

Description: In progress placement of soil barrier.

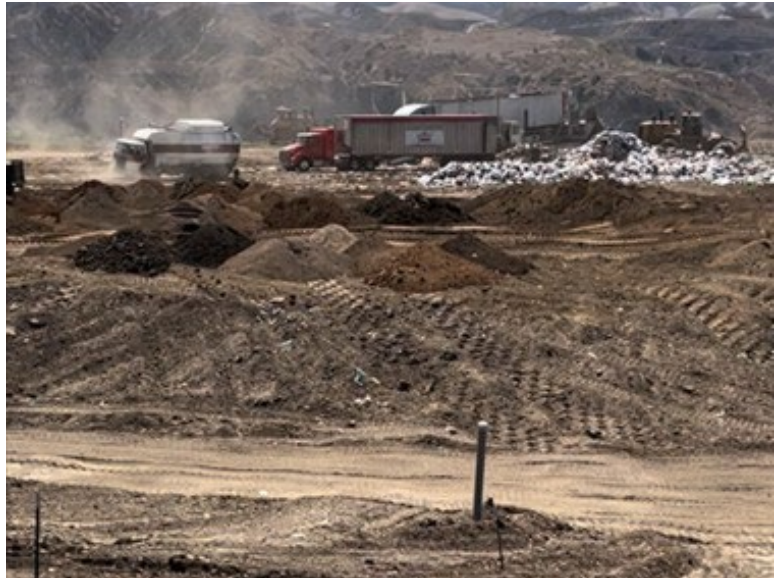
Photo #16

Description: Staking for soil barrier.

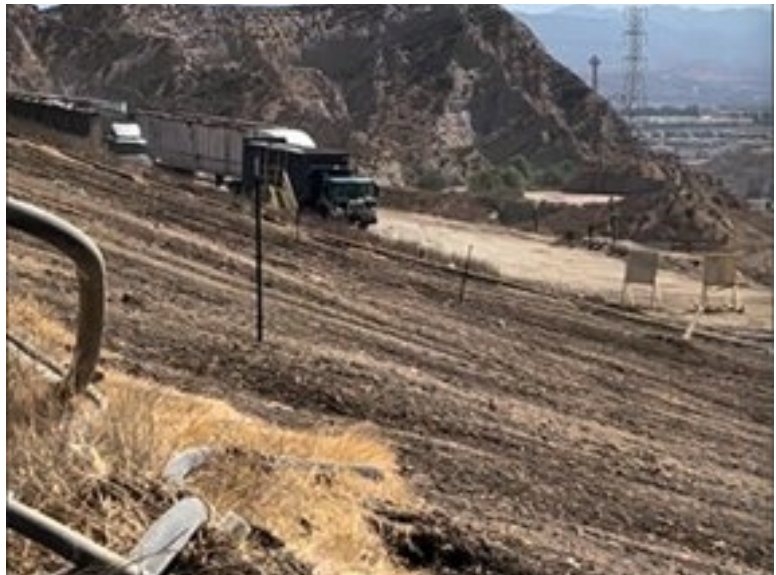
Photo #17

Description: Staking for soil barrier.

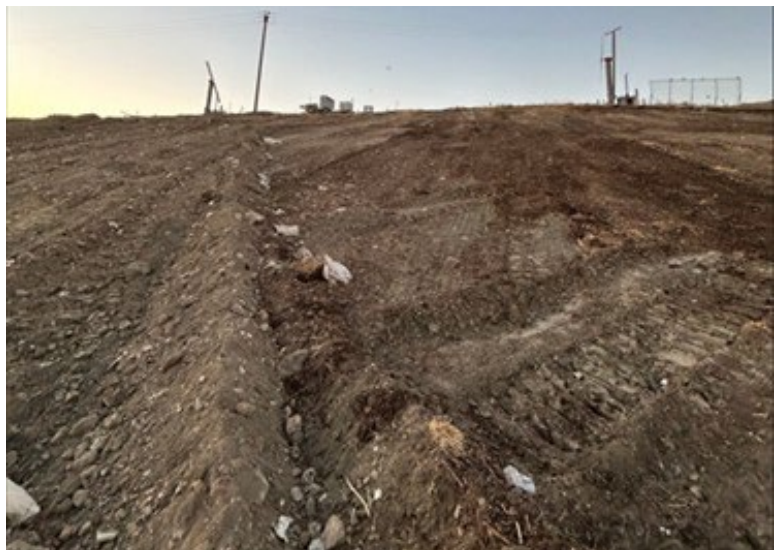
Photo #18

Description: In progress filling of soil barrier.

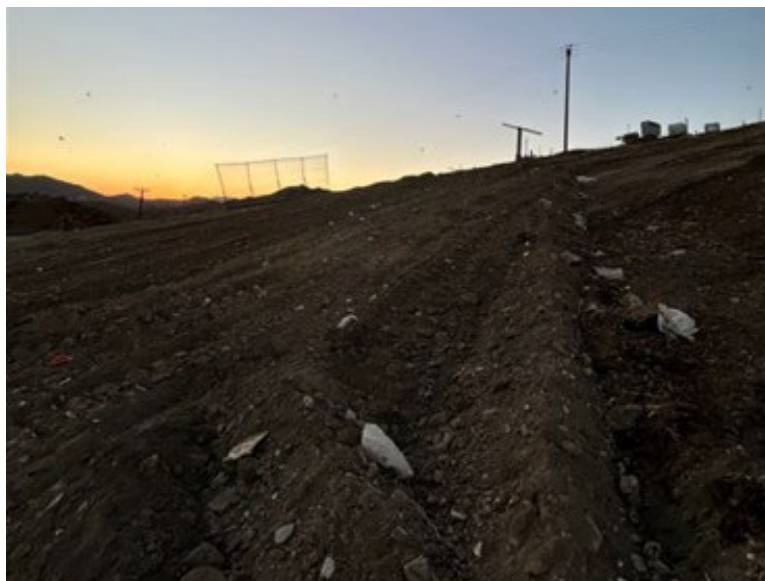
Photo #19

Description: In progress filling of soil barrier.

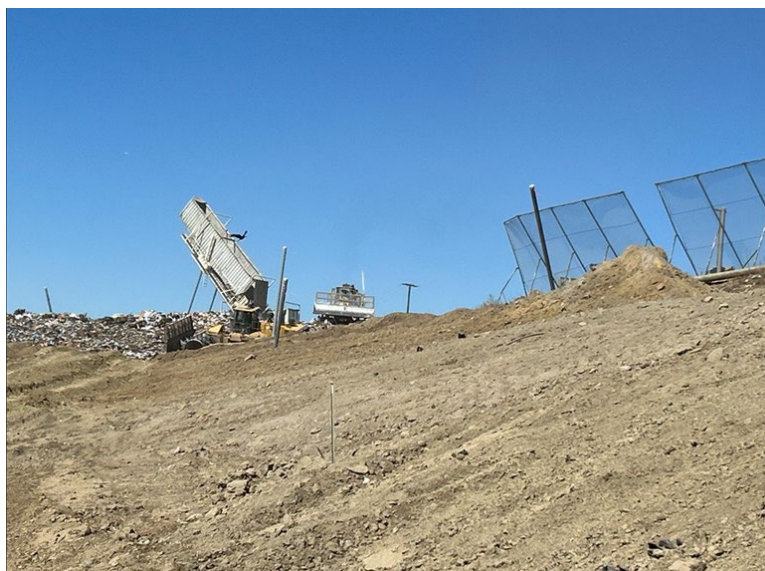
Photo #20

Description: Staking for soil barrier

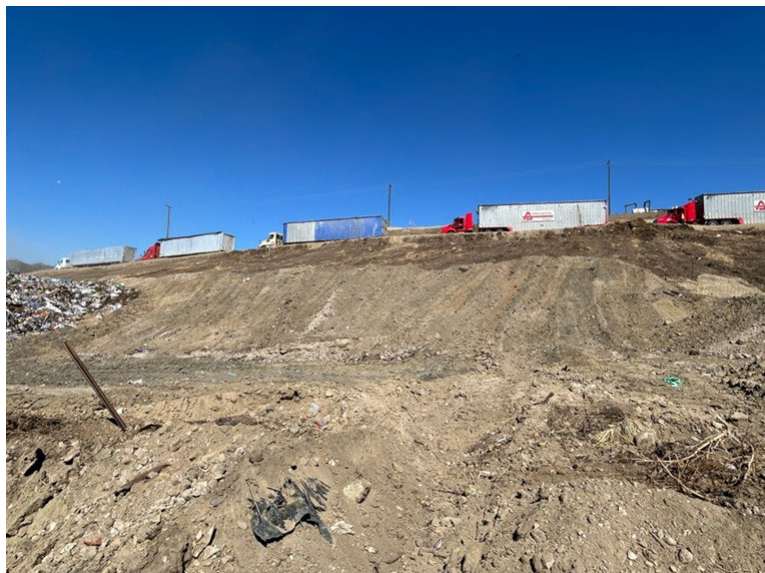
Photo #21

Description: Staking and placement of soil barrier.
