# CHIQUITA CANYON

**Re: Chiquita Canyon, LLC's Weekly Report on the Documentation and Tracking of Cover Issues**

# **Fissures and Tension Cracks**

# 4050 - Geosynthetic Cover Inspection

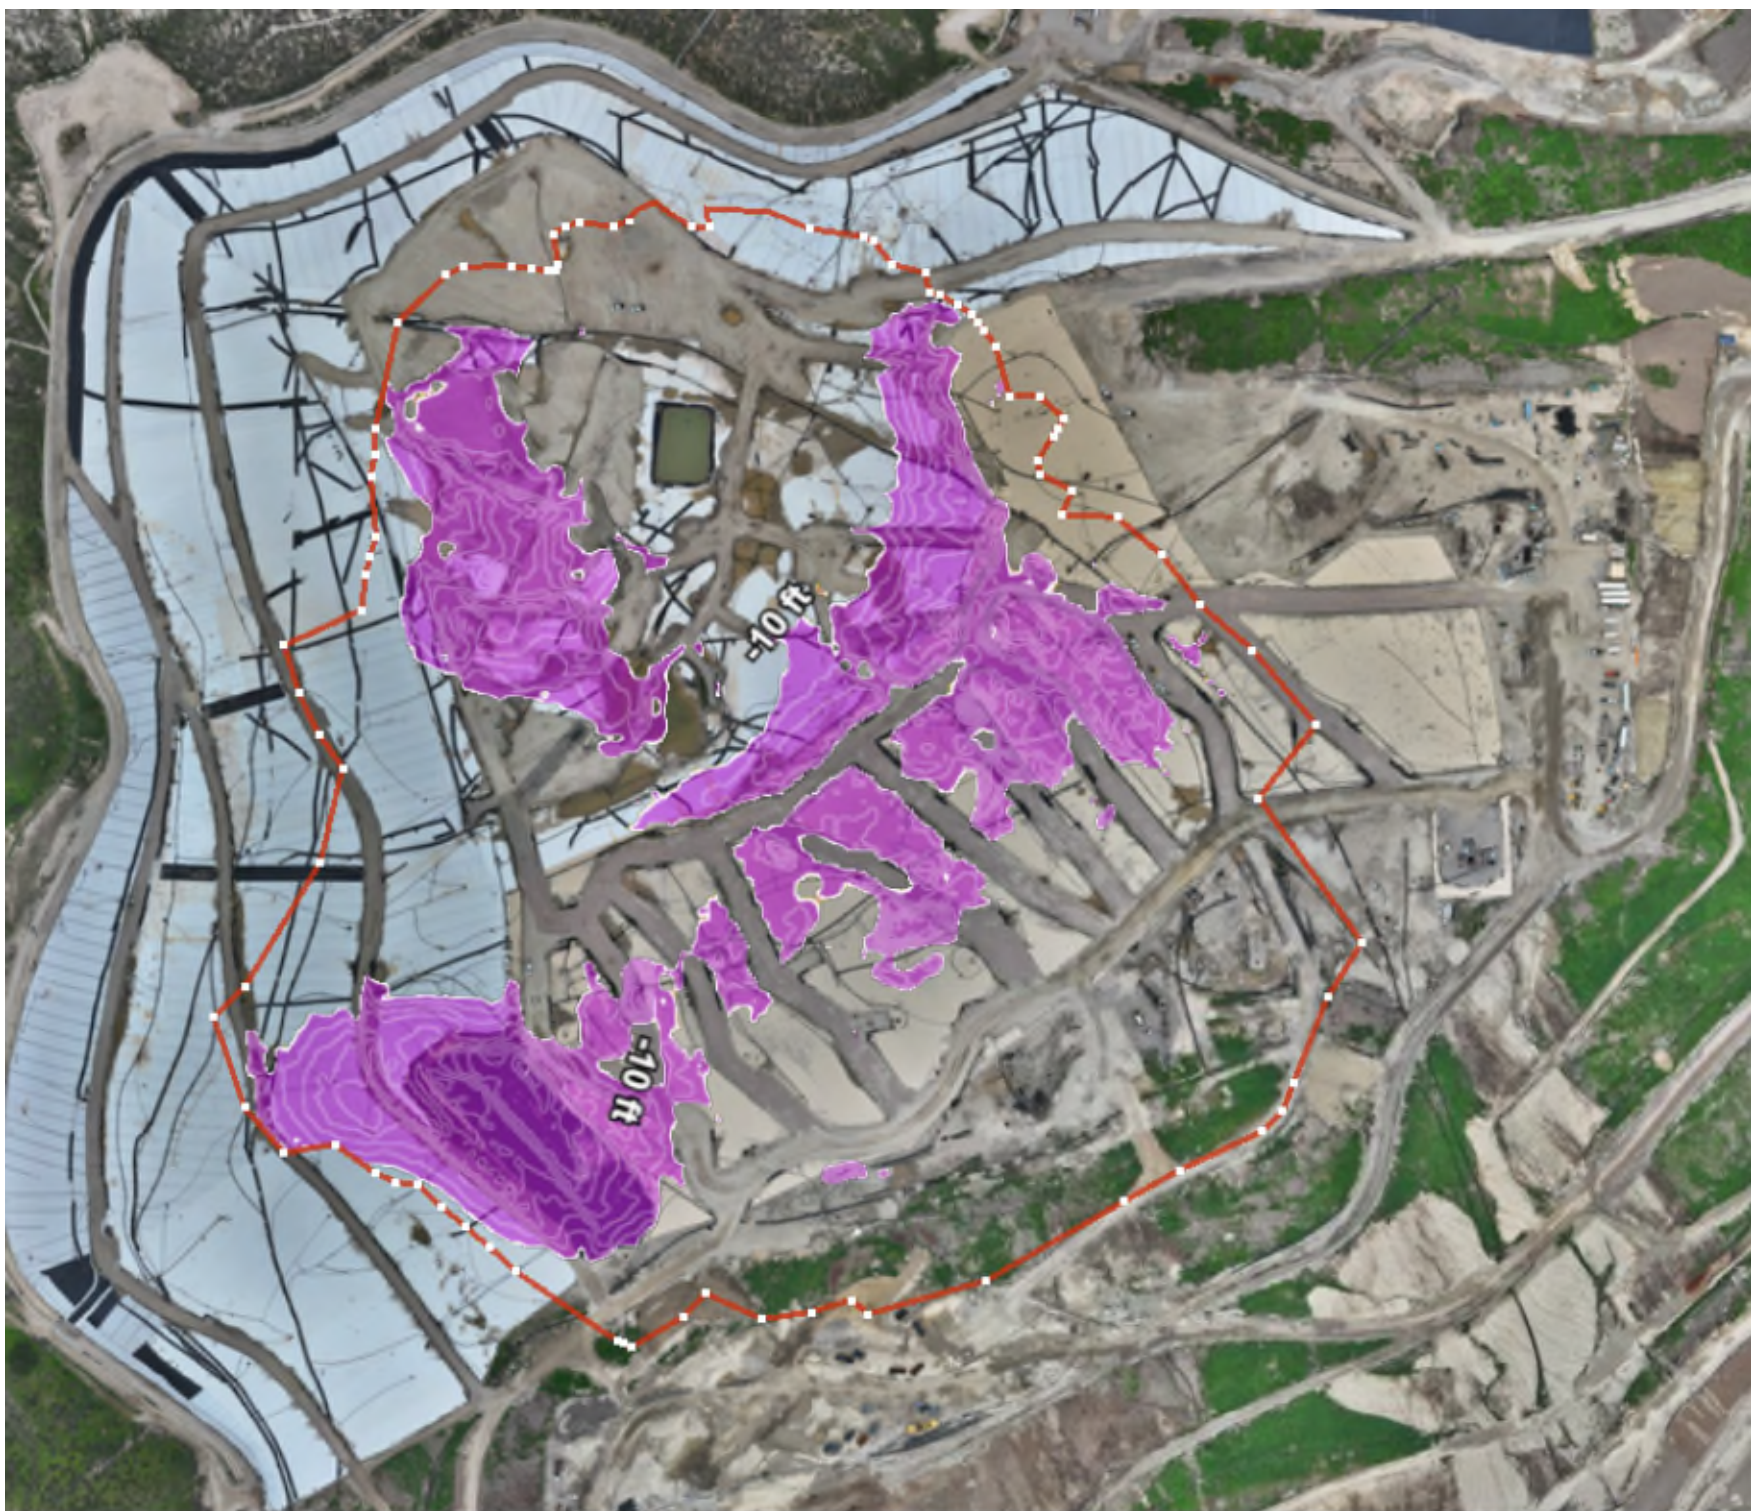
- The map shows the area between 12/26/2024 and 12/30/2025 where the grades have changed more than 10 feet. A typical MSW strain rate is 3% per year - for a landfill with a 300-foot waste column, this would be 9 feet per year.

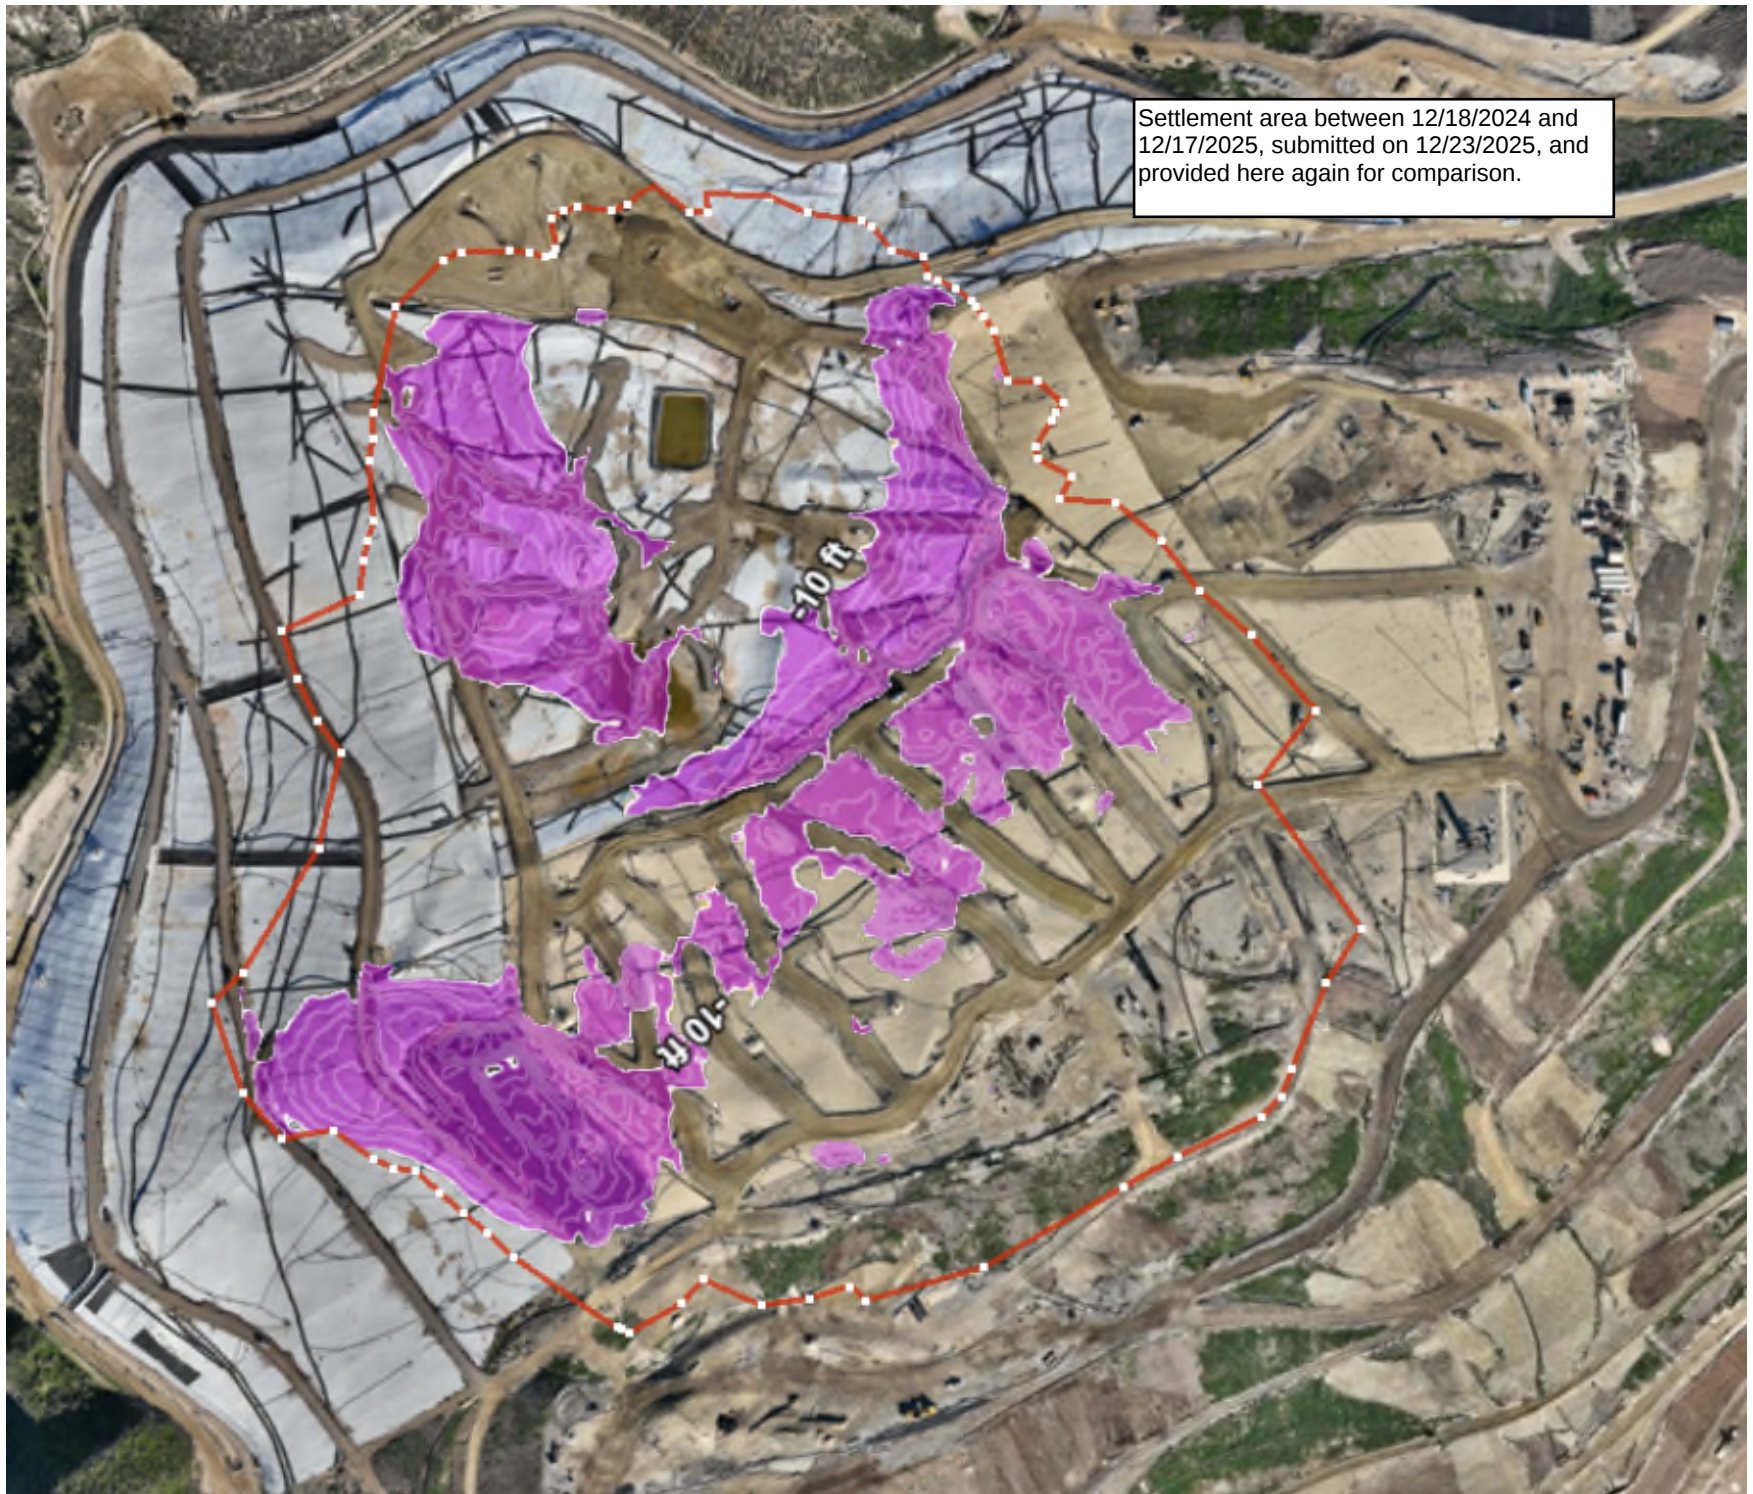
Settlement area between 12/18/2024 and 12/17/2025, submitted on 12/23/2025, and provided here again for comparison.

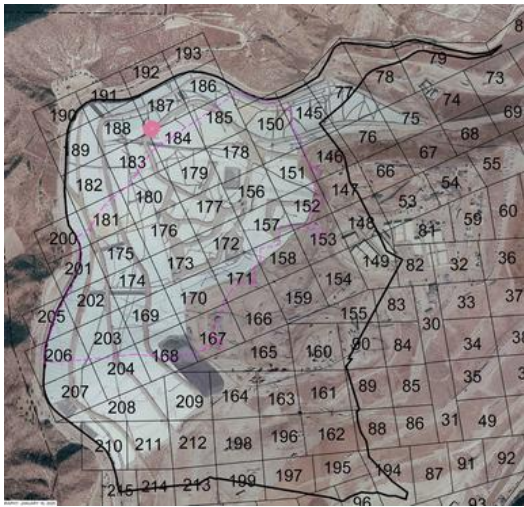
Grid 187

Tear in liner needs to be patched/extrusion welded.

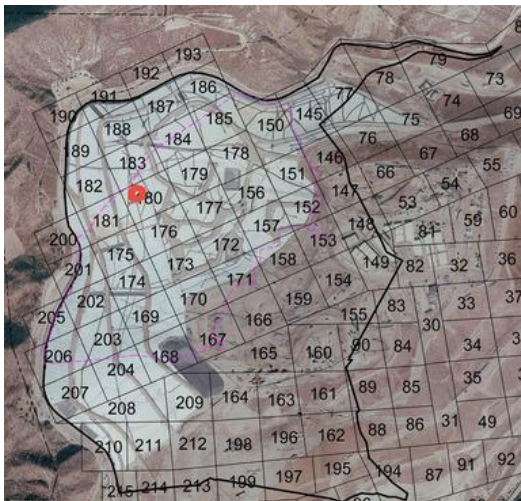
Grid 180

Three tears in liner side by side need to be patched and extrusion welded.
