CHIQUITA CANYON
A Waste Connections Company

January 9, 2026

**Subject: Leachate Leak Report
Chiquita Canyon Landfill
File No. 67-020**

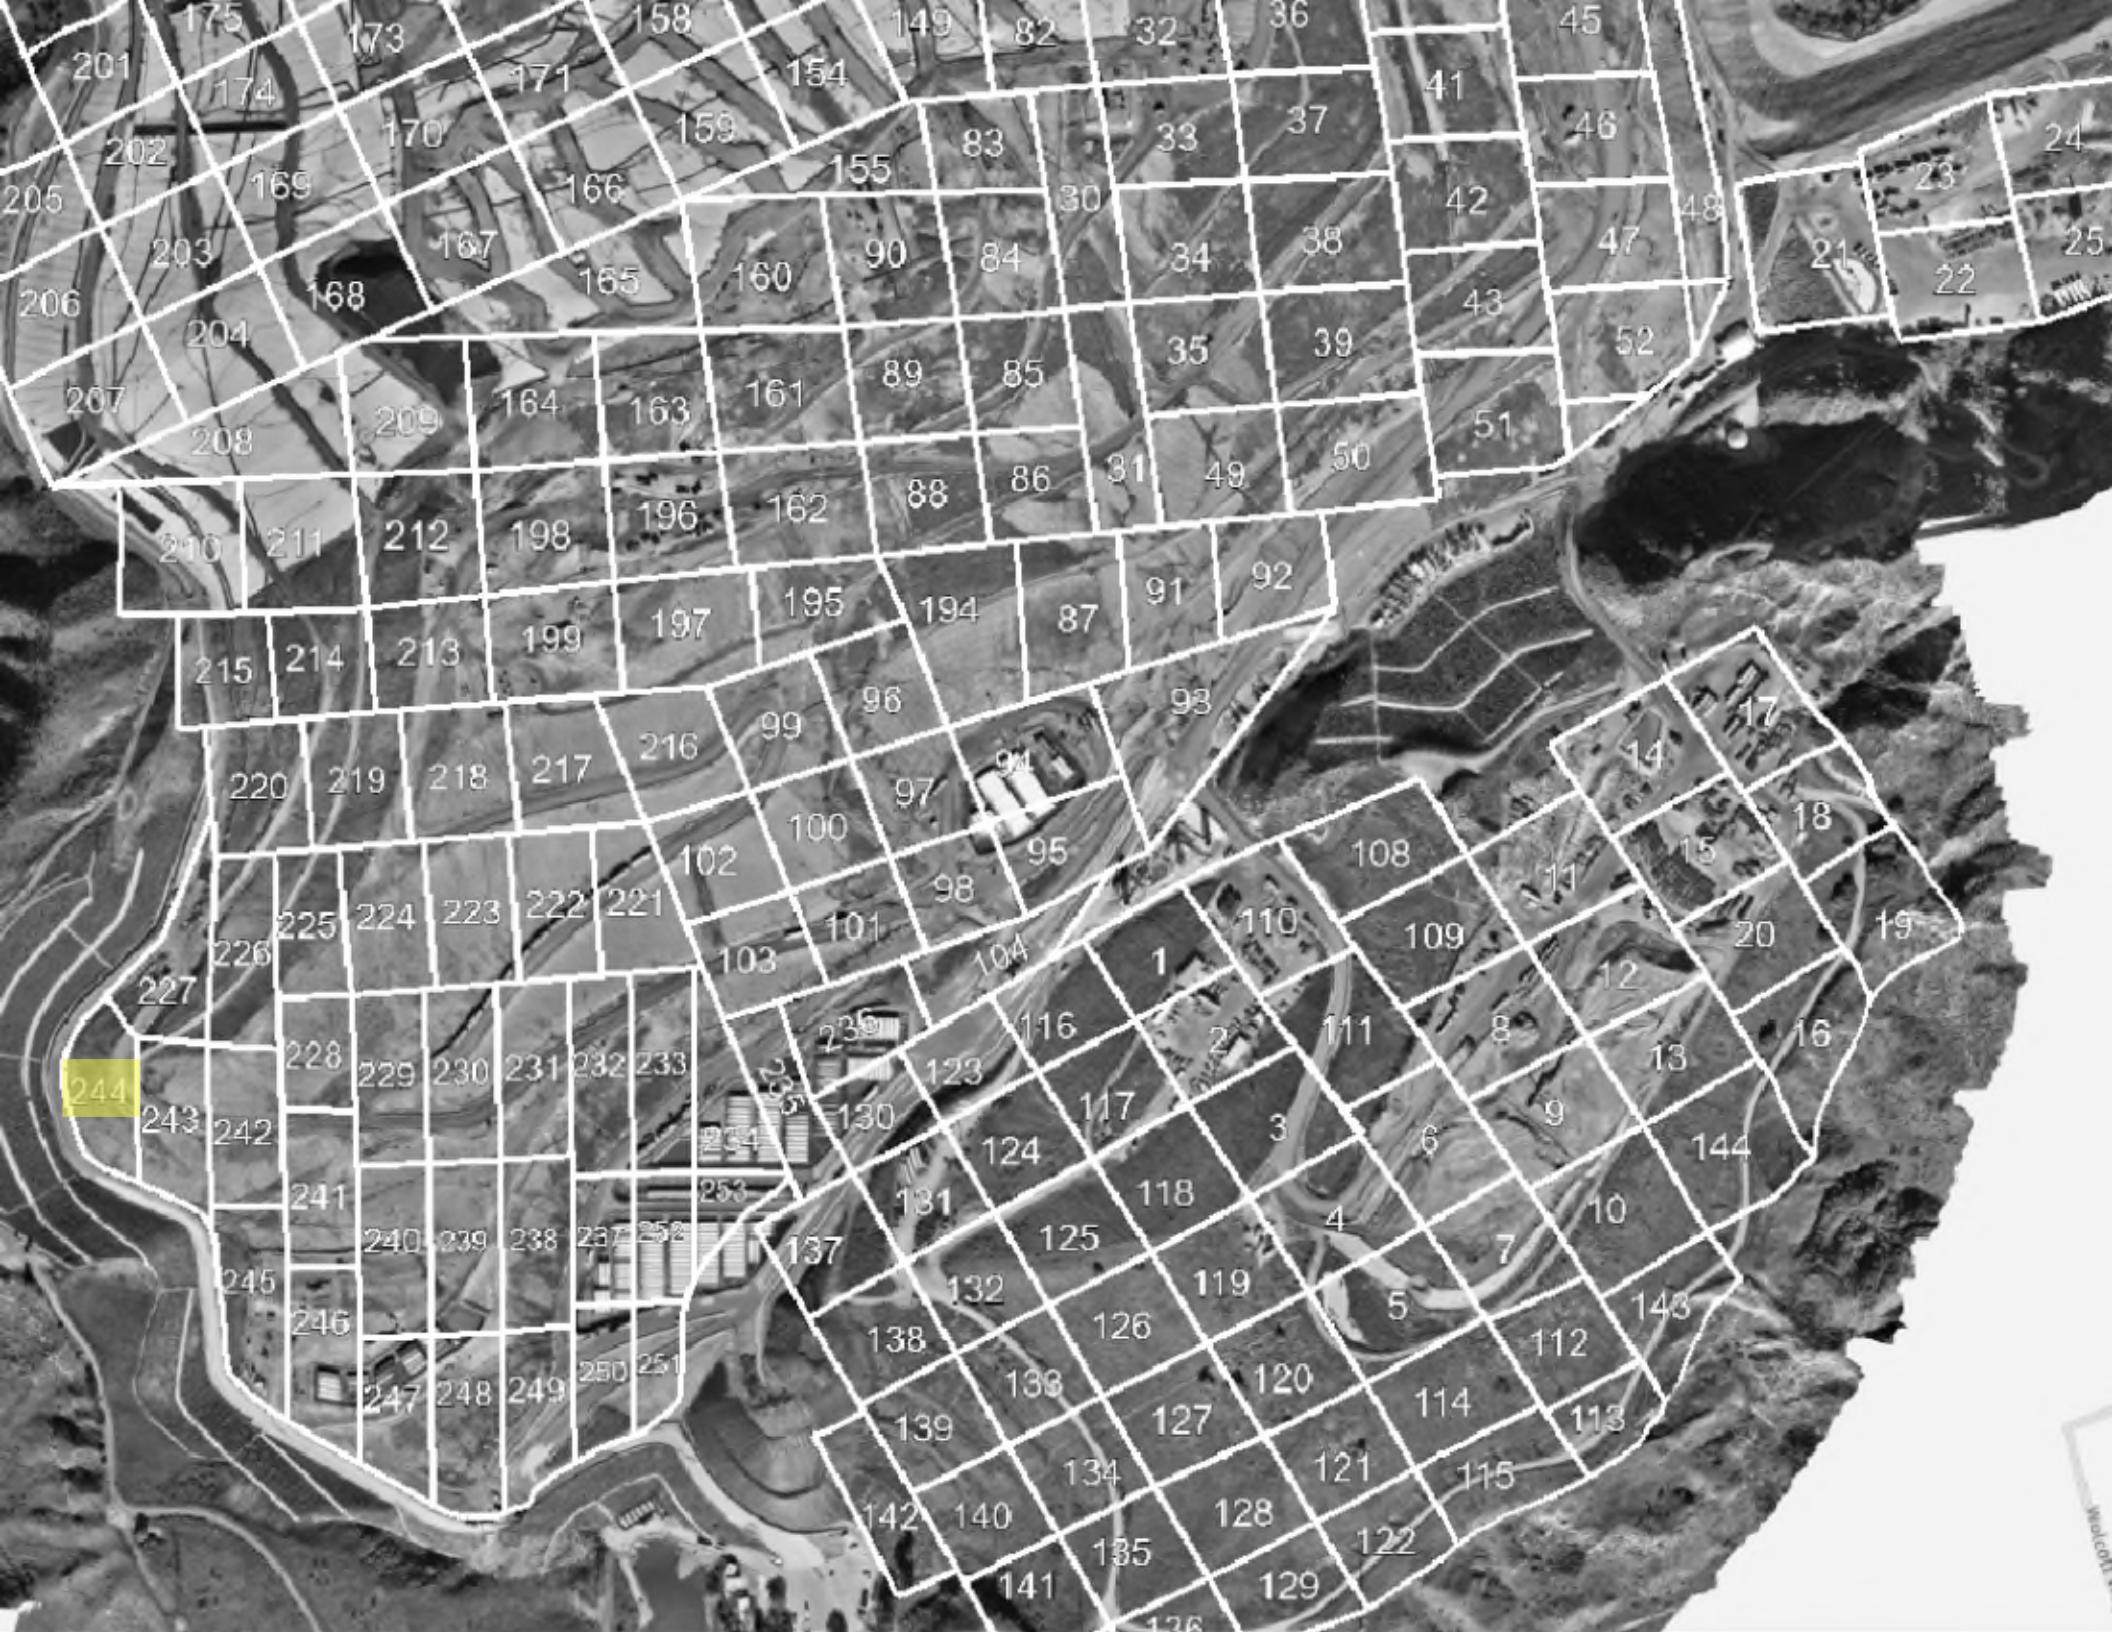
Attachments: Attachment A – Map depicting the location of the leak

The leak occurred from sump 7 located in grid 244 – as depicted in Attachment A.

- On January 4, 2026, at approximately 9:00 a.m., to the best of Chiquita’s knowledge, the sump pump on sump 7 shut down because the liquid levels in the sump’s casing were too low indicating that the sump’s casing was obstructing the flow of liquid. Chiquita attributes this leak to equipment malfunction. The liquid from the leak was dark brown in color with low viscosity, and traveled as a light trickle.

To prevent similar leaks from occurring in the future, Chiquita will disassemble the sump pump and add more perforations to the casing to allow liquid to enter more freely. The additional perforations will allow more liquid into the sump, which should prevent similar leaks in the future. Chiquita anticipates that these repairs will be completed by January 20, 2026.
