Re: Chiquita Canyon, LLC's Weekly Report on the Documentation and Tracking of Cover Issues, Monthly Summary and Monthly Isopach Map

4050 - Chiquita Reaction Area Tracking of Fissures and Tension Cracks

4050 - Geosynthetic Cover Inspection

**DECEMBER 2025 FISSURE AND TENSION CRACK MONITORING SUMMARY
CHIQUITA CANYON LANDFILL
CASTAIC, CALIFORNIA**

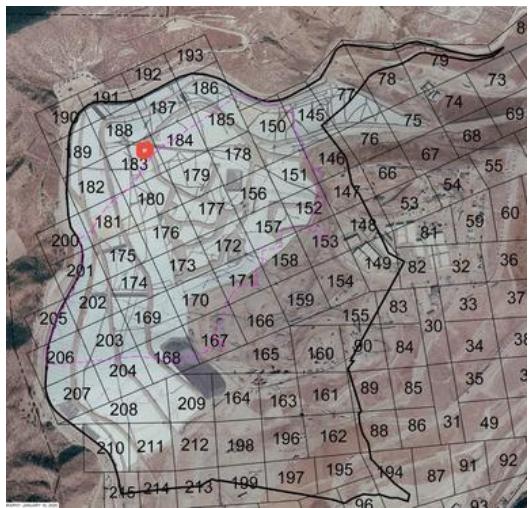
Grid 183

Tear in liner needs to be patched and extrusion welded.

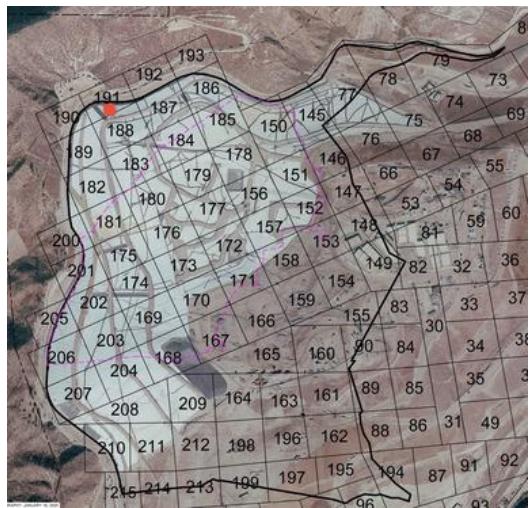
Grid 191

A tear was found in grid 191

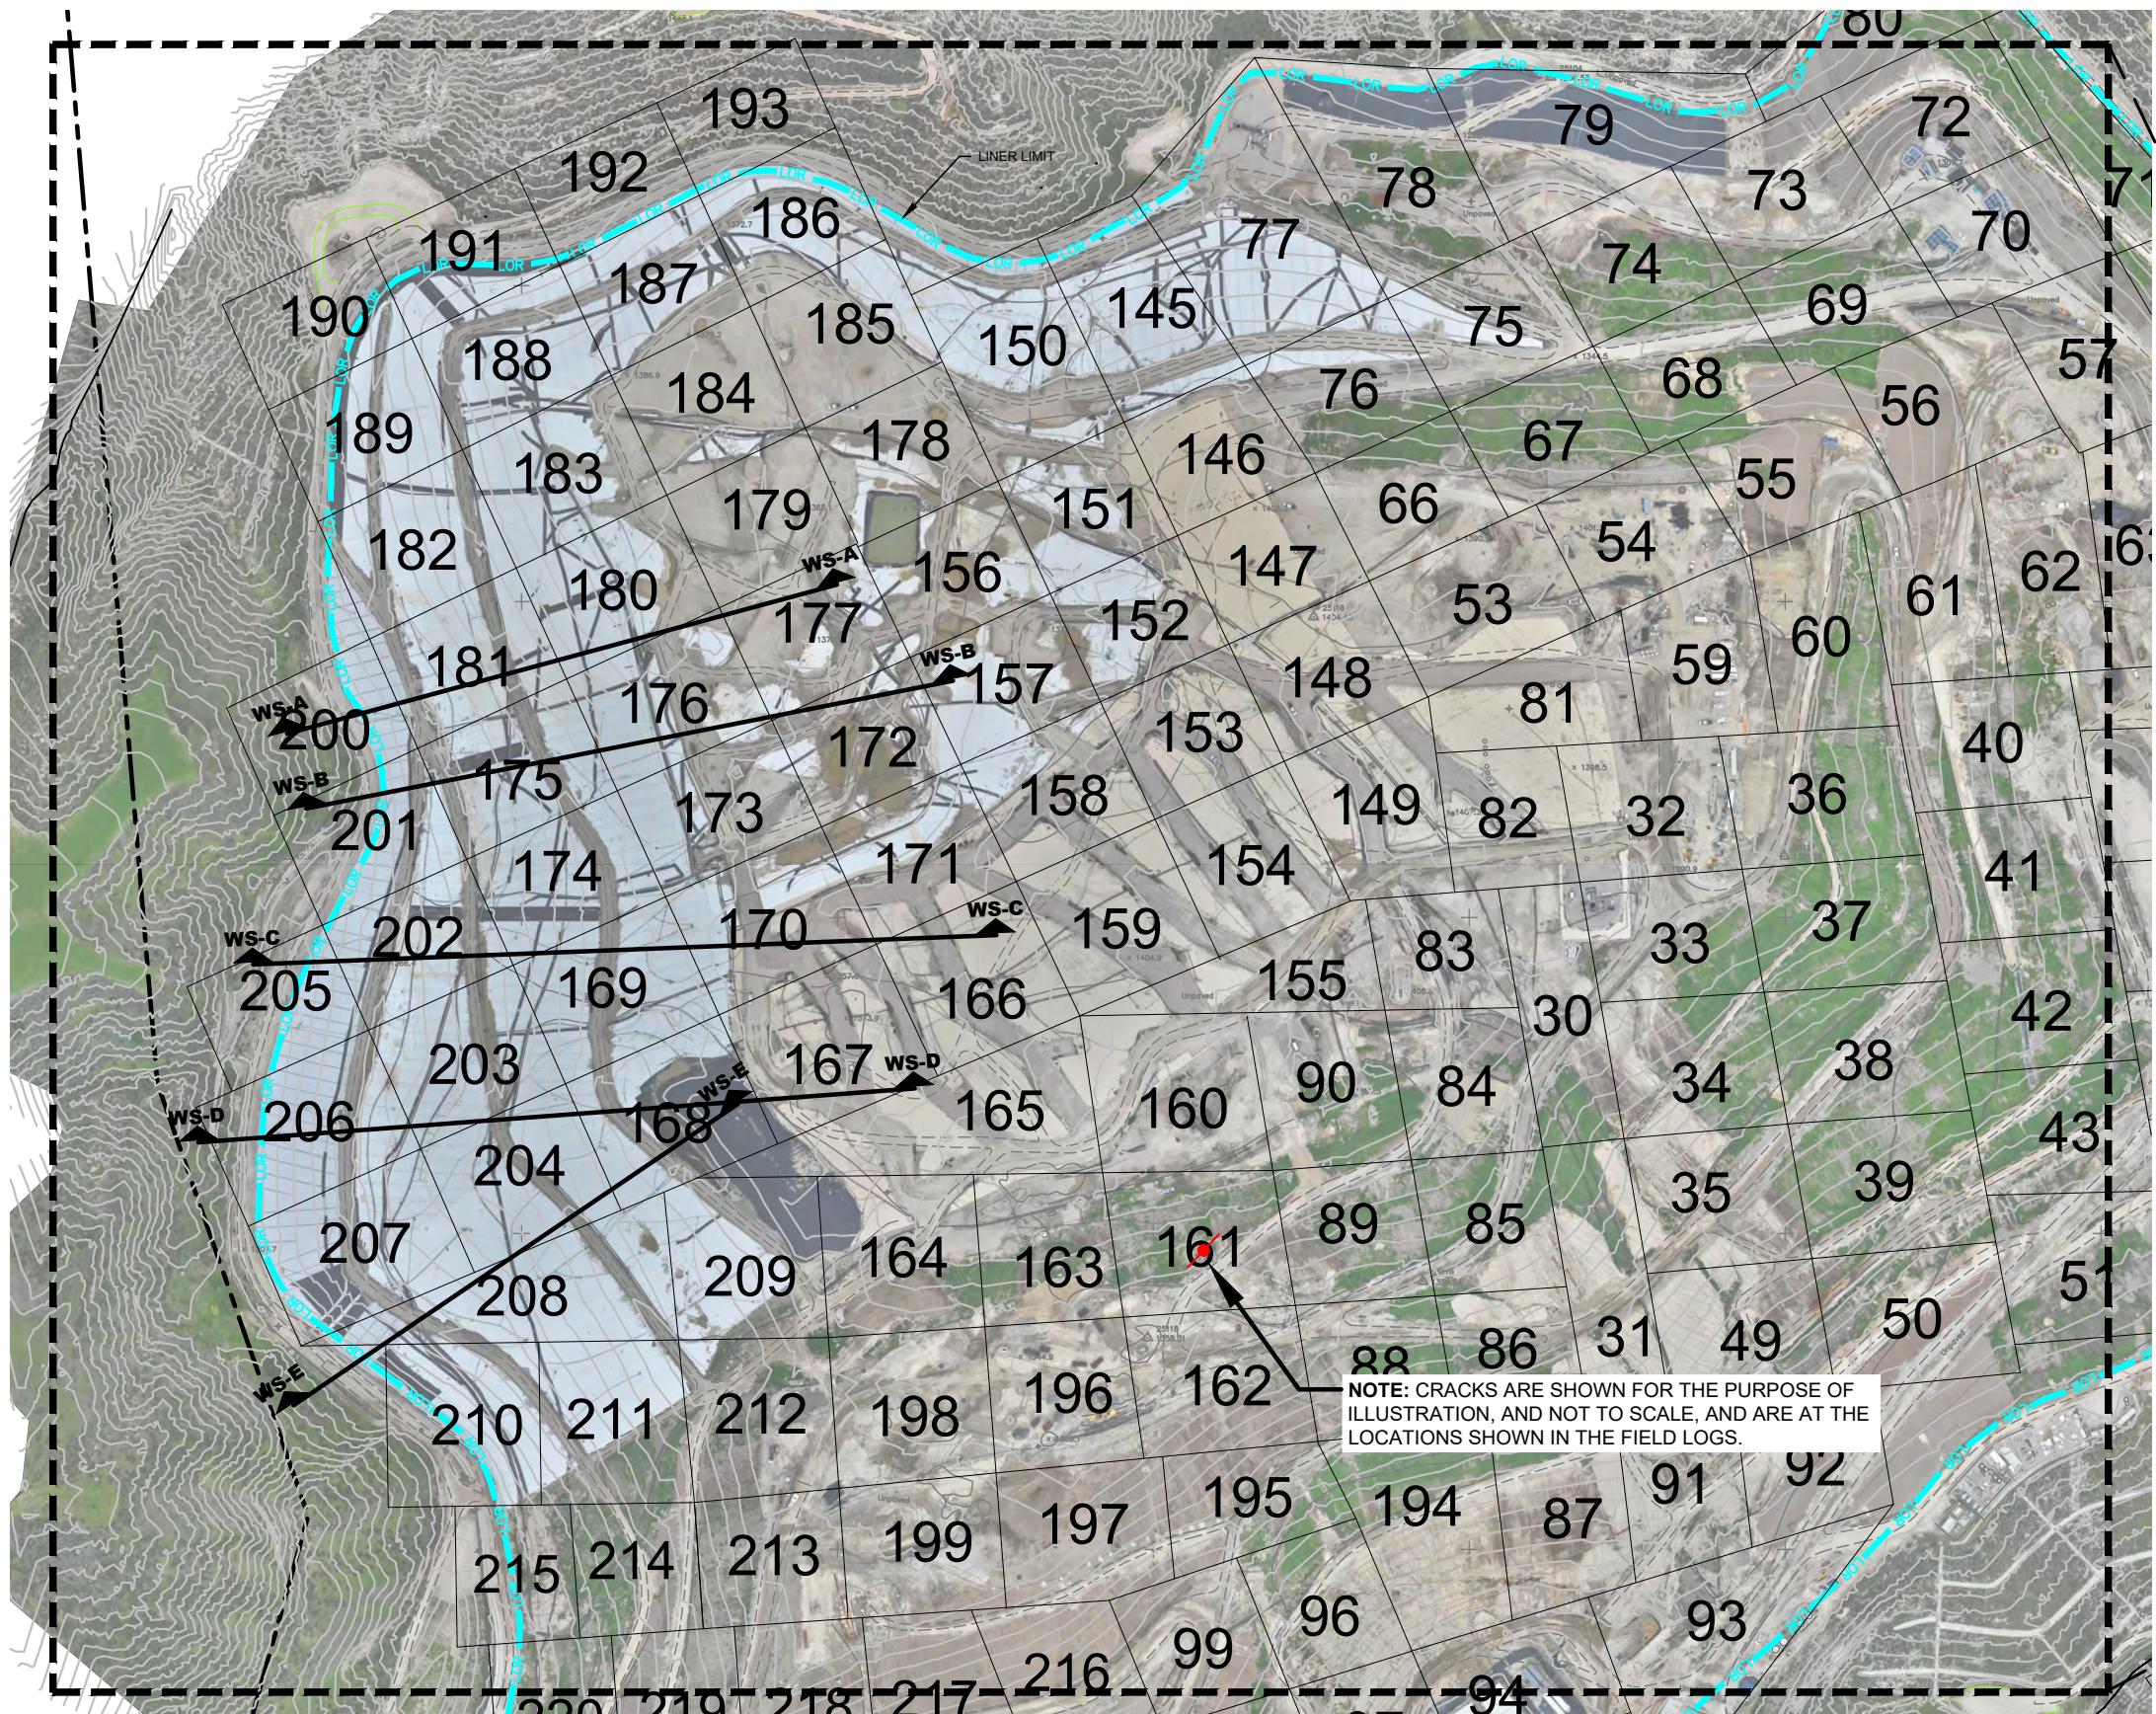
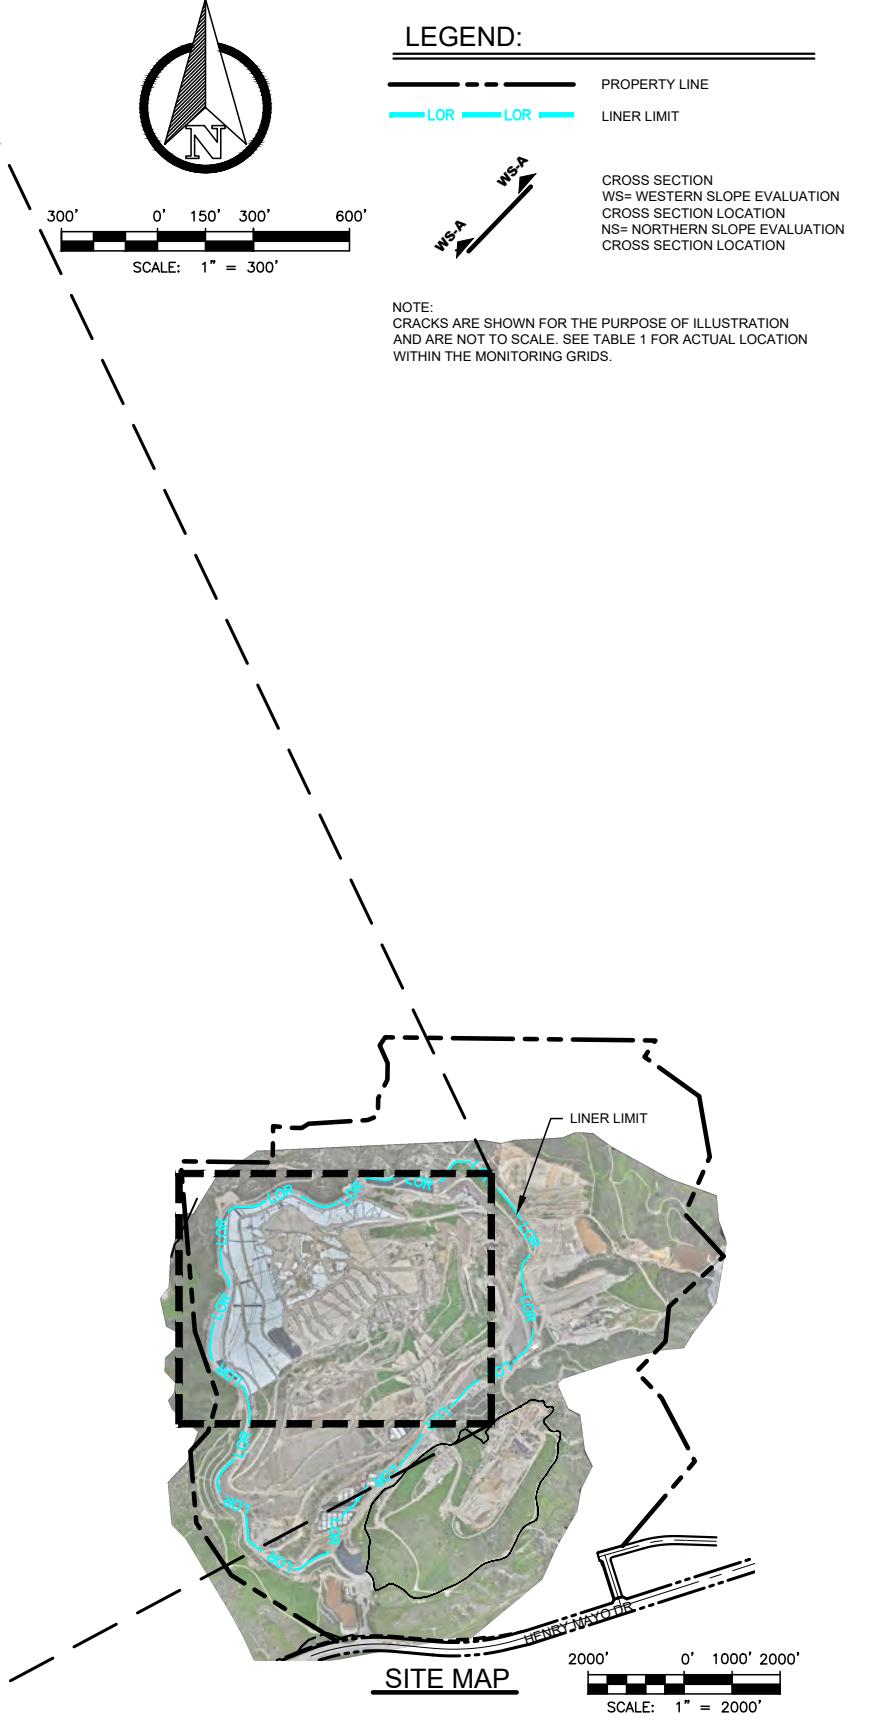
REFERENCE AERIAL TOPO BASED ON DECEMBER 30, 2025 AERIAL SURVEY PROVIDED BY PROPELLER	DECEMBER 2025 MONITORING SUMMARY CHIQUITA CANYON LANDFILL COUNTY OF LOS ANGELES, CA	FIG NO. 01 PROJECT NO. RM22.1077
	MONITORING GRID

- An approximately 4 ft long crack with “medium” horizontal offset and “extra small” vertical offset was observed in Grid 161 on December 18, 2025. This crack is not significant. The approximate location of this crack is shown in Figure 1 for consistency with prior documentation of all cracks or fissures with medium or greater horizontal and/or vertical offsets.

As summarized in Table 1, no “significant” cracks or fissures were identified in December 2025. One non-significant crack with “medium” offset and “extra small” vertical offset was observed in Grid 161 at the approximate location shown in Figure 1 during December 2025. Although much of the affected area is now geomembrane-covered, monitoring to date indicates the documented cracking is attributable to settlement and does not constitute evidence of slope instability.

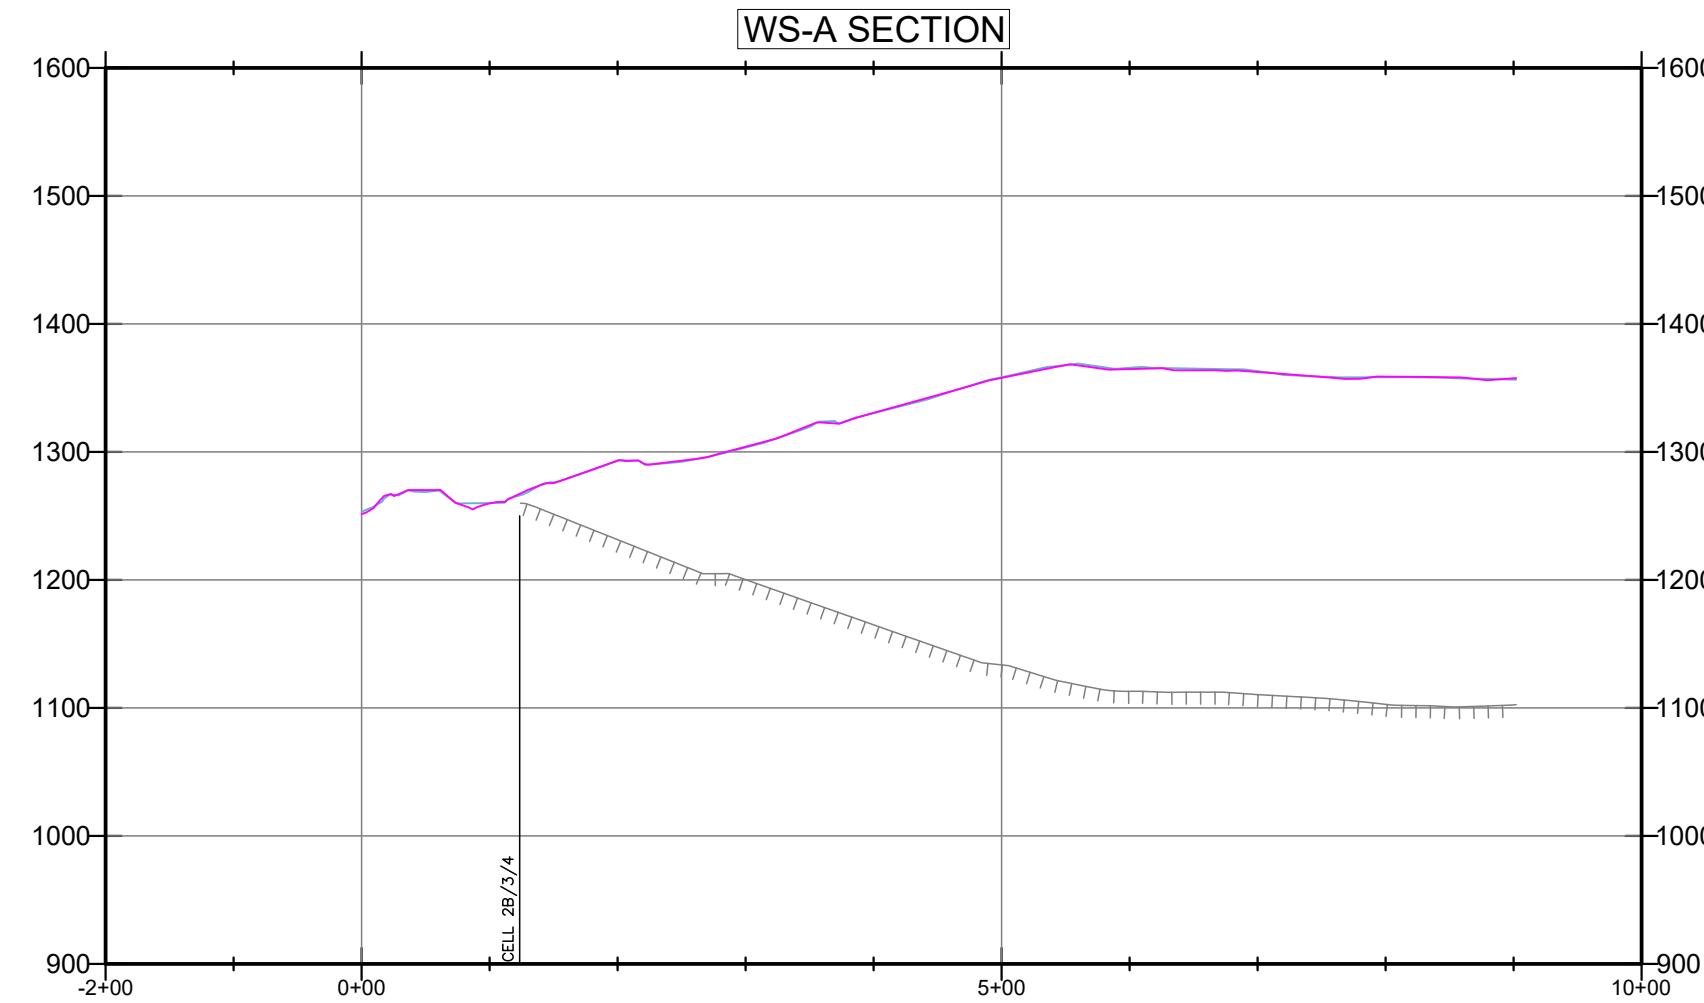
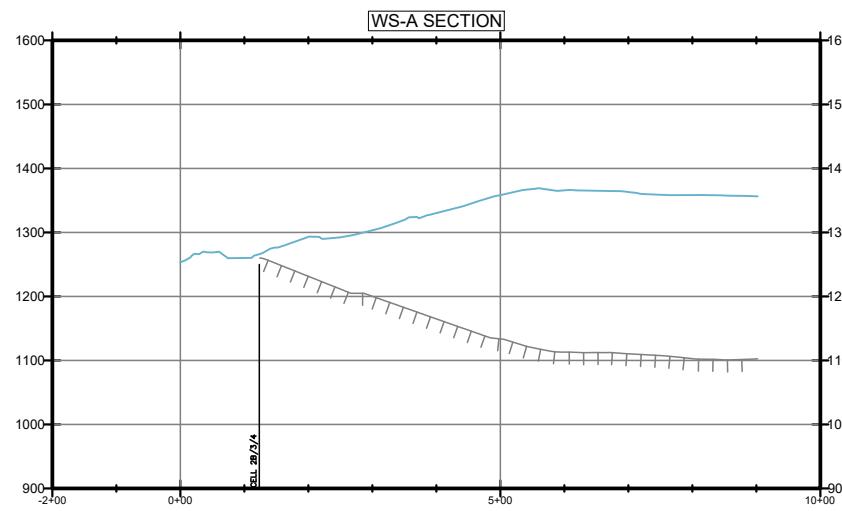
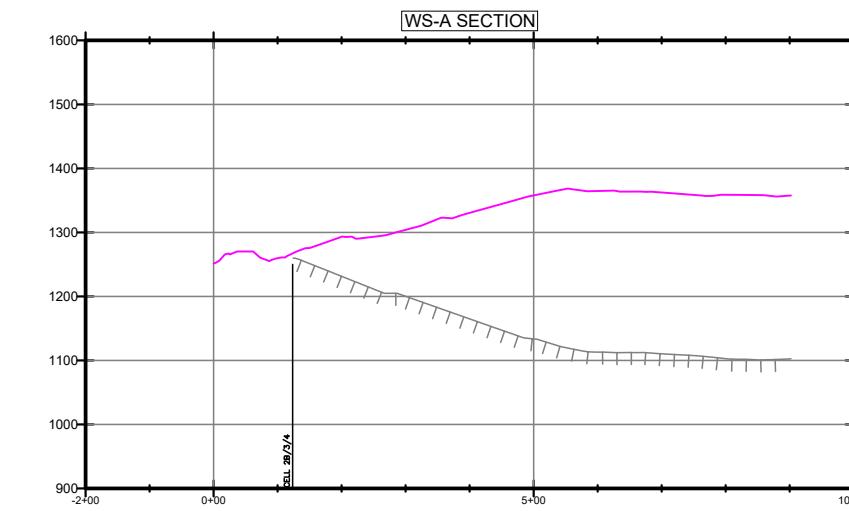
FIGURE 2A

All the cracks identified in Table 1 and summarized above were repaired. Cross sections that compare November 26, 2025 and December 30, 2025 topography are shown in Figures 2A through 2E. The locations of these cross sections are shown in Figure 1. The sections show no significant differences in slope or evidence of instability between the November 2025 and December 2025 profiles, which is consistent with the observational records summarized in Tables 1 and 2.
