**Subject: Leachate Leak Report  
Chiquita Canyon Landfill  
File No. 67-020**

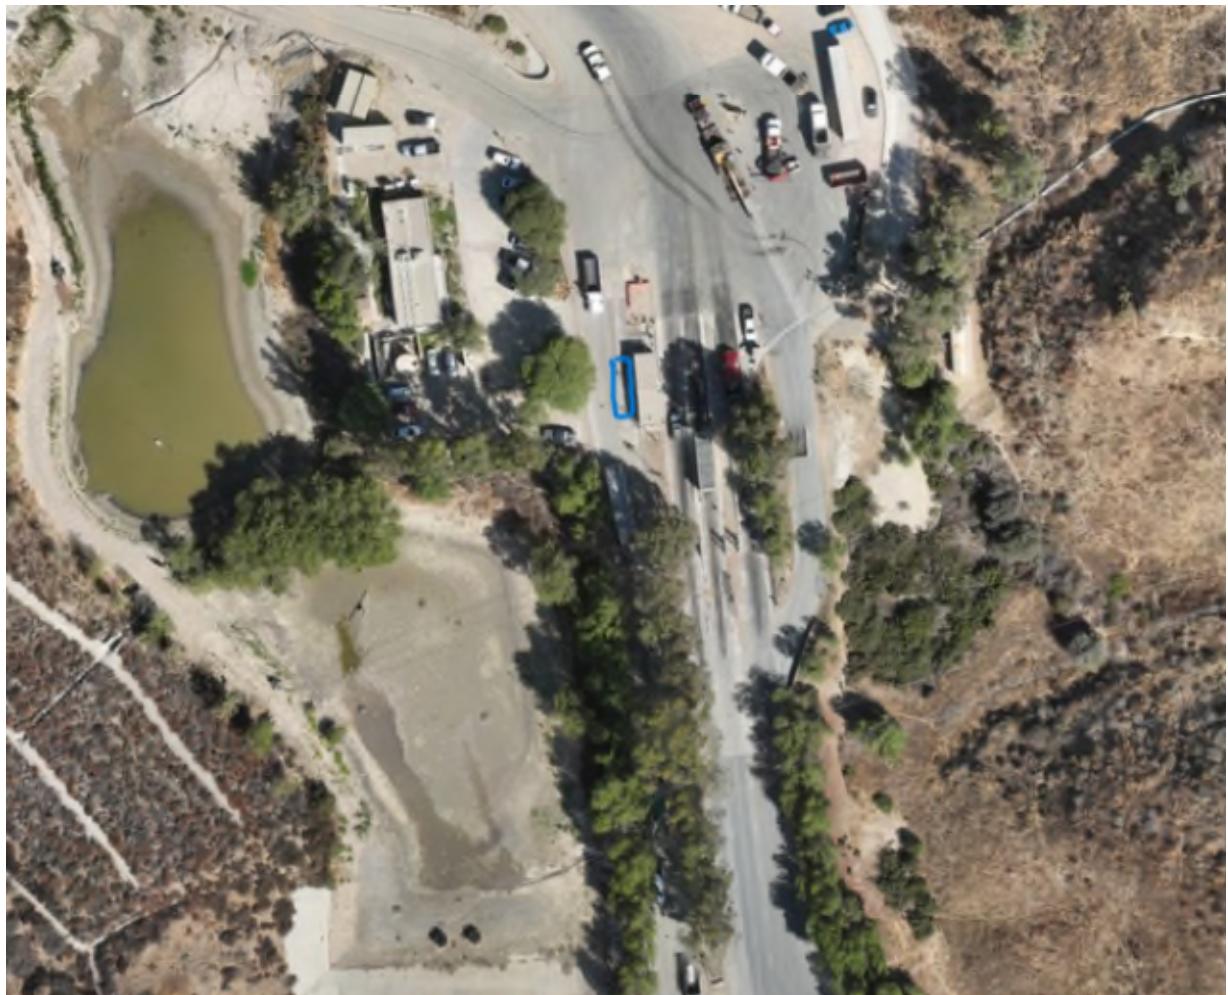
Attachments: Attachment A – Map depicting the location of the leak

The leak occurred at the outbound scale – as depicted in Attachment A.

On January 8, 2026, at approximately 3:00 a.m., to the best of Chiquita’s knowledge, a weld on the top of the third-party tanker trailer failed. Chiquita attributes this leak to third-party equipment malfunction. The liquid from the leak was dark brown in color with low viscosity, and traveled as a light trickle.

Upon discovering the leak, Chiquita personnel promptly applied absorbent to the area impacted by the leak. Chiquita personnel promptly removed the soiled absorbent and placed it into a container for proper disposal. Cleanup commenced immediately and was completed within approximately 1 hour.

To prevent similar leaks from occurring in the future, Chiquita personnel will continue to walk around each third-party tanker trailer at the end of each filling.
