Re: Chiquita Canyon, LLC's Weekly Report on the Documentation and Tracking of Cover Issues

4050 - Chiquita Reaction Area Tracking of Fissures and Tension Cracks

4050 - Geosynthetic Cover Inspection

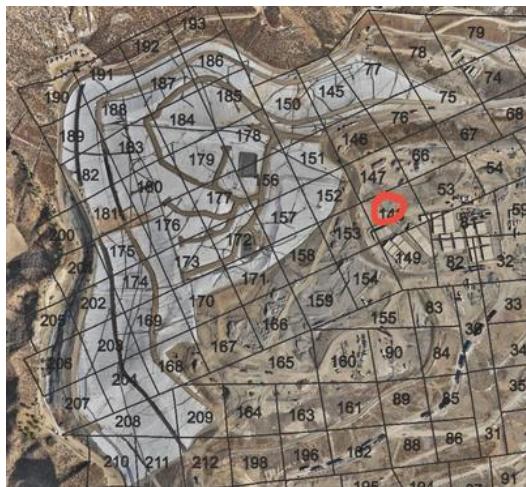
148

Yes

Using the attached image, annotate all areas where inspectors identified a fissure or tension crack.

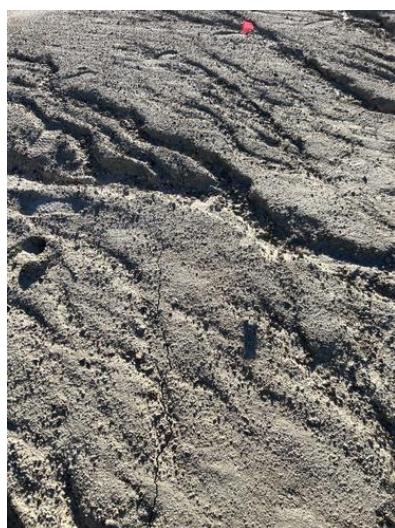
Photo 1

130ft x 8ft

No section of crack over 50ft

Small 0.5-2" in width

Extra small <0.5" in height

NW to SE

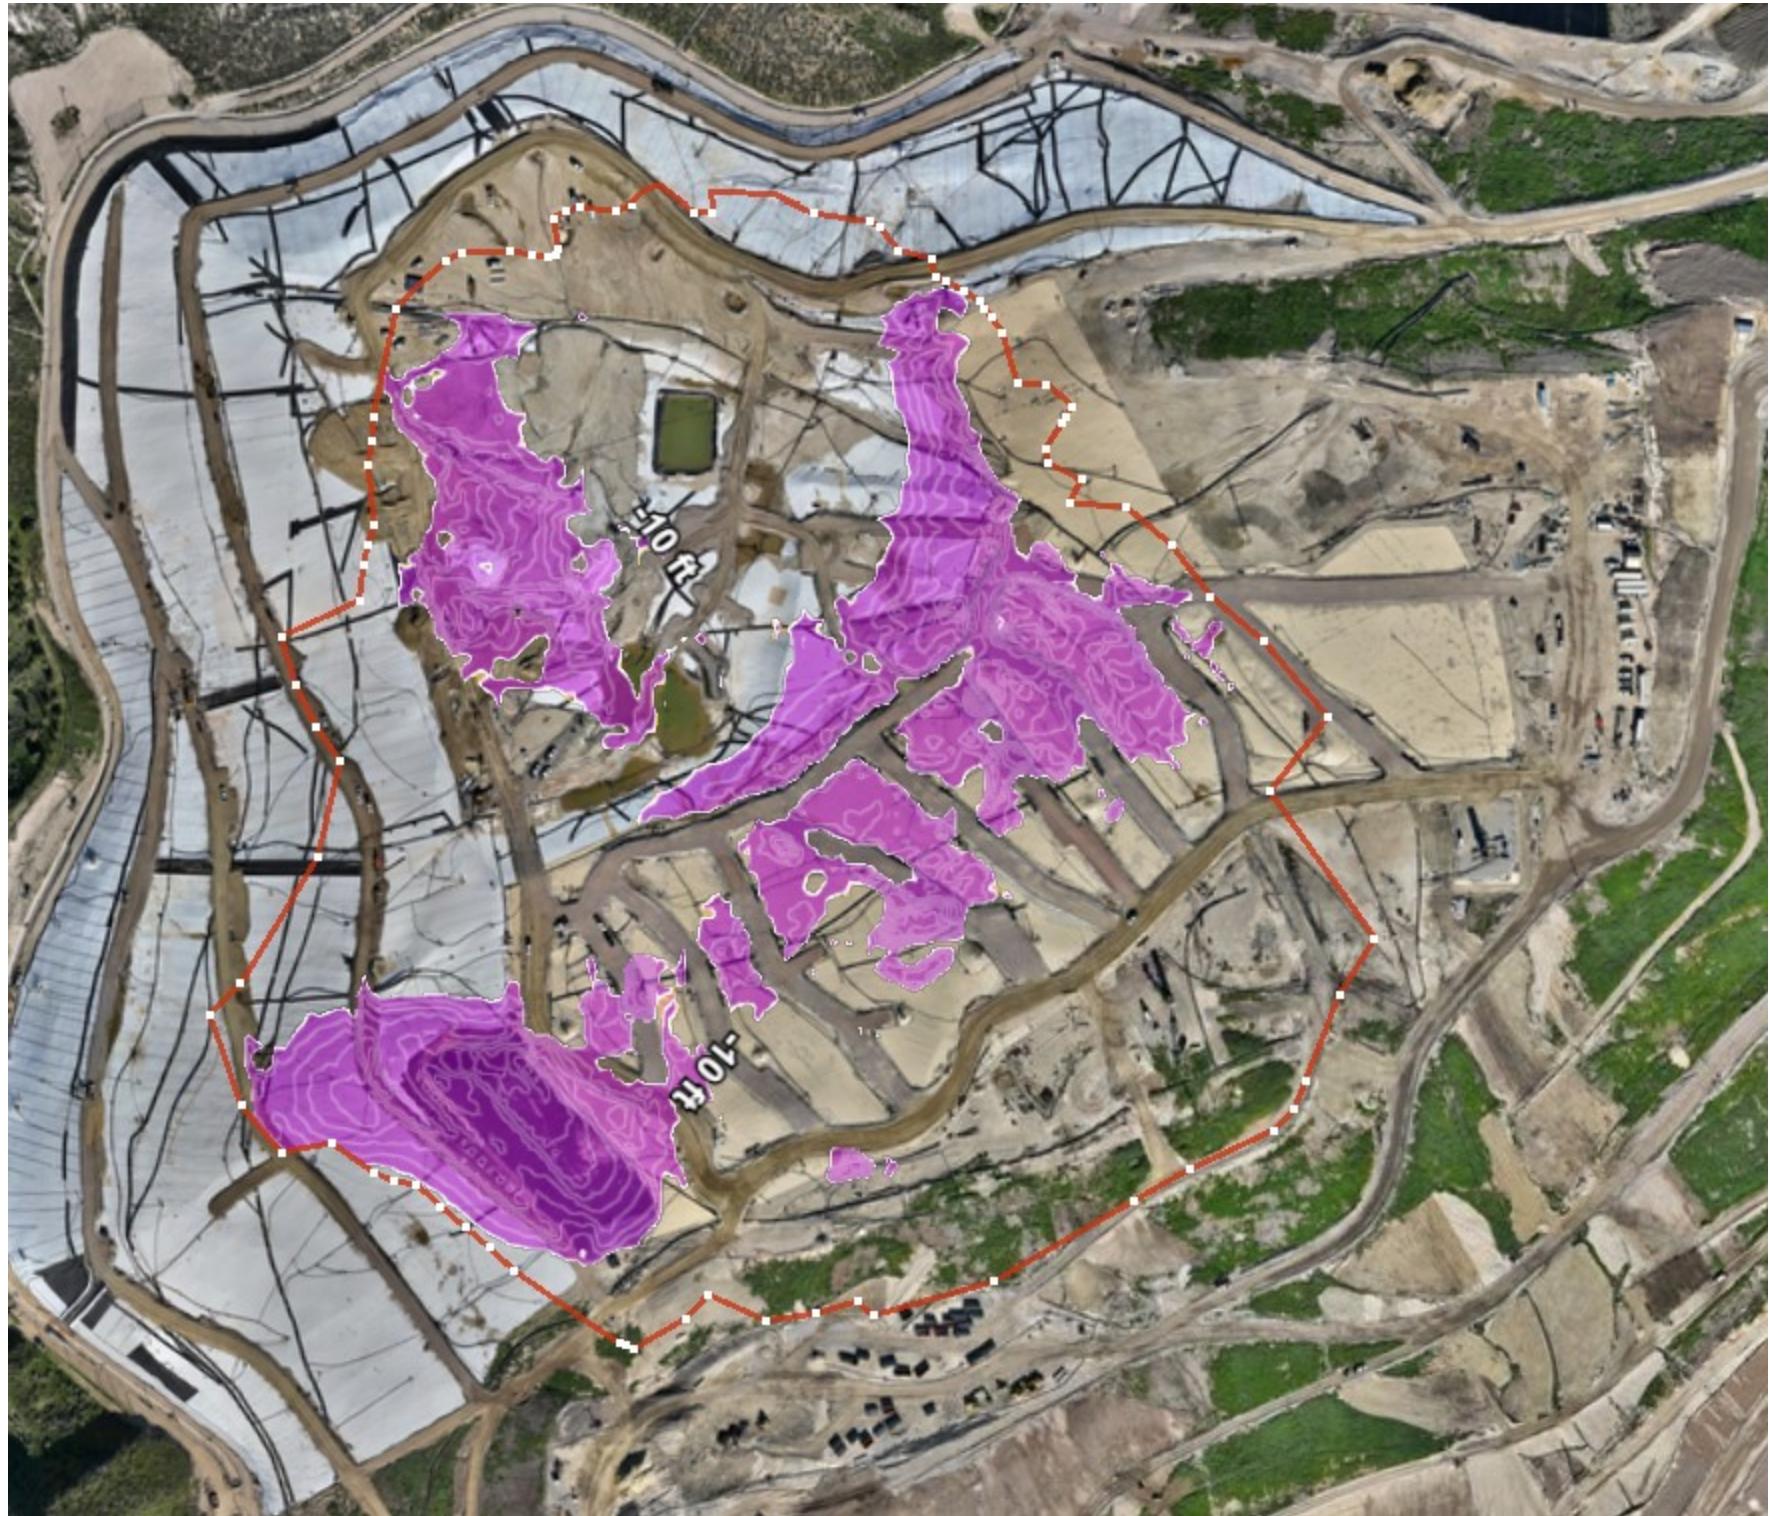
- The map shows the area between 1/10/2025 and 1/14/2026 where the grades have changed more than 10 feet. A typical MSW strain rate is 3% per year - for a landfill with a 300-foot waste column, this would be 9 feet per year.

- Recently, Castaic, California has experienced atypical amounts of rainfall resulting in standing stormwater across the landfill. As the water evaporates and the levels of standing water decrease, the evaporation manifests as increased settlement in the drone flyovers, although no such settlement has occurred. Chiquita anticipates that the imaging, and settlement results, will return to normal once the stormwater has fully evaporated.

- As previously noted, on November 19, 2025, landfill gas piping was temporarily offline in certain areas to perform tie in work as part of the EVOH/HDPE geomembrane cover deployment work. Taking the piping offline caused a small amount of landfill gas to temporarily accumulate under the geomembrane cover. As a result, the image gives the impression of more settlement than what actually occurred. The piping has since been reinstalled and is back online, and the landfill gas bubbles are no longer present.

- During normal site operations before site closure, large stockpiles of rock materials were maintained, and sometimes moved as other operations necessitated. The areas used for these material stockpiles were south and east of the lined area. There is not a way to differentiate between settlement and stockpile movements.
