Re: Chiquita Canyon, LLC's Weekly Leachate Inspection Report for Stipulated Order for Abatement (Case No. 6177-4), Condition 27(c)

Attachment: Leachate Inspection Logs from January 12 – January 18, 2026

4050 - Chiquita Leachate Seep/Pooling Inspection

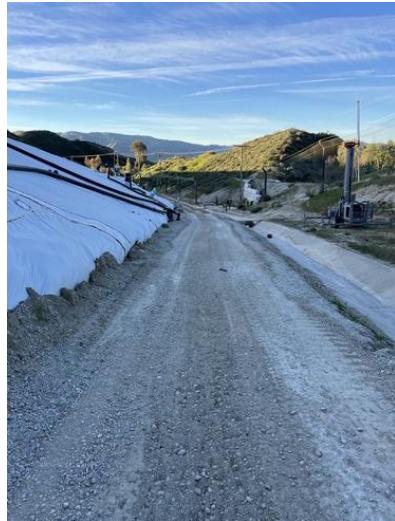
Photo 1

Description of area in photo where there is no leachate seepage or pooling.

Westside perimeter road.

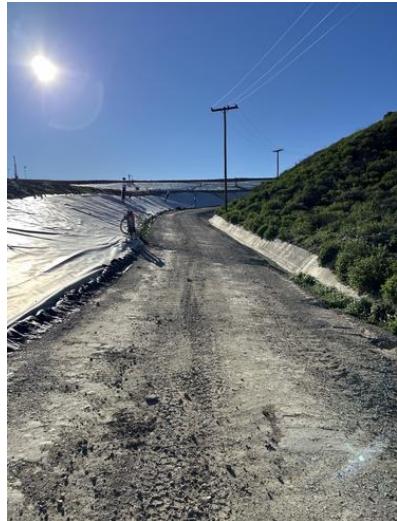
Photo 1

Description of area in photo where there is no leachate seepage or pooling.

North perimeter road.

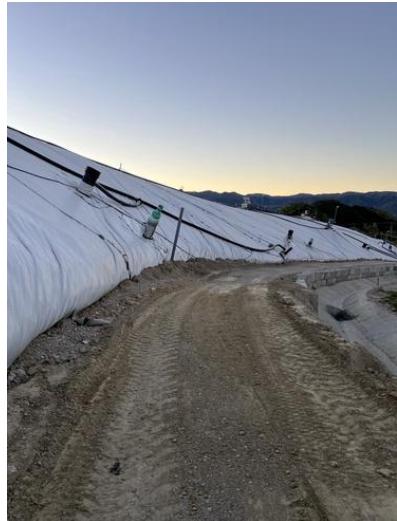
Photo 1

Description of area in photo where there is no leachate seepage or pooling.

Westside perimeter road.

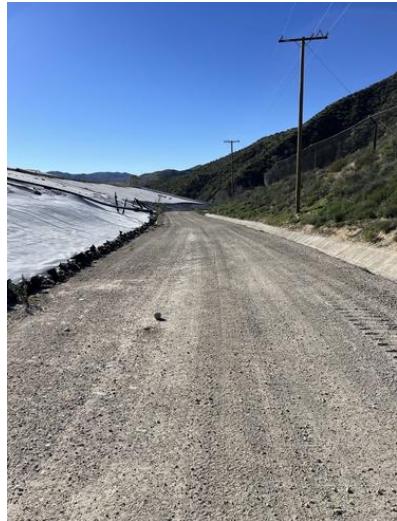
Photo 1

Description of area in photo where there is no leachate seepage or pooling.

North perimeter road.

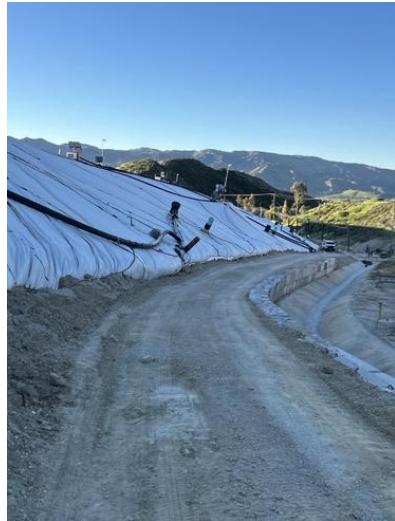
Photo 1

Description of area in photo where there is no leachate seepage or pooling.

West side perimeter road

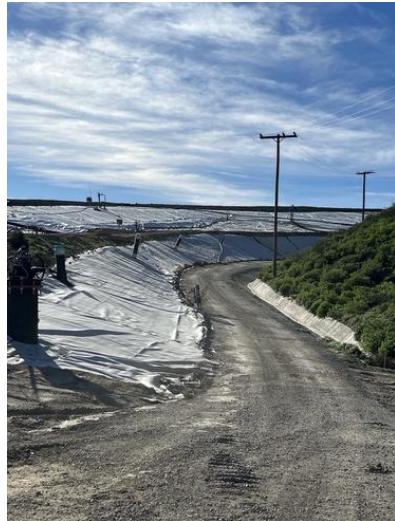
Photo 1

Description of area in photo where there is no leachate seepage or pooling.

North side perimeter road

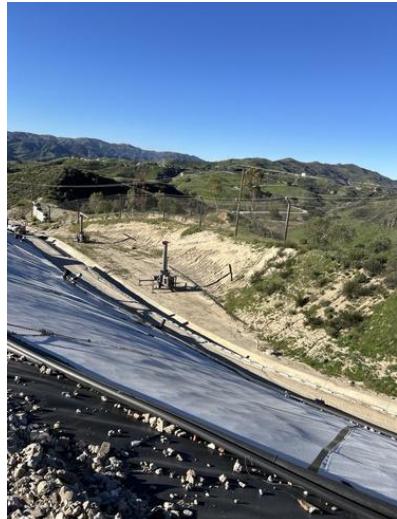
Photo 1

Description of area in photo where there is no leachate seepage or pooling.

West side perimeter road

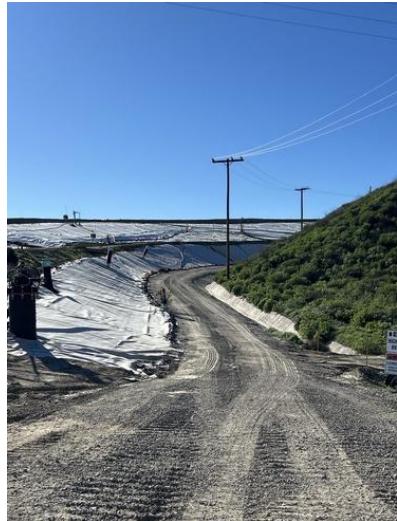
Photo 1

Description of area in photo where there is no leachate seepage or pooling.

North side perimeter road

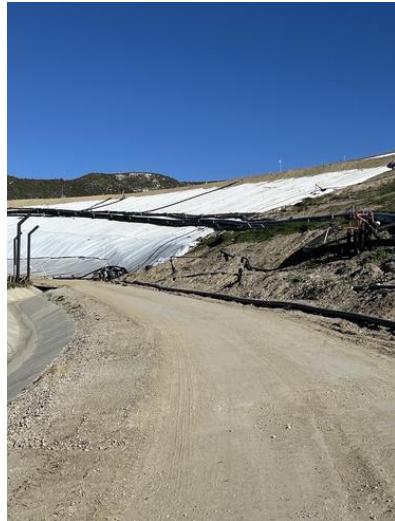
Photo 1

Description of area in photo where there is no leachate seepage or pooling.

West side perimeter road

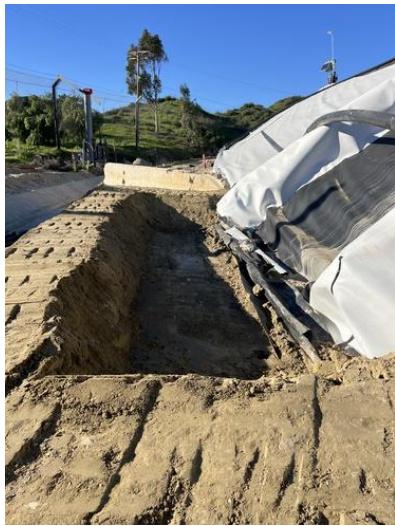
Photo 1

1 hour

<1 gallons

1.5sq ft

2 - Light Odor Detected

Berm constructed around effected area, liner placed and sandbagged overtop to contain atmospheric exposure, vacuum hose inserted to collect any liquids should any pooling accumulate inside containment area

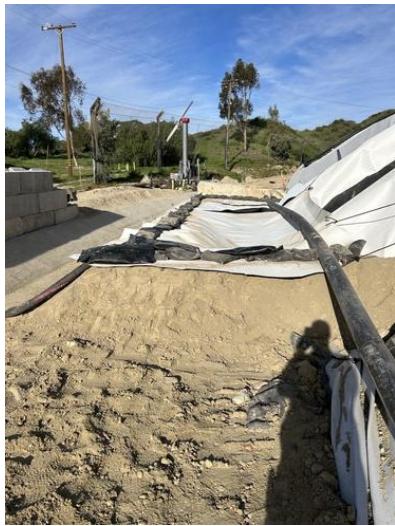
Photo 1

17 hours

<1 gallons

15 sq ft

1 - Very Light Odor Detected

Berm constructed around effected area, liner placed and sandbagged overtop to contain atmospheric exposure, vacuum hose inserted to collect any liquids should any pooling accumulate inside containment area

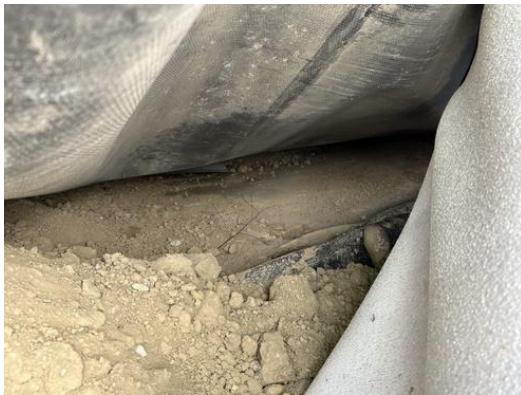
Photo 1

22

<1 gallons

1.5sq ft

1 - Very Light Odor Detected

Berm constructed around effected area, liner placed and sandbagged overtop to contain atmospheric exposure, vacuum hose inserted to collect any liquids should any pooling accumulate inside containment area

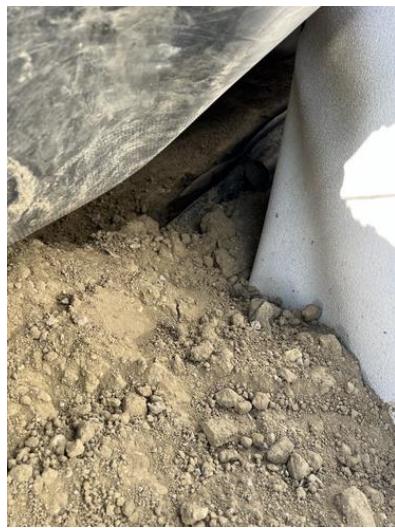
Photo 1

38 hrs

<1 gallons

1.5 sq ft

1 - Very Light Odor Detected

Berm constructed around effected area, liner placed and sandbagged overtop to contain atmospheric exposure, vacuum hose inserted to collect any liquids should any pooling accumulate inside containment area

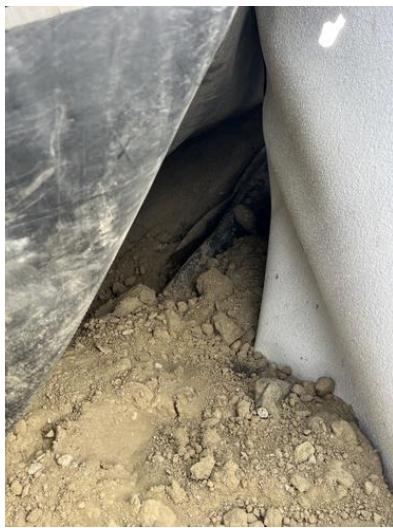
Photo 1

44 hrs

<1 gallons

1.5 ft

1 - Very Light Odor Detected

Vacuum truck pulling on clean out was not getting any liquid, just air

Berm constructed around effected area, liner placed and sandbagged overtop to contain atmospheric exposure, vacuum hose inserted to collect any liquids should any pooling accumulate inside containment area
