CHIQUITA CANYON
A Waste Connections Company

Re: Chiquita Canyon, LLC's Weekly Report on the Documentation and Tracking of Cover Issues

4050 - Chiquita Reaction Area Tracking of Fissures and Tension Cracks

4050 - Geosynthetic Cover Inspection

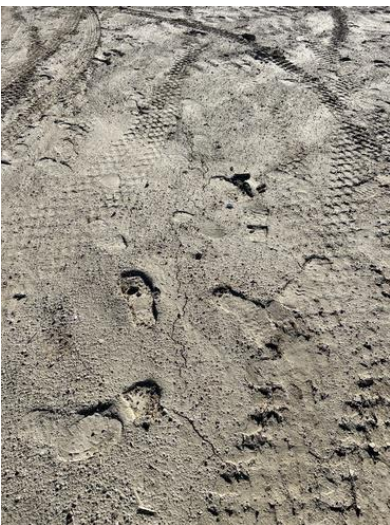
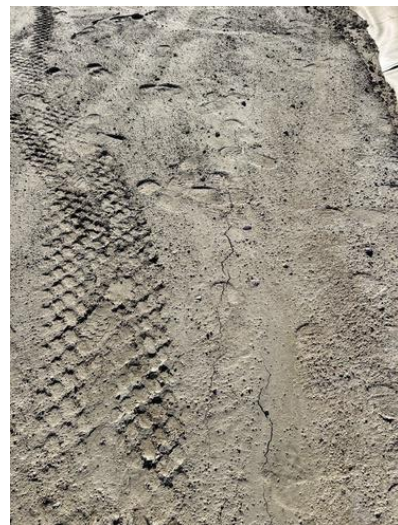
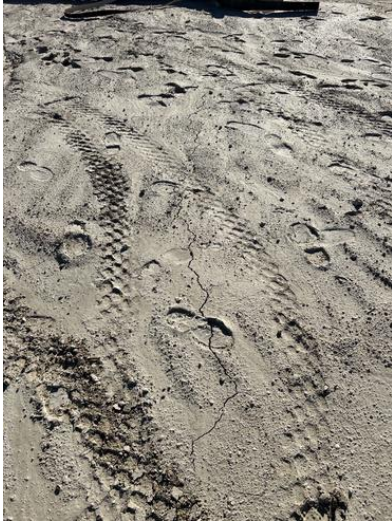
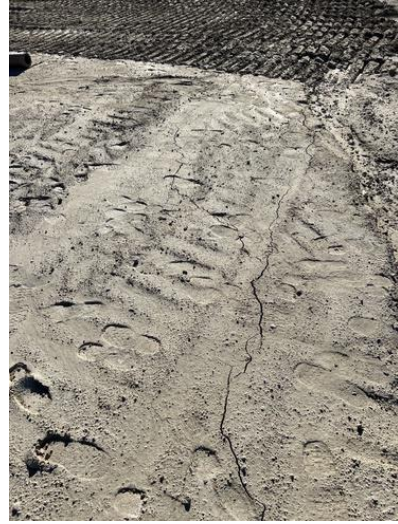
Length of crack (ft) or area containing multiple cracks (ft x ft) 20ft x 35ft

Horizontal Offset (width) Small 0.5-2" in width

Vertical Offset (height) Extra small <0.5" in height

Orientation (direction) NW to SE

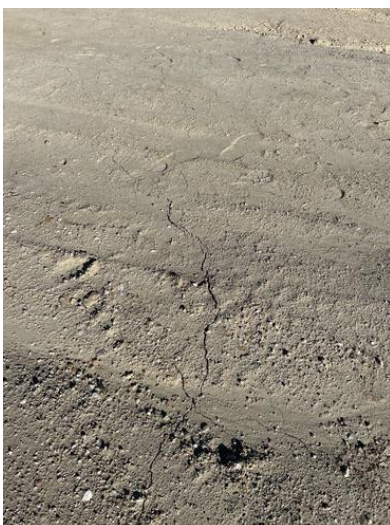
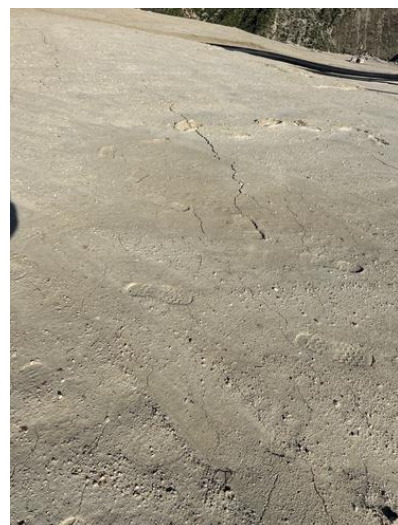
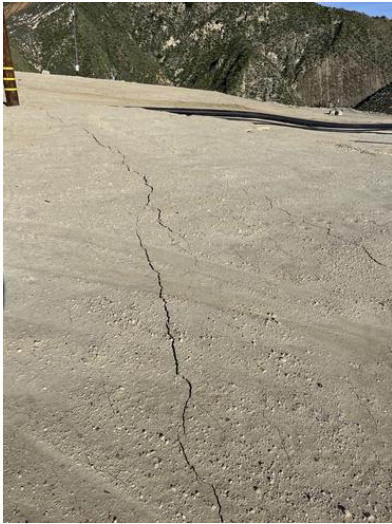
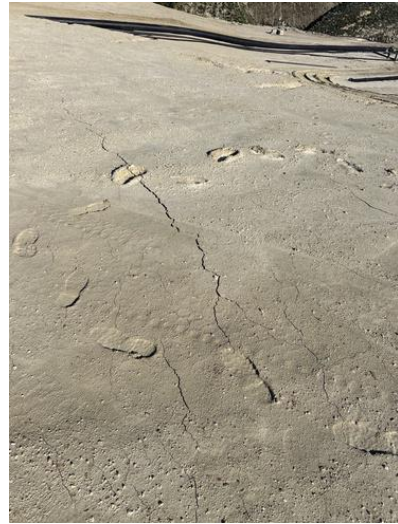
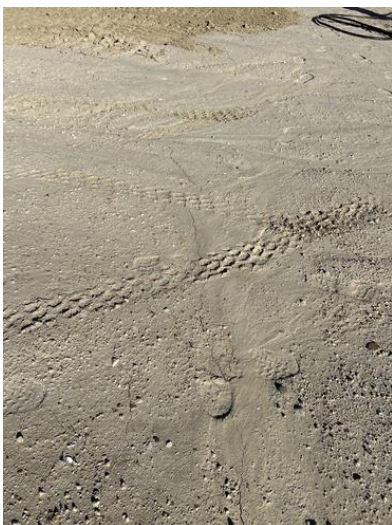
60ft x 45ft

No individual crack over 50 ft.

Small 0.5-2" in width

Extra small <0.5" in height

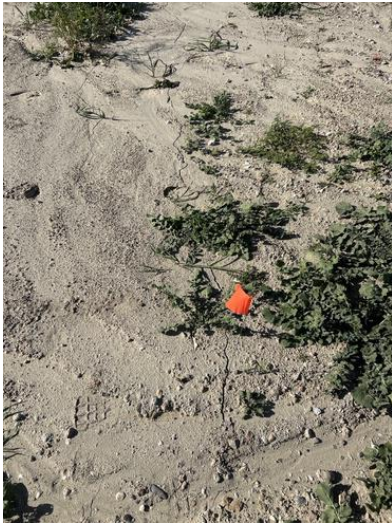
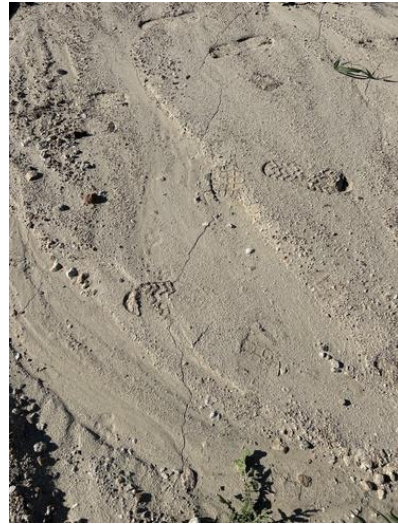
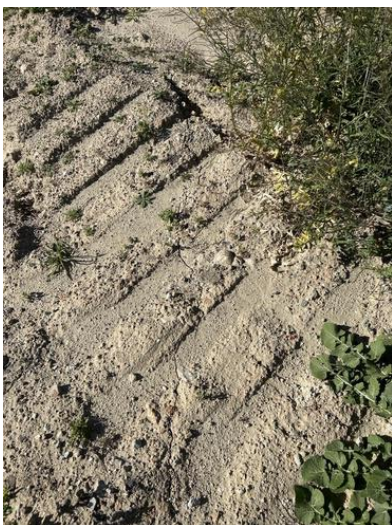
Length of crack (ft) or area containing multiple cracks (ft x ft)	40ft x 6ft
Horizontal Offset (width)	Extra Small <0.5 in width
Vertical Offset (height)	Extra small <0.5" in height
Orientation (direction)	E to W
Location	Castaic CA 91384 United States (34.43252671347615, -118.64837630125139)
Was Fissure or Crack fixed? If yes, add photo and description of repairs performed	Yes

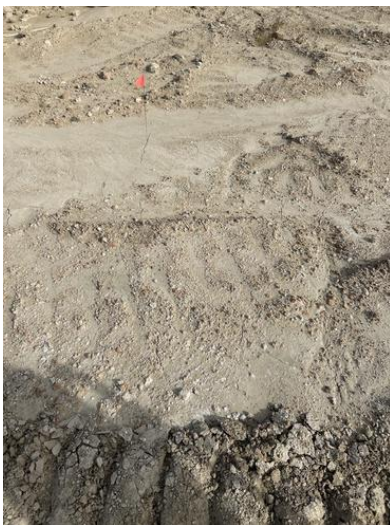
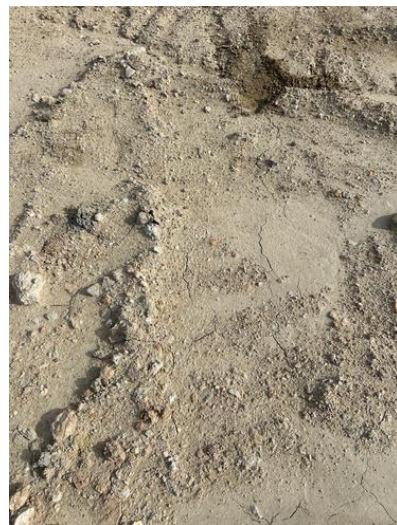
15ft x 3ft

Horizontal Offset (width)	Extra Small <0.5 in width
Vertical Offset (height)	Extra small <0.5" in height
Orientation (direction)	NE to SW
Location	Castaic CA 91384 United States (34.43437523960082, -118.64572449211354)
Was Fissure or Crack fixed? If yes, add photo and description of repairs performed	Yes

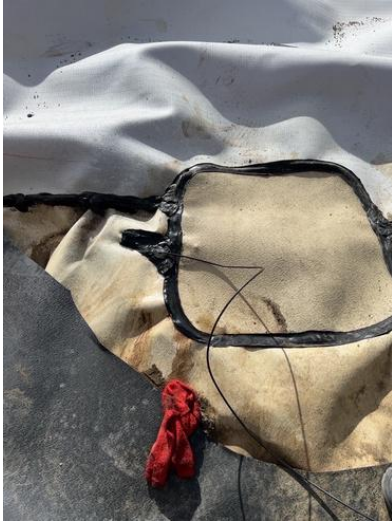
Photo 1

Small hole in cover associated with a failed weld between 30 mil and 60 mil covers needs to be patched and extrusion welded.

Description of repair work	Hole was patched and extrusion welded.
Date and time of repair (within 2 hours)	19 Jan 2026 2:15 PM PST
Date and time of permanent repair (if needed)	
Are further permanent repairs required?	No
Instability under the cover	
Are there any anomalous (unusual or unexpected) areas of cover damage or deformation that may indicate underlying instability?	No
Are there any signs of a downslope tension crack at the top of the slope or bulging at or near the toe of the slope?	No
Is there any movement of the equipment that vertically penetrates the cover (e.g., tilting)?	No

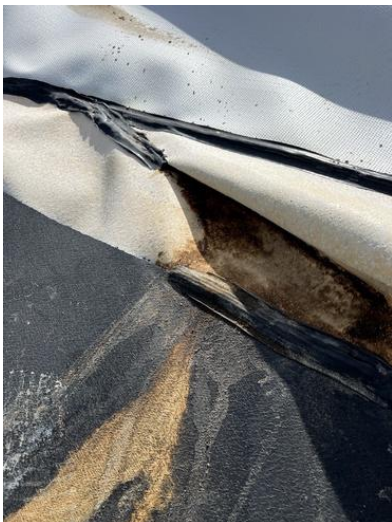
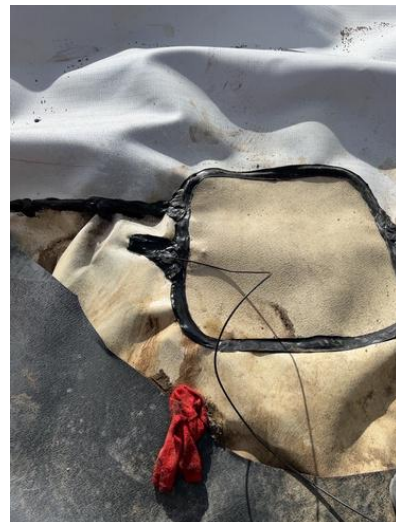
Repair made on 11/19 failed and needs to be patched and extrusion welded. Additional small hole in weld between 30mil and 60mil liner found nearby in same

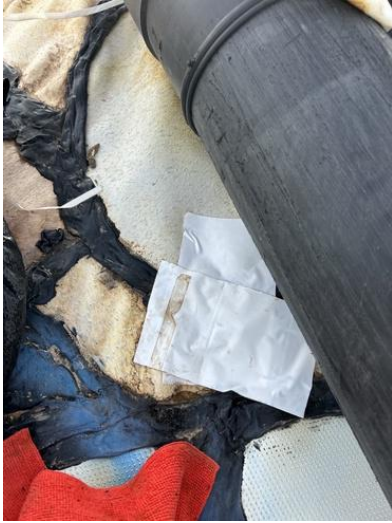
Photo 5

Small hole in weld with condensation coming out. Hole was taped before it could be photographed

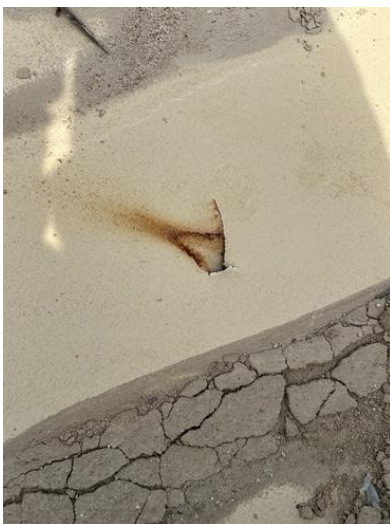
Photo 1

Liner torn. Needs to be patched and extrusion welded

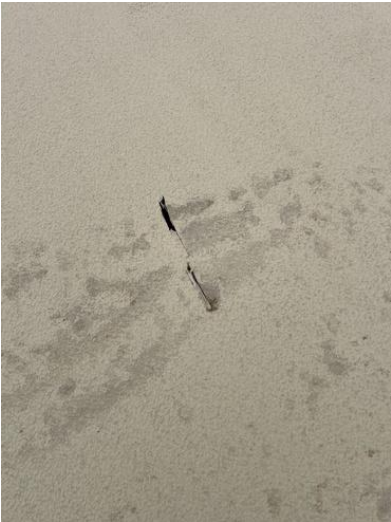
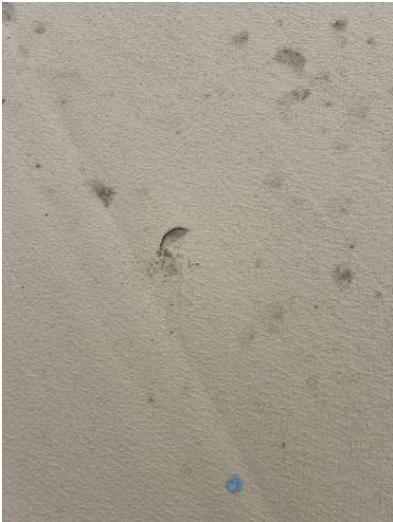
Two tears in liner in close proximity to each other needs to be patched/extrusion welded.

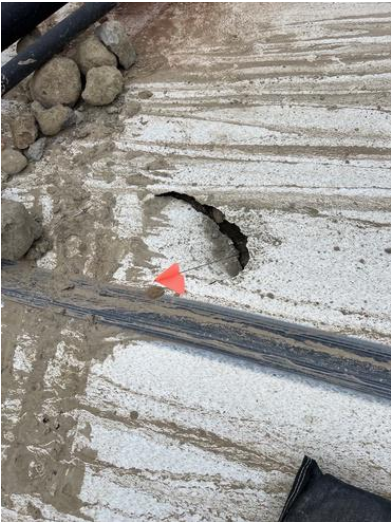
Photo 11

Tear in liner needs to be patched and extrusion welded.

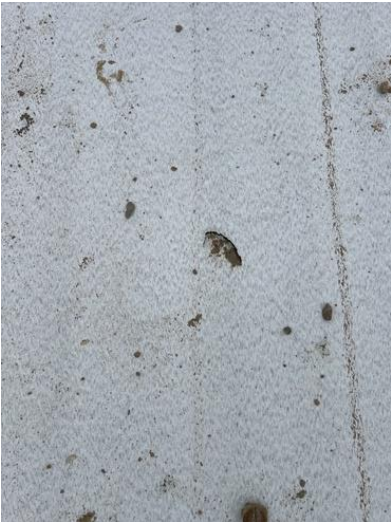
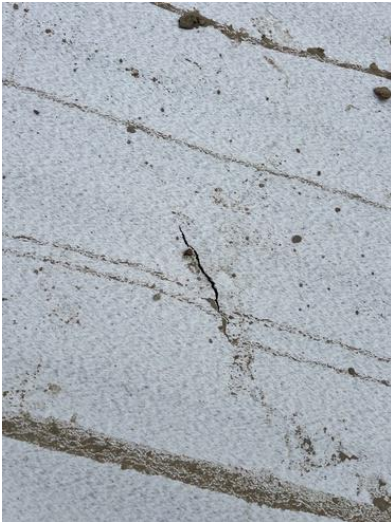
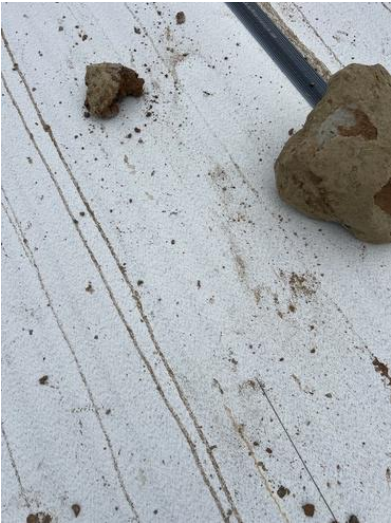
4 tears in close proximity to each

other need to be patched/extrusion welded.

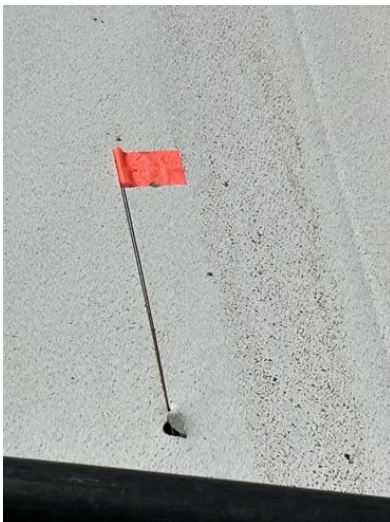
Photo 1

Small hole in liner. Needs to be patched and extrusion welded

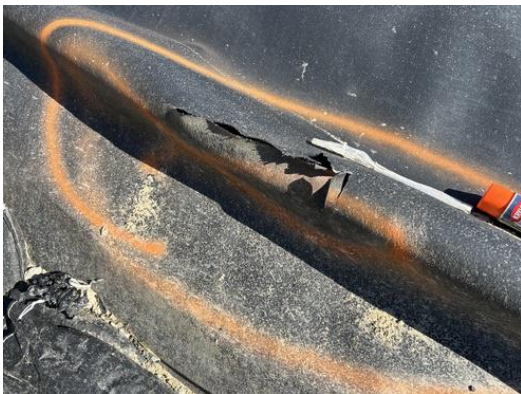
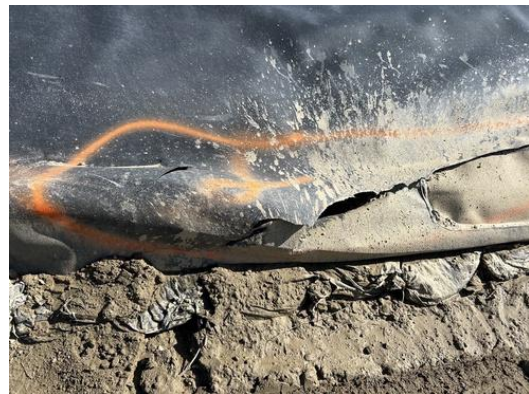
Liner torn, needs to be patched and extrusion welded

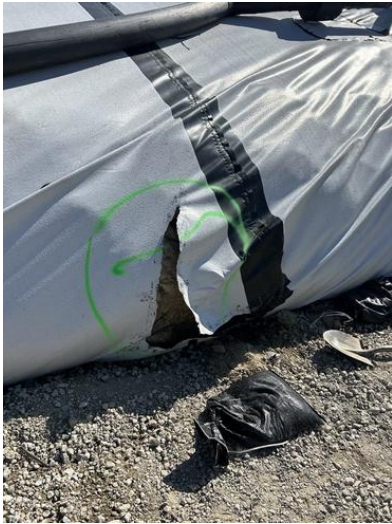
Photo 5

Liner torn. Needs to be patched and extrusion welded
