**Re: Chiquita Canyon, LLC's Weekly Leachate Inspection Report for Stipulated Order for Abatement (Case No. 6177-4), Condition 27(c)**

# 4050 - Chiquita Leachate Seep/Pooling Inspection

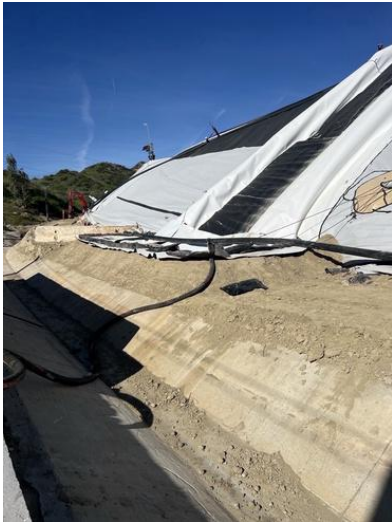
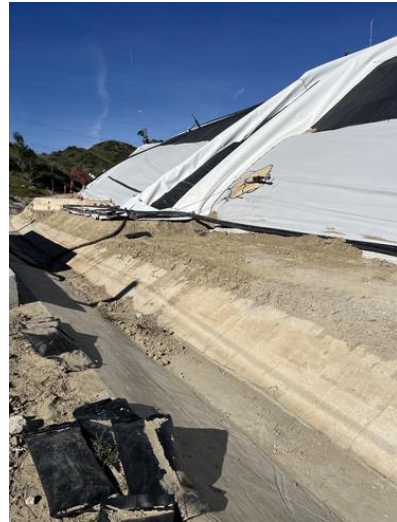
With respect to the seep that began on January 11, 2026, and was reported on January 20, 2026, no liquid has been observed at that location since liquid was last pulled from the area on the afternoon of January 14th.

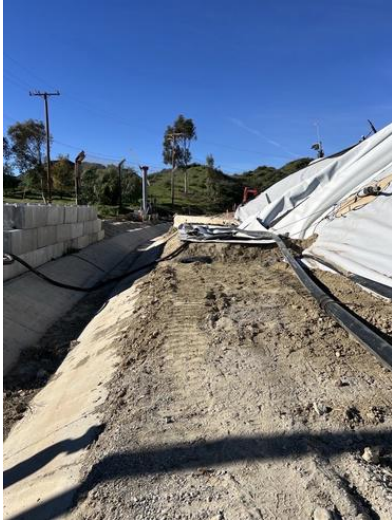
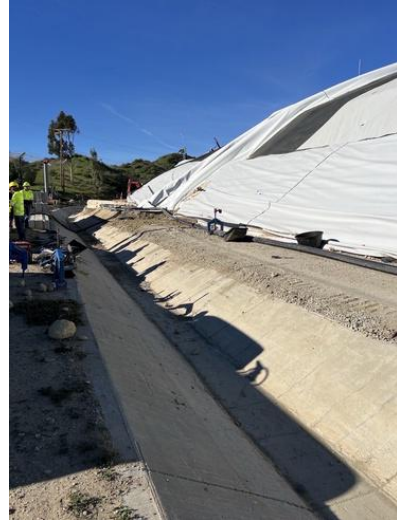
With respect to the seep that began on January 11, 2026, and was reported on January 20, 2026, no liquid has been observed at that location since liquid was last pulled from the area on the afternoon of January 14th.

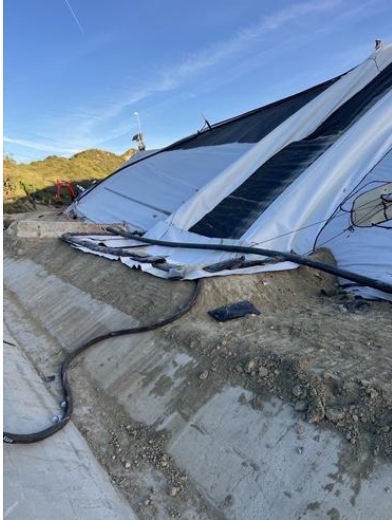
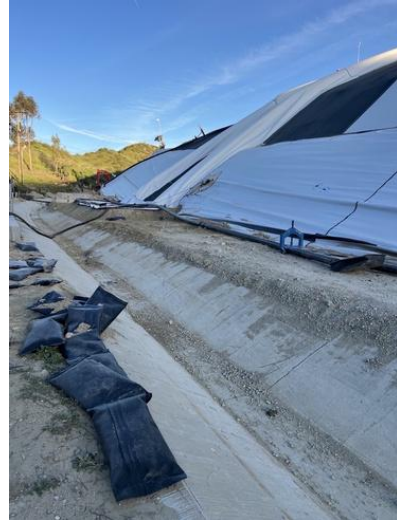
With respect to the seep that began on January 11, 2026, and was reported on January 20, 2026, no liquid has been observed at that location since liquid was last pulled from the area on the afternoon of January 14th.

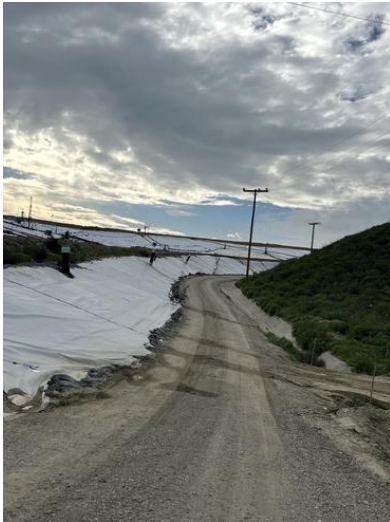
North side perimeter road

Some rainwater runoff
