Los Angeles Regional Water Quality Control Board

January 7, 2026

NOTICE OF VIOLATION: STORMWATER COMMINGLED WITH UNAUTHORIZED NON-STORMWATER DISCHARGE – CHIQUITA CANYON LANDFILL, 29201 HENRY MAYO DRIVE, CASTAIC, CA 91384, WDID NO. 4 191022488

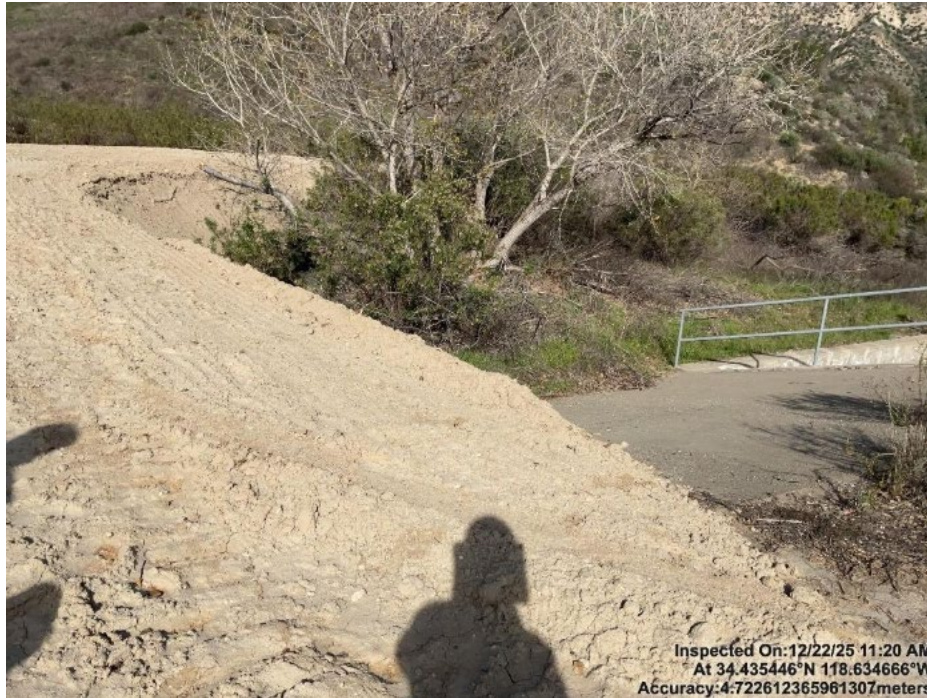
Photo 1

On December 22, 2025, Los Angeles Water Board Staff inspected CCL prior to a forecasted storm event.¹ The Discharger had installed a berm in the East Basin to separate the basin outlet from the East Basin (Photo 1). The Discharger also installed a barrier over the East Basin outlet with steel plates, and a plastic covering with wood braces and sandbags (Photo 2). According to Ms. Amanda Froman of Waste Connections, the barrier also consisted of a sealing foam. The intention of these Best Management Practices (BMPs) was to prevent the discharge of leachate comingled stormwater.

A view of the dirt berm placed in the East Basin during the December 22, 2025, inspection.

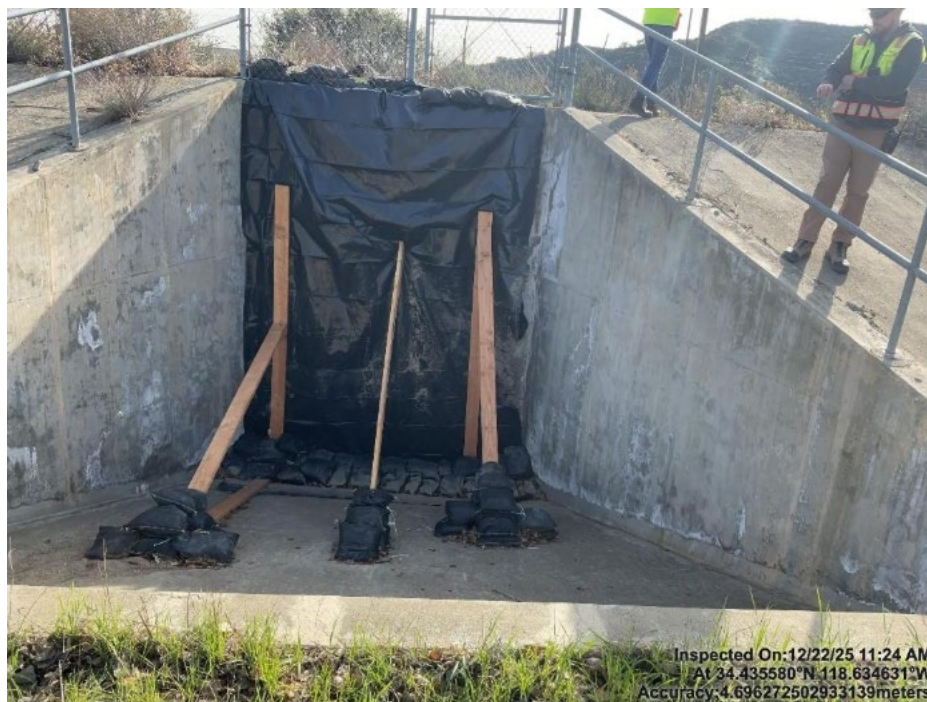
Photo 2

A view of the barrier placed over the East Basin outlet during the December 22, 2025, inspection.

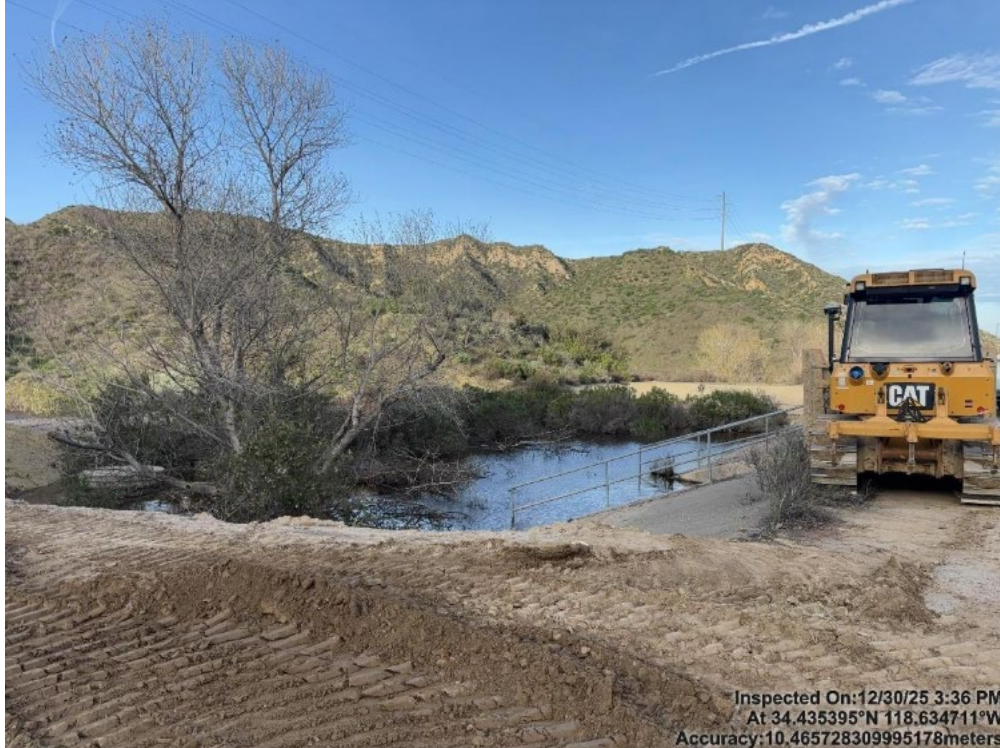
Photo 3

During the storm event that occurred from December 23-26, 2025, the leachate comingled stormwater overtopped the installed berm and filled up the area behind the installed barrier (Photos 3-4). On December 29, 2025, CCL staff heard water from the East Basin flowing through the barrier into the stormwater channel that flows into Castaic Creek. Castaic Creek flows into Reach 5 of the Santa Clara River. Both Castaic Creek and Santa Clara River are designated waters of the United States. The leachate comingled stormwater continued to discharge during and after the December 23-26, 2025, storm event until the water level dropped below the level of the leak.

A photo showing the comingled leachate with stormwater flowed into the area behind the dirt berm.

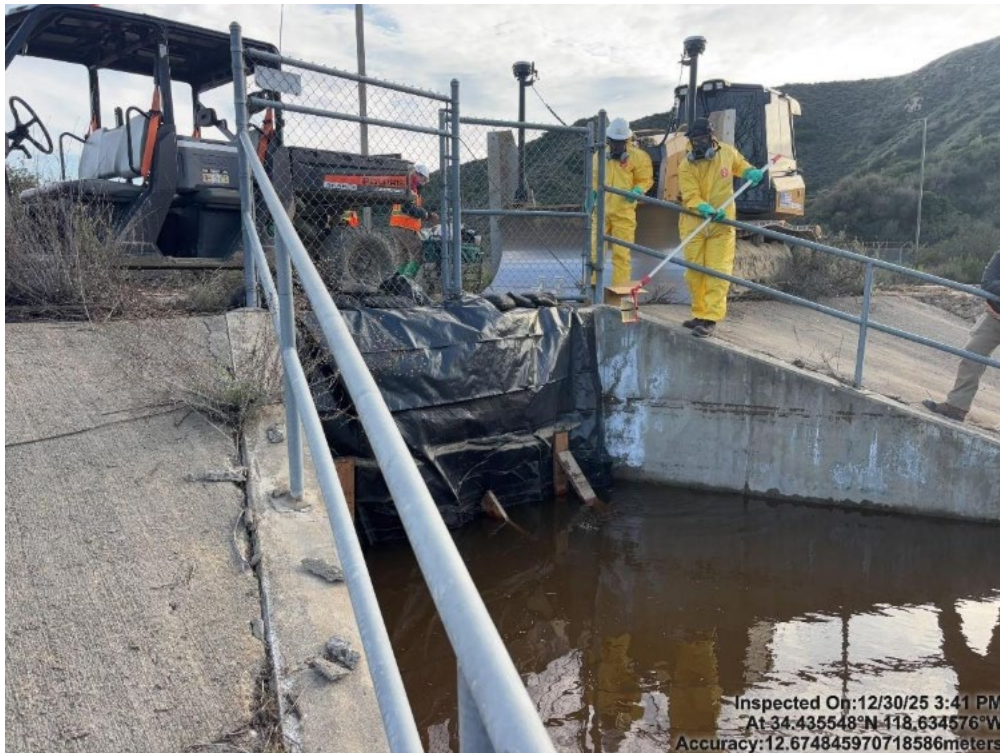
Photo 4

A photo showing the outlet of the East Basin.
