**CHIQUITA CANYON**  
*A Waste Connections Company*

January 23, 2026

**Subject: Leachate Spill Report  
Chiquita Canyon Landfill  
File No. 67-020**

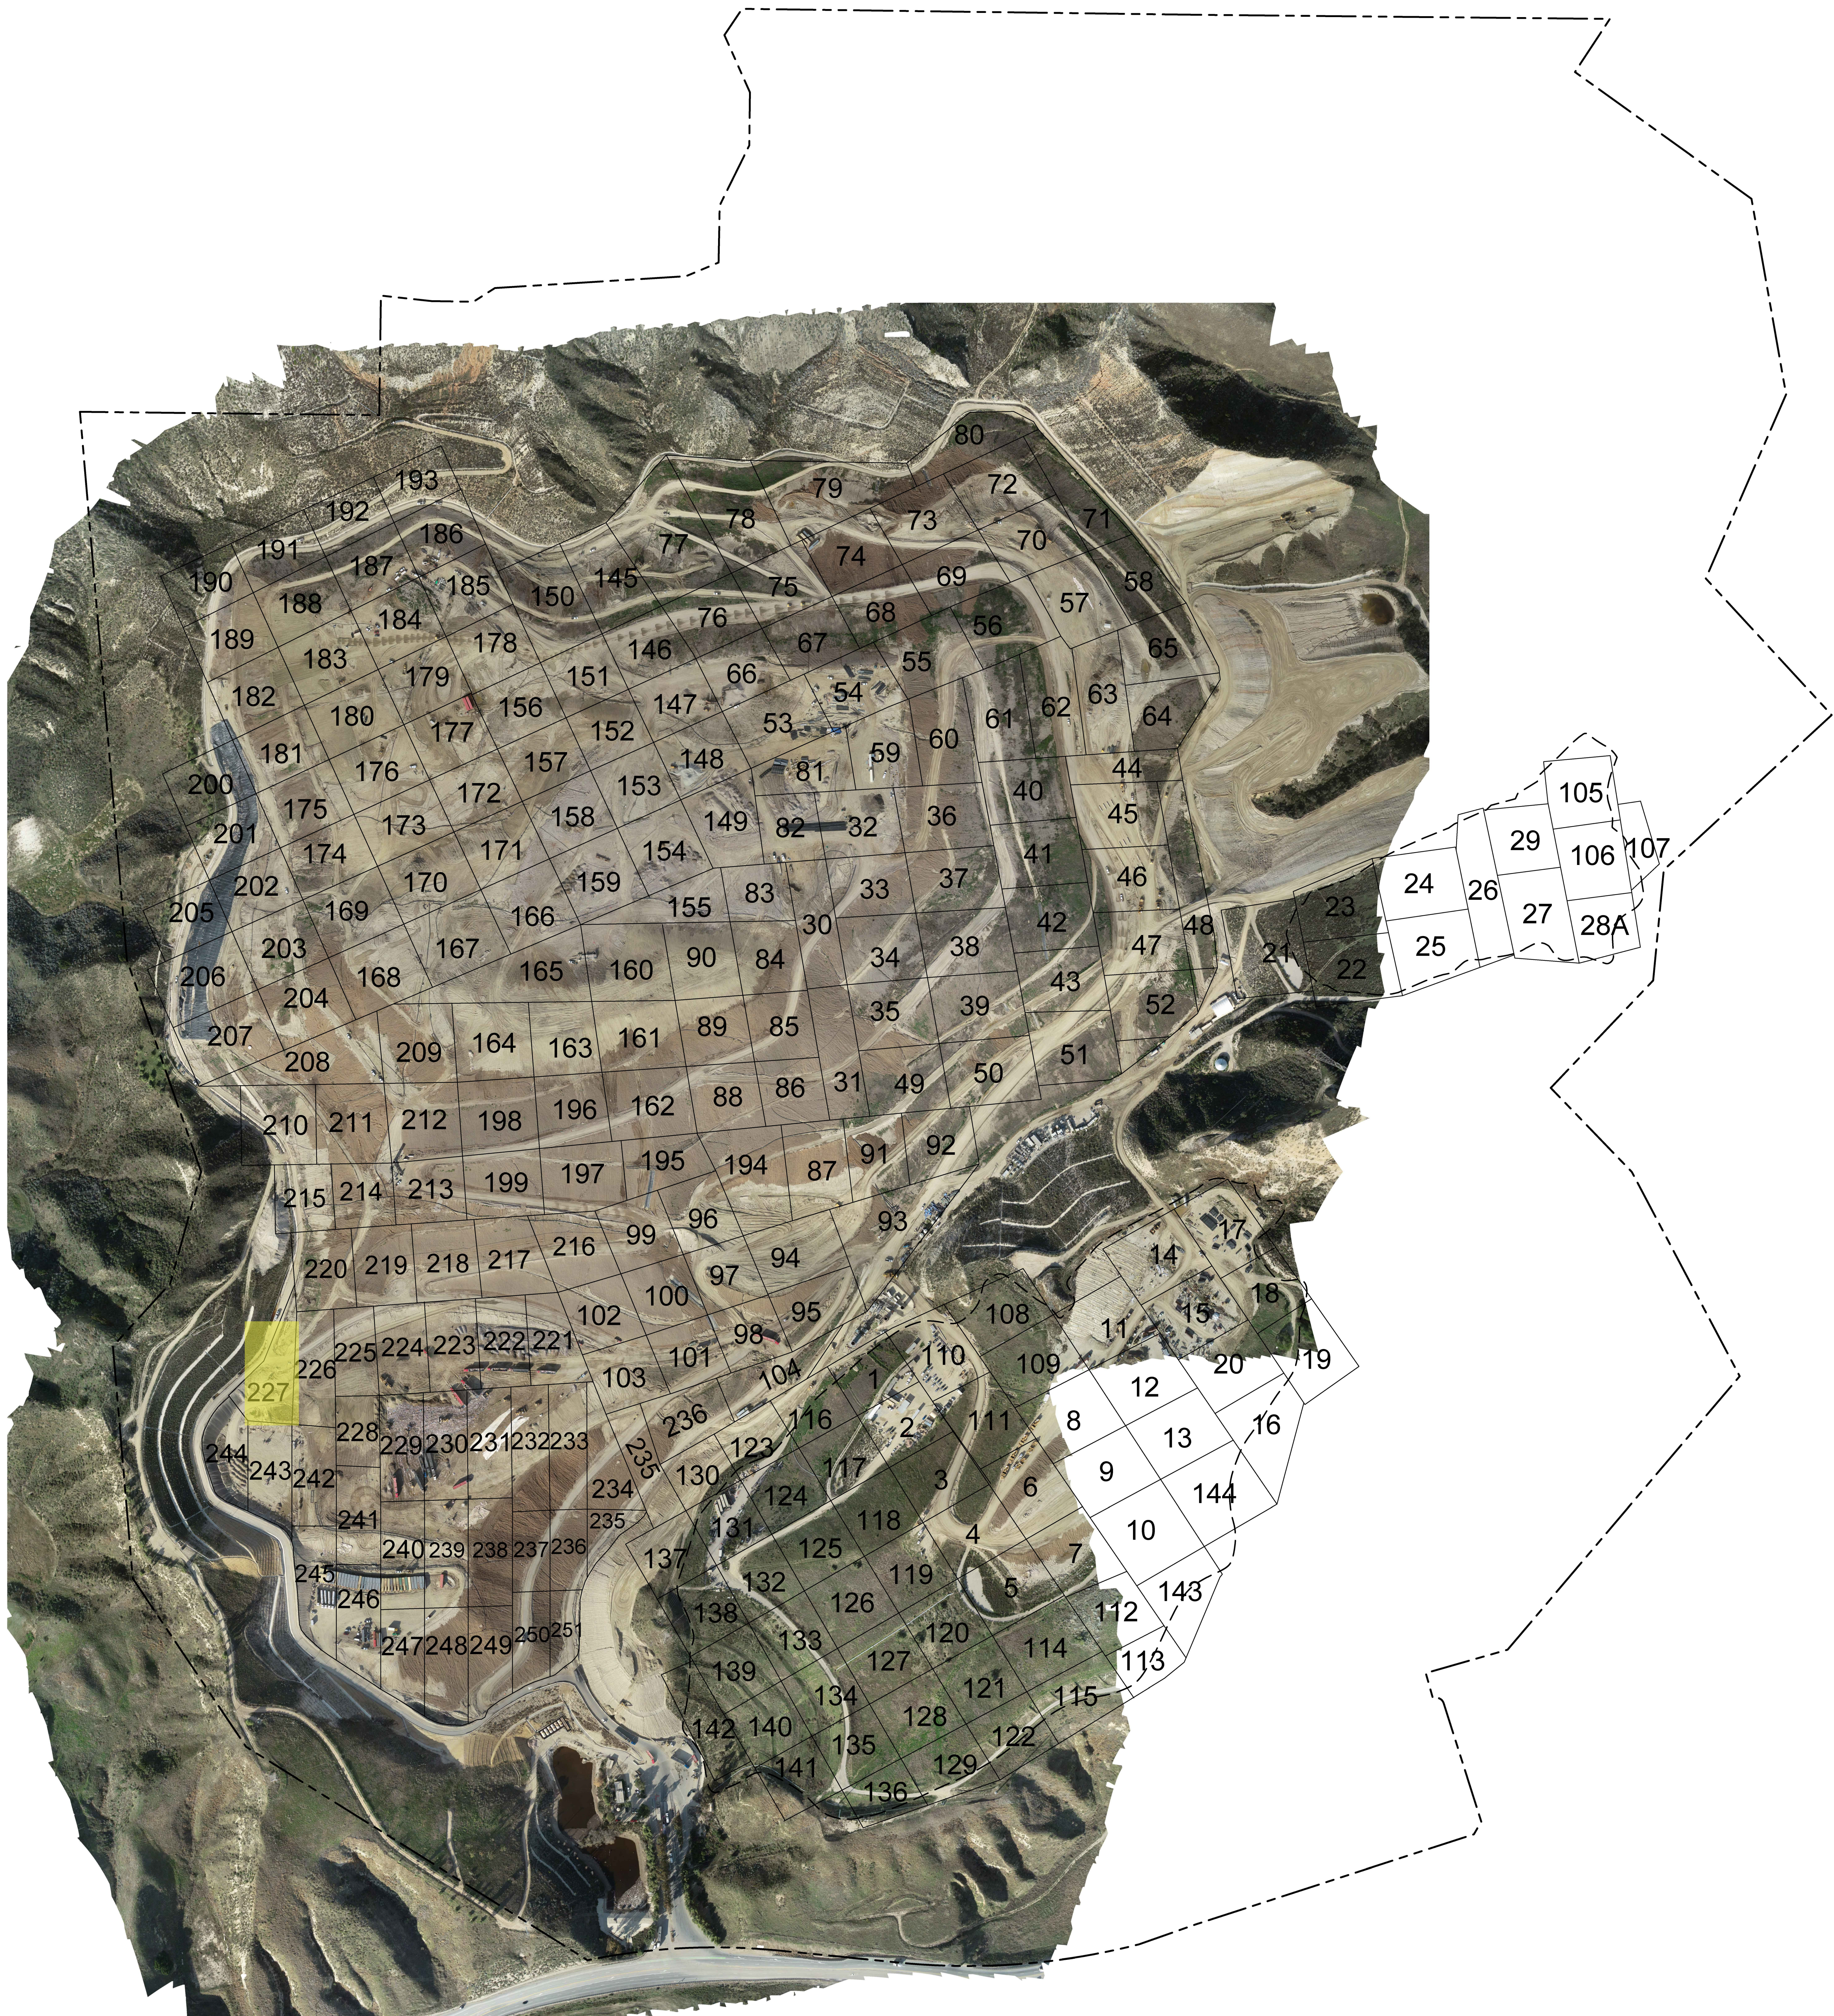
Attachment A – Map depicting the location of the spill

The spill occurred in Grid 227 – as depicted in **Attachment A**.

At approximately 4:00 p.m. on January 16, 2026, Chiquita discovered a spill in Grid 227 of the landfill. Based on Chiquita’s current knowledge, it appears that the leachate spilled while a third-party contractor attempted to pinch off a pipe and cap it because the pipe was no longer going to be used. During that process, equipment used to support the pipe clipped the cleanout pipe, causing liquid in the pipe to spill onto the lined landfill surface and partially onto the perimeter road.

Chiquita attributes this spill to third-party contractor error. The liquid was dark brown in color, with a thicker viscosity, and traveled as a light trickle.

Upon discovering the spill, Chiquita personnel pinched the pipe to stop the flow of liquid and created a soil berm to contain the liquid. Chiquita then removed the impacted soil from the area and placed it into a container for proper disposal. Fresh soil was then added to the area. Cleanup commenced immediately and was completed within approximately one hour.

Additionally, Chiquita is taking steps to prevent a similar spill from occurring in the future. Chiquita personnel discussed this event with the third-party contractor.
