CHIQUITA CANYON
A Waste Connections Company

Re: Chiquita Canyon, LLC's Weekly Report on the Documentation and Tracking of Cover Issues

4050 - Chiquita Reaction Area Tracking of Fissures and Tension Cracks

4050 - Geosynthetic Cover Inspection

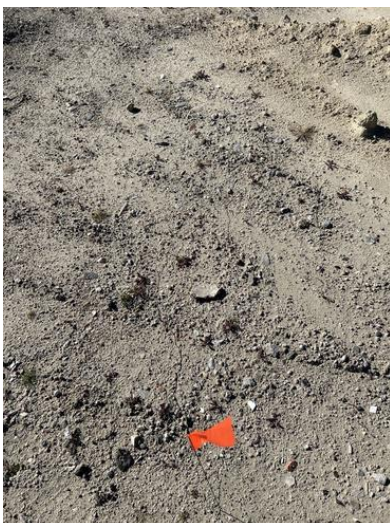
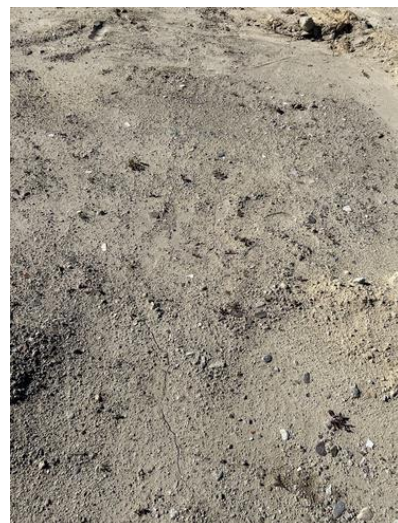
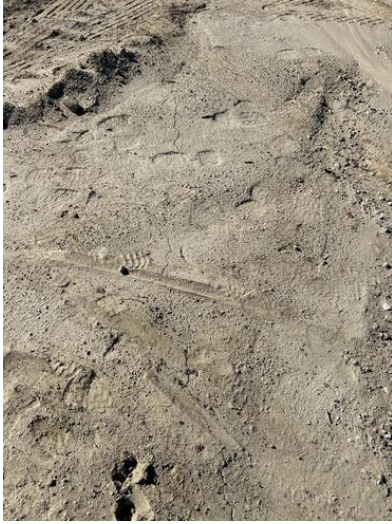
Length of crack (ft) or area containing multiple cracks (ft x ft) 30ft x 35ft

Horizontal Offset (width) Extra Small <0.5 in width

Vertical Offset (height) Extra small <0.5" in height

Orientation (direction) NE to SW

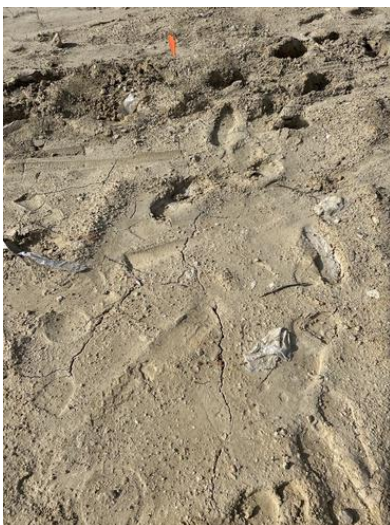
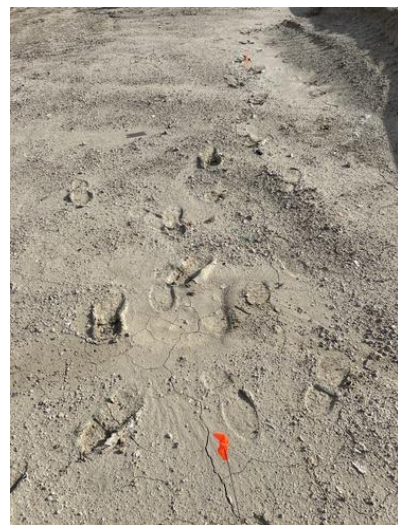
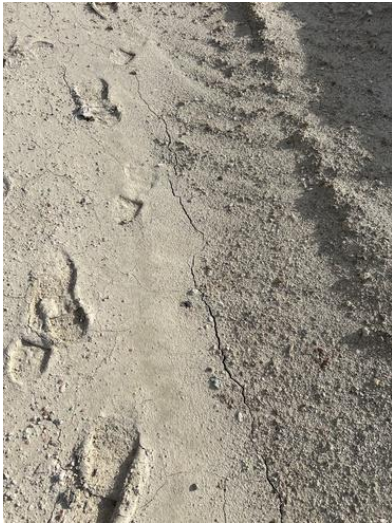
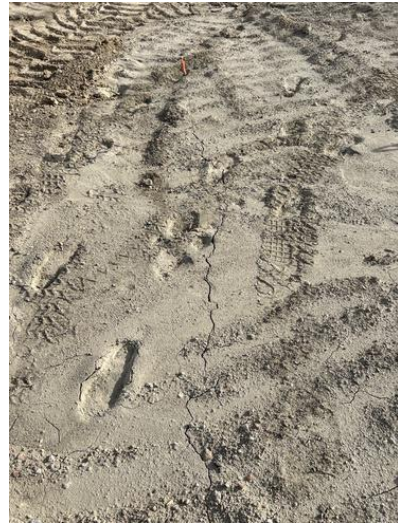
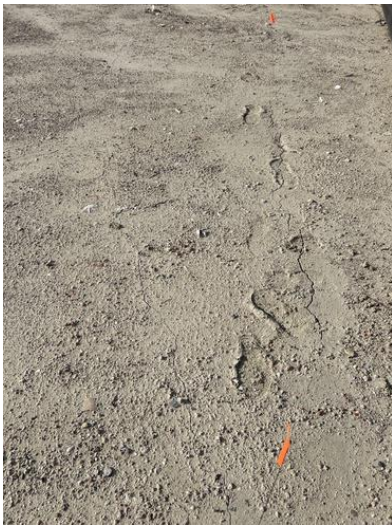
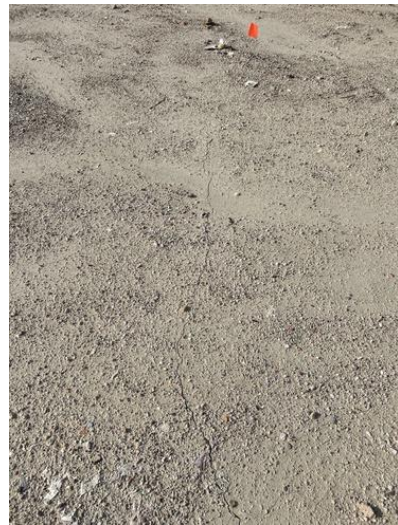
70ft x 35ft

No individual crack over 50ft

Small 0.5-2" in width

Extra small <0.5" in height

NE to SW

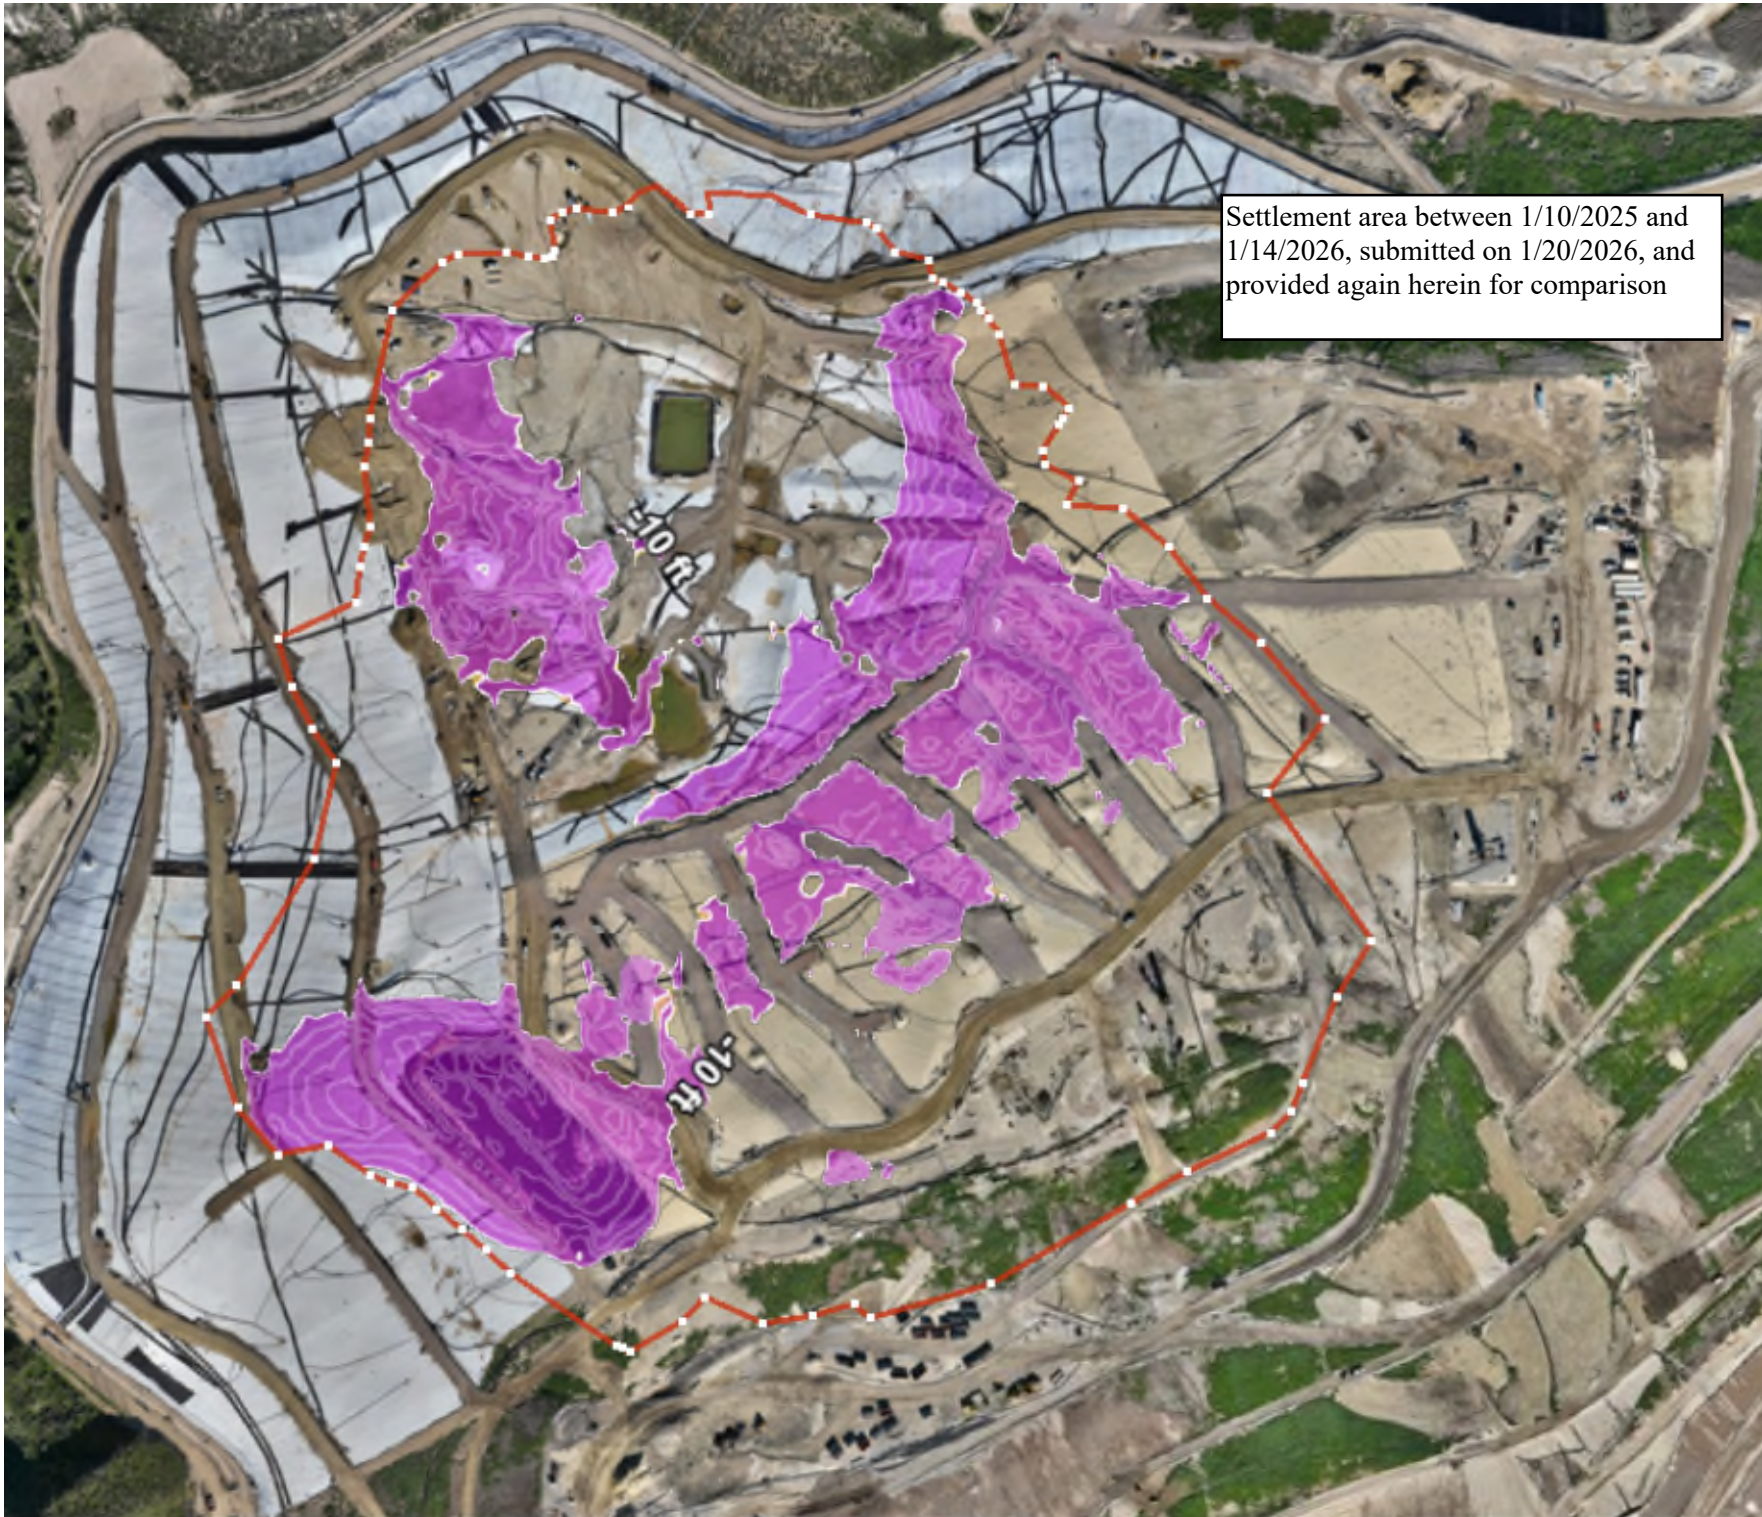
Settlement area between 1/10/2025 and 1/14/2026, submitted on 1/20/2026, and provided again herein for comparison

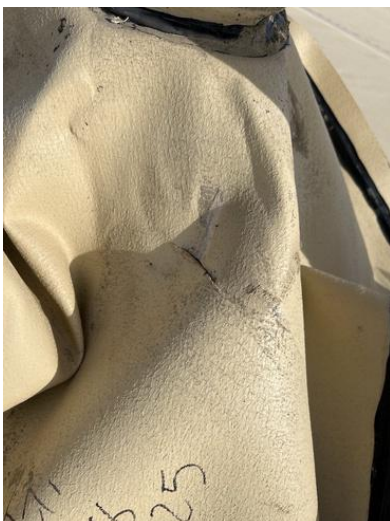
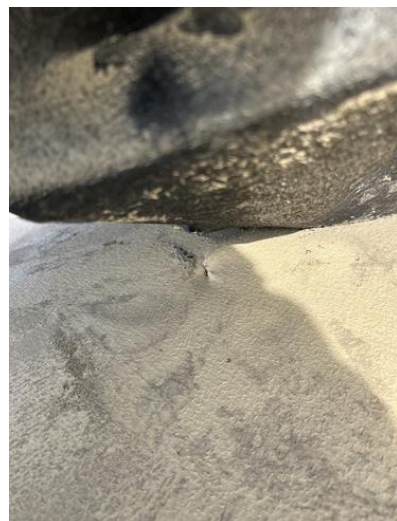
Boot needs to be lowered. Tears in liner need to be extrusion welded.

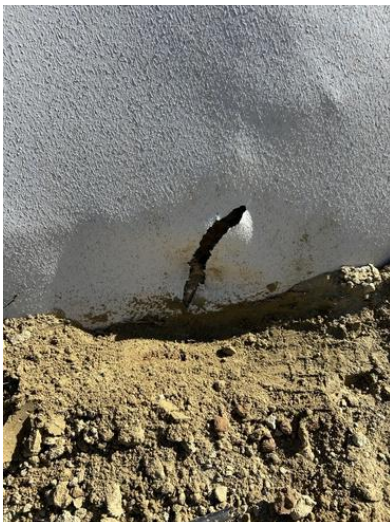
Photo 1

Tear in liner needs to be patched/extrusion welded.

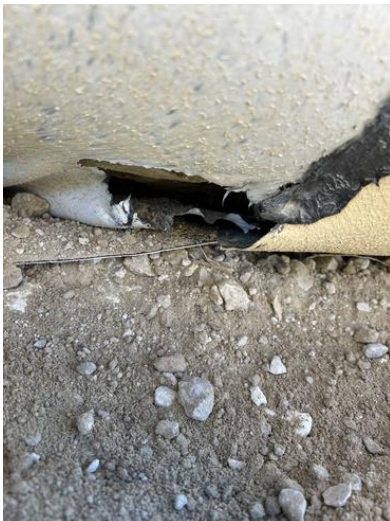
Photo 5

Tear in liner needs to be patched
and extrusion welded.

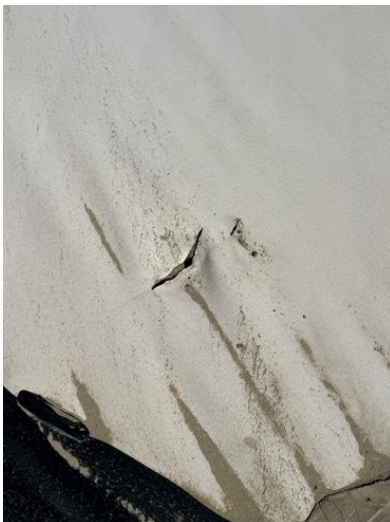
Photo 1

Two small tears side by side need to be patched/extrusion welded.

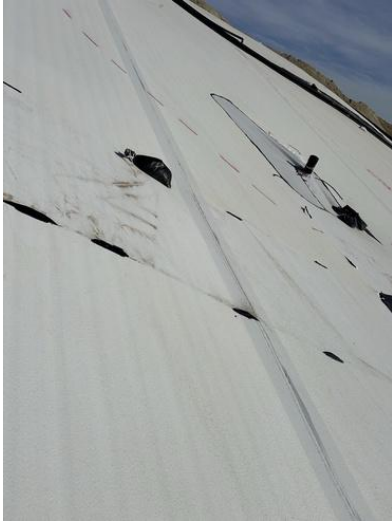
Photo 4

Tears in liner need to be patched/extrusion welded.

Tears are in an area that cannot be safely accessed at this time. A repair plan is being developed.

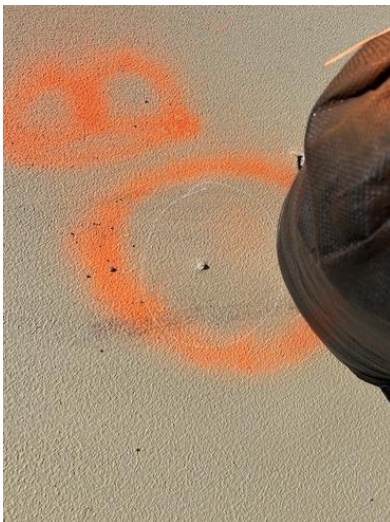
Photo 1

Small pinhole in liner needs to be patched and extrusion welded
