**Subject: Leachate Spill Report
Chiquita Canyon Landfill
File No. 67-020**

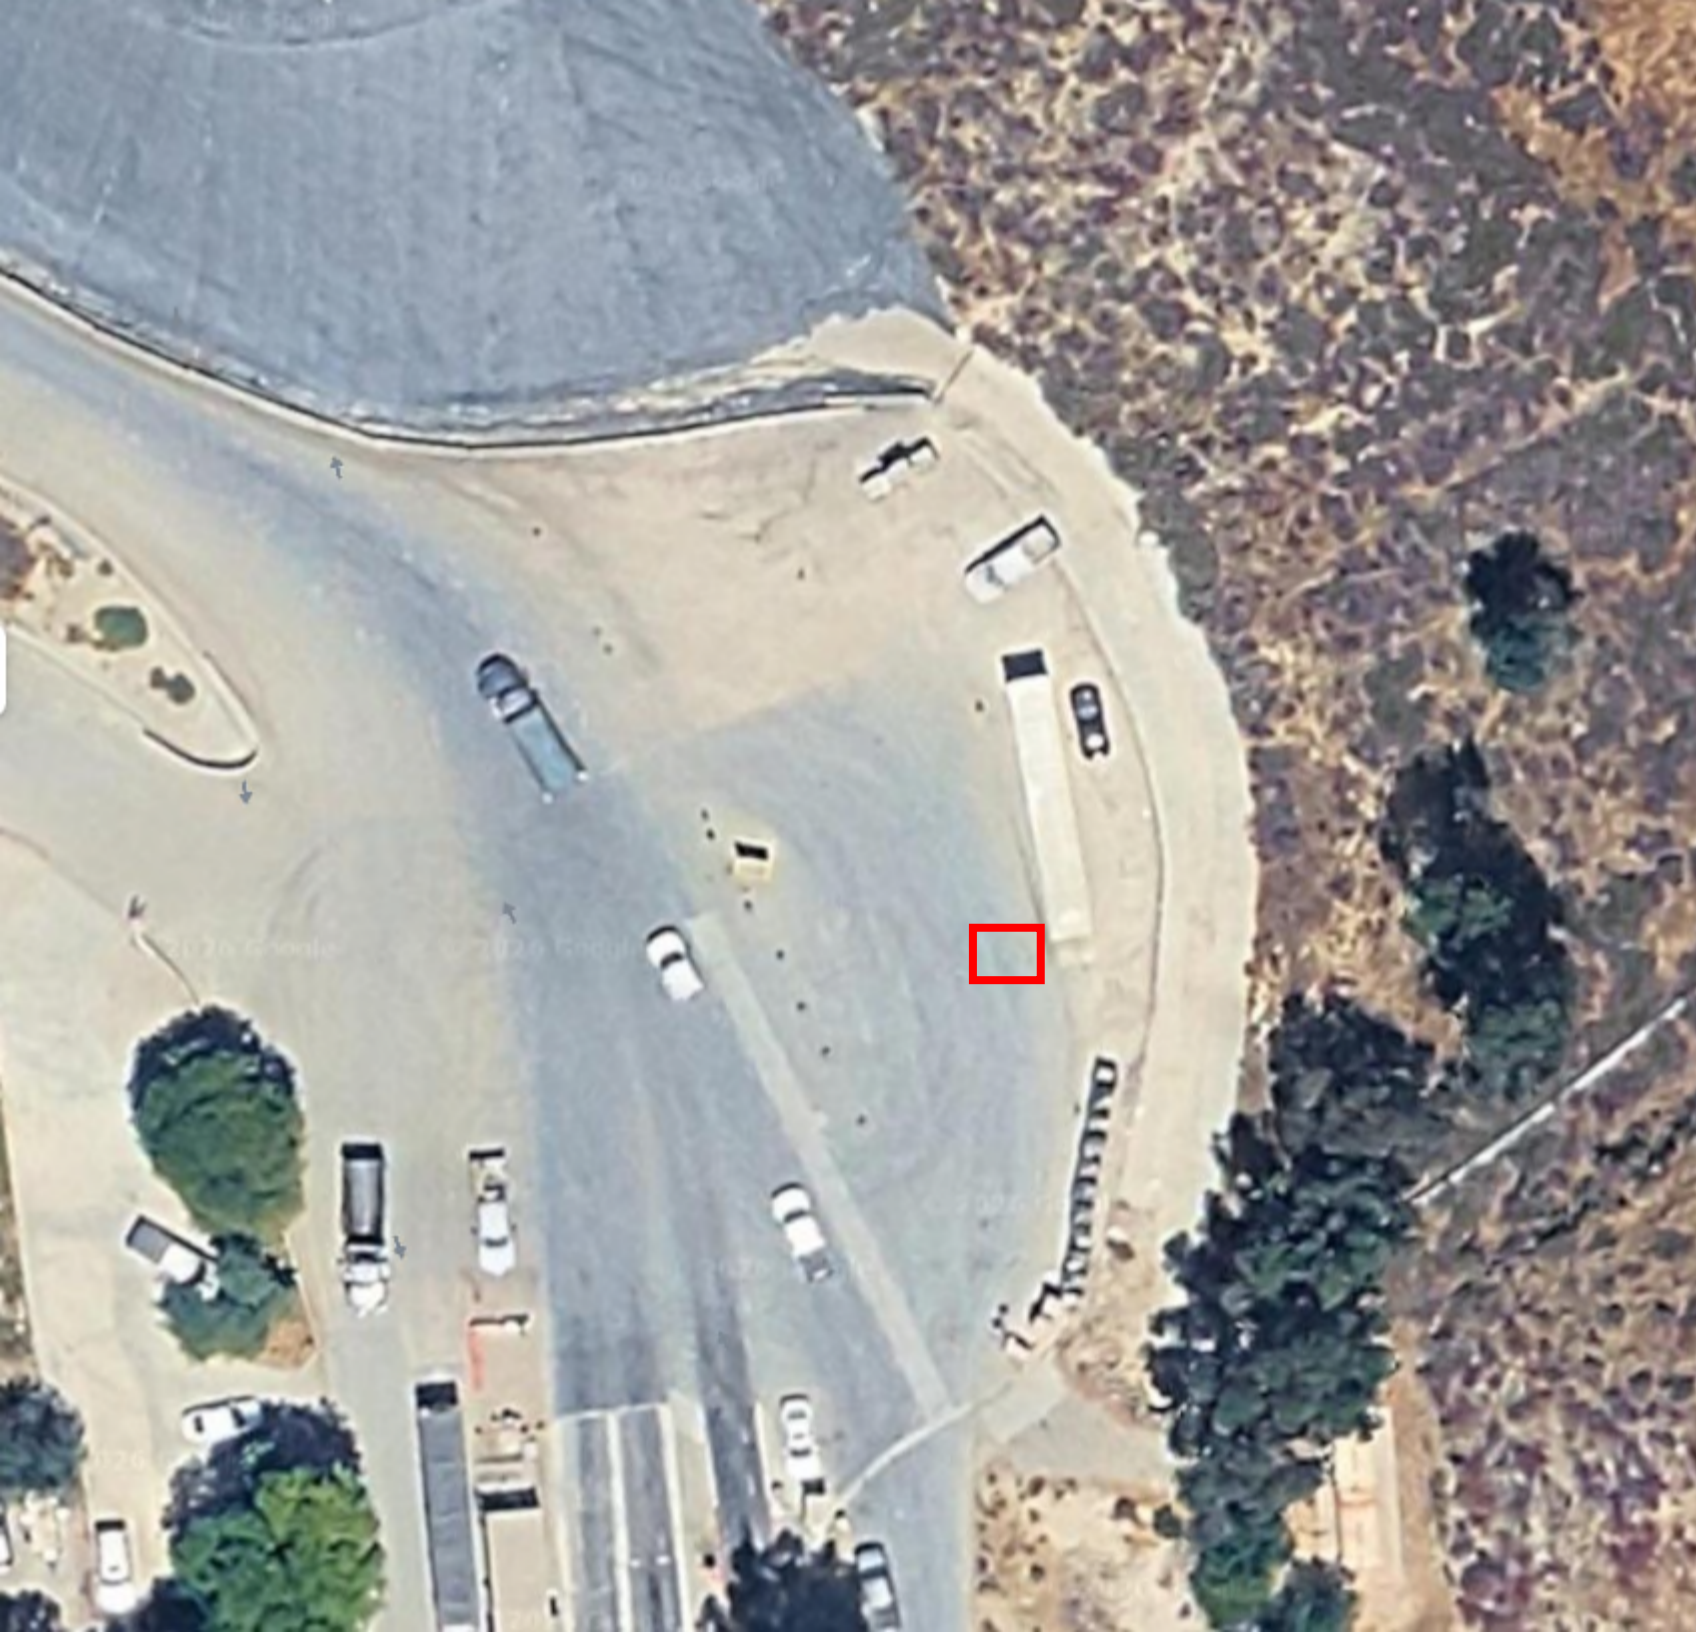
Attachment A – Map depicting the location of the spill

The spill occurred near the scale house adjacent to Grid 142 – as depicted in **Attachment A**.

At approximately 10:30 a.m. on January 27, 2026, Chiquita discovered a spill near the scale house of the landfill. Based on Chiquita’s current knowledge, it appears that after a leachate pump in Tank Farm 7 was disconnected, drained, and moved to the staging area to be transported offsite by a third-party contractor for maintenance, the third-party contractor instead began to perform maintenance in the staging area, resulting in a spill. Chiquita attributes this spill to third-party

operator error. The liquid was dark brown in color, with a thicker viscosity, and had a very low flow rate.

Upon discovering the spill, Chiquita personnel promptly applied absorbent to the area impacted by the spill. The soiled absorbent was then removed from the area and placed into a container for proper disposal. Cleanup commenced immediately and was completed within approximately 10 minutes.

Additionally, Chiquita is taking steps to prevent a similar spill from occurring in the future. Chiquita personnel discussed the appropriate areas for maintenance work with the third-party contractor and reminded personnel to continue to check equipment for any liquid before moving it.
