**Re: Chiquita Canyon, LLC's Weekly Leachate Inspection Report for Stipulated Order for Abatement (Case No. 6177-4), Condition 27(c)**

Pursuant to Condition 27(c) of the Stipulated Order for Abatement (the “SOFA”) with the South Coast Air Quality Management District (“South Coast AQMD”) in Case No. 6177-4, Chiquita Canyon, LLC (“Chiquita”) encloses a compilation of the twice daily leachate seep inspection logs for the dates of January 26, 2026 through February 1, 2026.

# 4050 - Chiquita Leachate Seep/Pooling Inspection

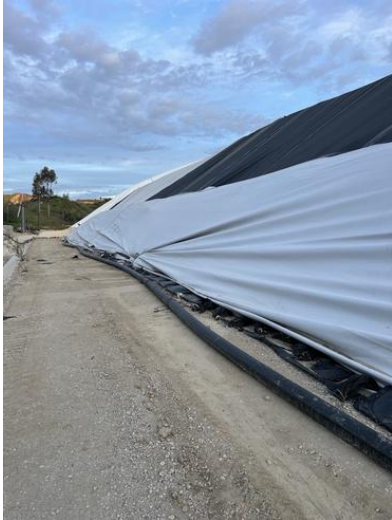
Photo 1

Westside perimeter road.

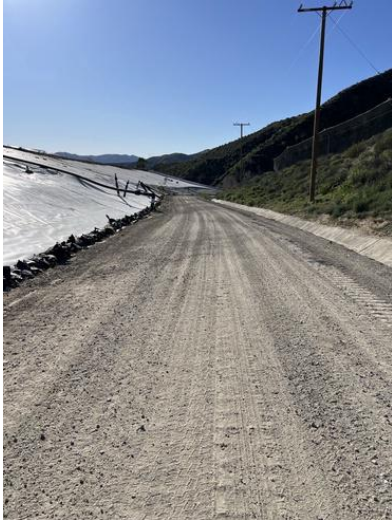
Photo 1

North perimeter road.

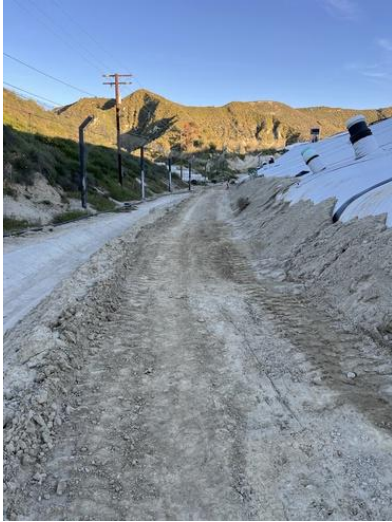
Photo 1

Westside perimeter road.

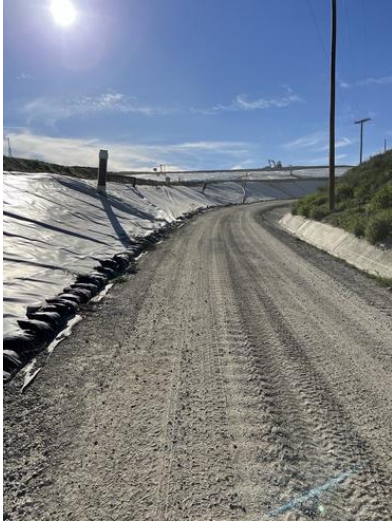
Photo 1

North perimeter road.

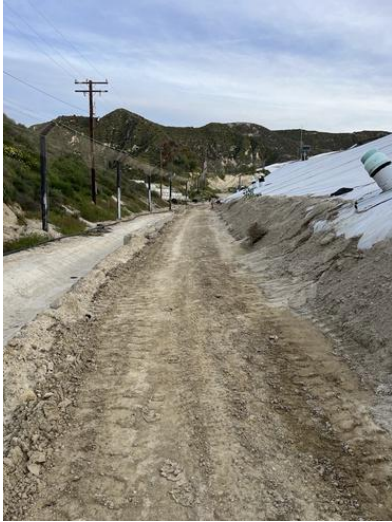
Photo 1

Westside perimeter road.

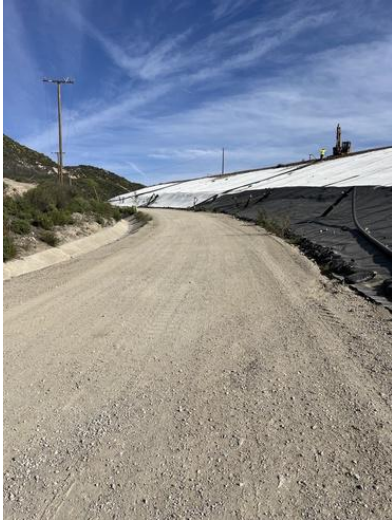
Photo 1

North perimeter road.

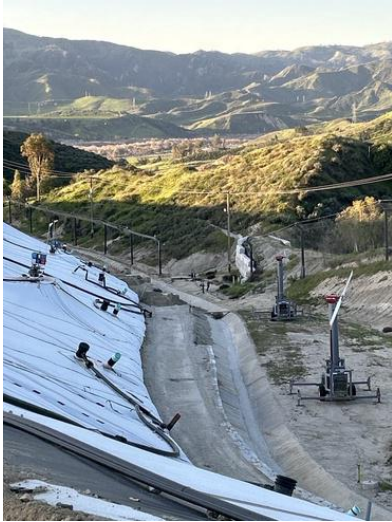
Photo 1

West side perimeter road

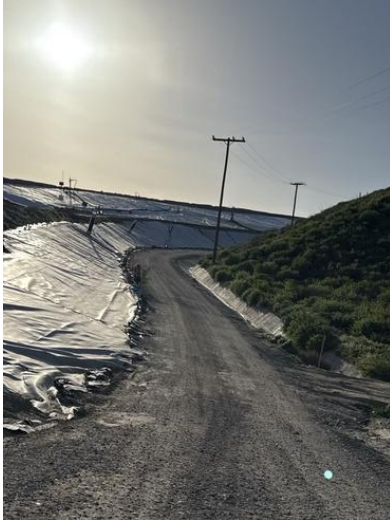
Photo 1

North side perimeter road

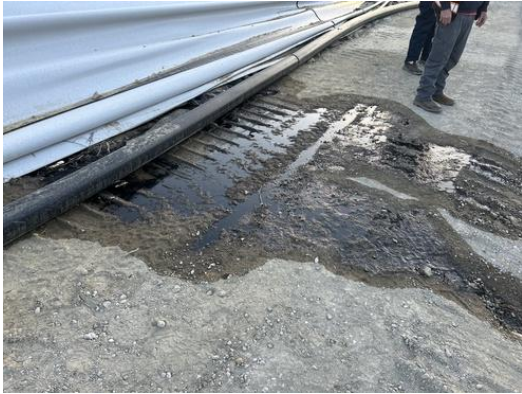
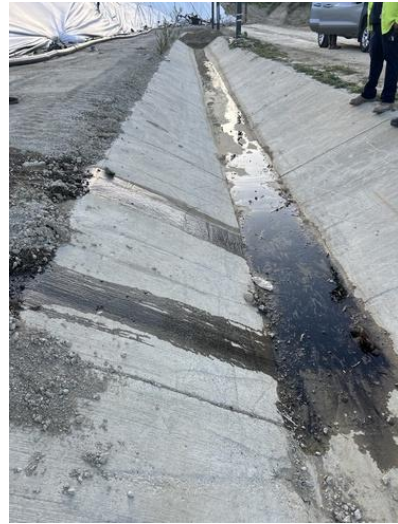
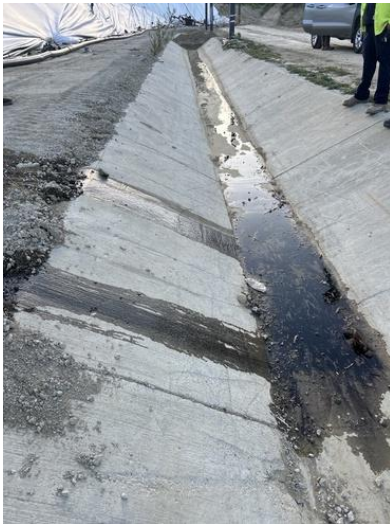
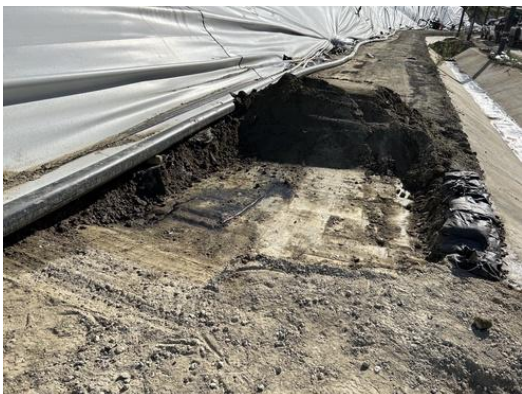
On January 30, 2026, at approximately 2:30 a.m., a seep was observed in grid 210, as described in the enclosed logs. Between 6-10 gallons of leachate leaked from the ground beneath the cover and into the stormwater channel. The total area impacted was approximately 100 square feet. The impacted soil in the area was saturated. Odor from the seep ranged from strong odor to light odor. Chiquita personnel pressure washed the stormwater channel while applying vacuum to ensure the proper collection of all wash water and standing liquid. A berm was created around the location of the seep. A steel plate and geomembrane cover were then placed on top of the beamed area to mitigate the potential for odors. Finally, a hose was inserted to remove any standing liquid from

Which grid is the leachate seep/pooling located?

210

4.5 hours

6-10 gallons

100sq ft

4 - Strong Odor

Standing free liquid

Yes

Leachate vacuumed out, storm water channel pressure washed and vacuumed, shallow hole dug and sandbag berm created around seep location to contain seep. work is ongoing to contain seep.

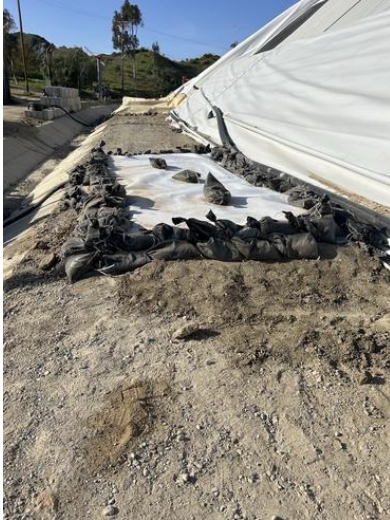
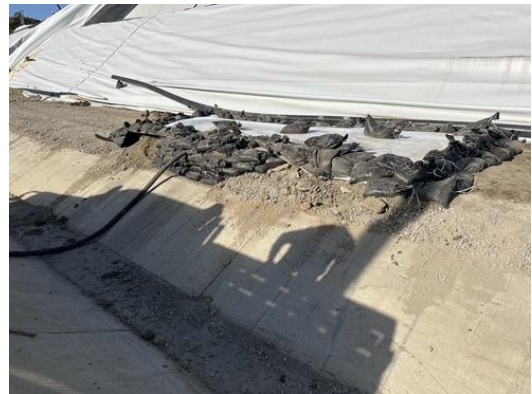
Seep from previous inspection was not observed. Berm was created around morning seep location. Steel plate and liner placed on top to prevent atmospheric exposure. Hose inserted to remove any standing liquid should any present itself.

the bermed area in the event the seep produced any additional liquid. No liquid has been observed in the area since January 30, 2026. Notwithstanding, Chiquita personnel continue to inspect the area multiple times per day.

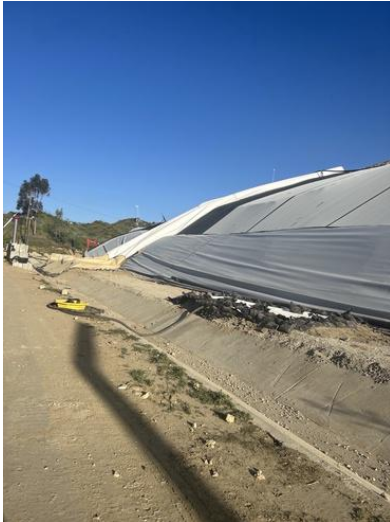
Photo 1

Seep from previous inspection has maintained containment and no actively seeping location has been observed.

West side perimeter road

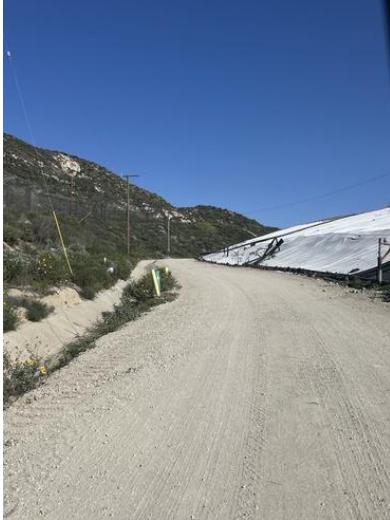
Photo 1

North side perimeter road

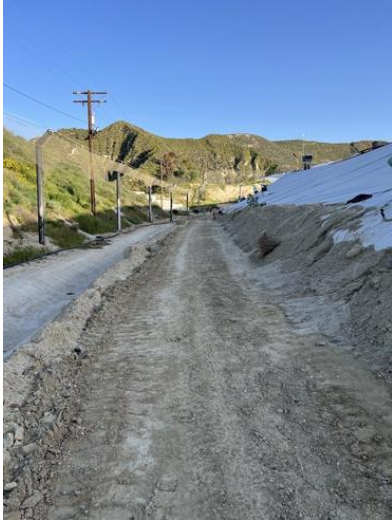
Photo 1

Westside perimeter road.

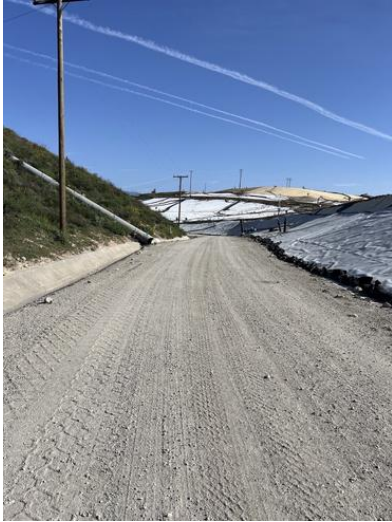
Photo 1

North perimeter road.
