**Re: Chiquita Canyon, LLC's Weekly Report on the Documentation and Tracking of Cover Issues, Monthly Summary and Monthly Isopach Map**

# 4050 - Chiquita Reaction Area Tracking of Fissures and Tension Cracks

**JANUARY 2026 FISSURE AND TENSION CRACK MONITORING SUMMARY  
CHIQUITA CANYON LANDFILL  
CASTAIC, CALIFORNIA**

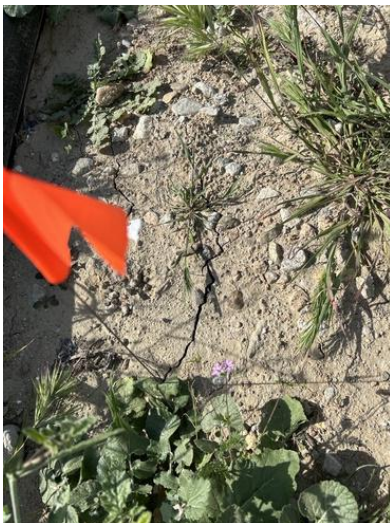
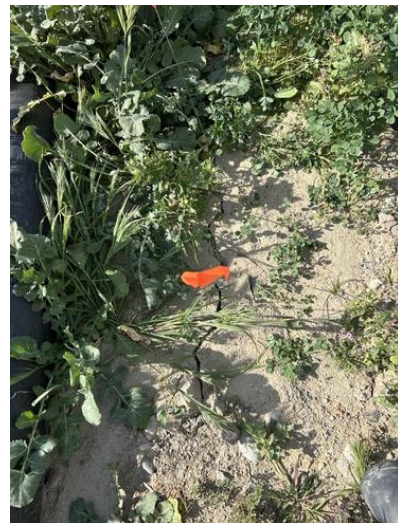
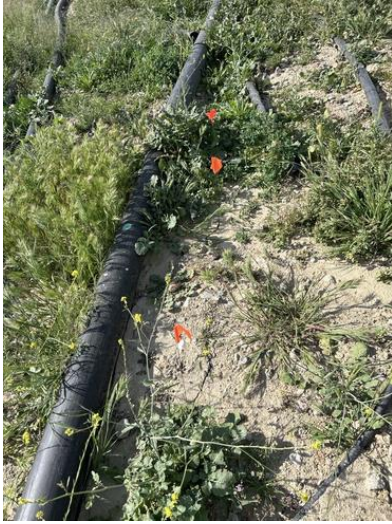
198

**Length of crack (ft) or area containing multiple cracks (ft x ft)** 4ft

**Description of repairs** Cracks were track walked.

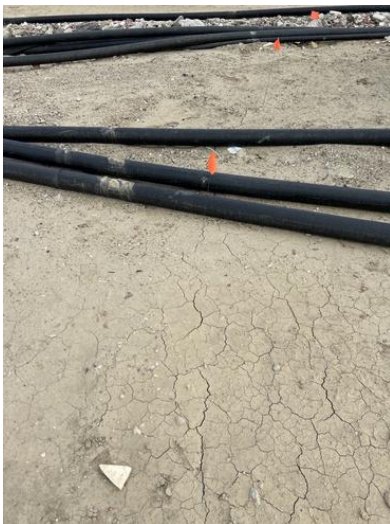
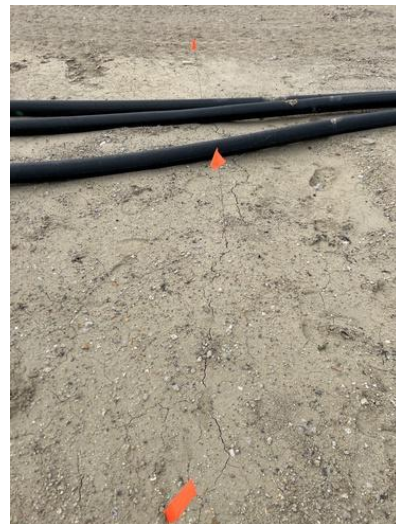
83

Cracks were track walked.

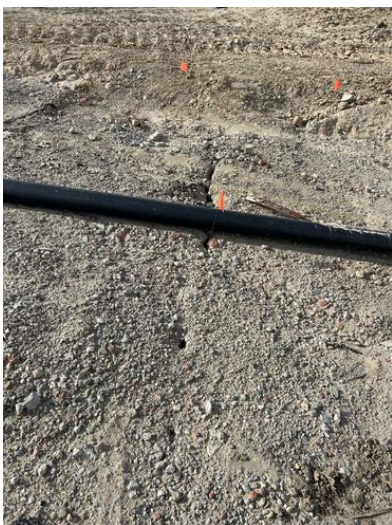
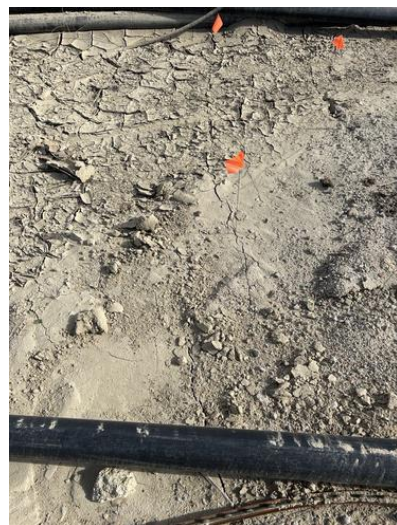
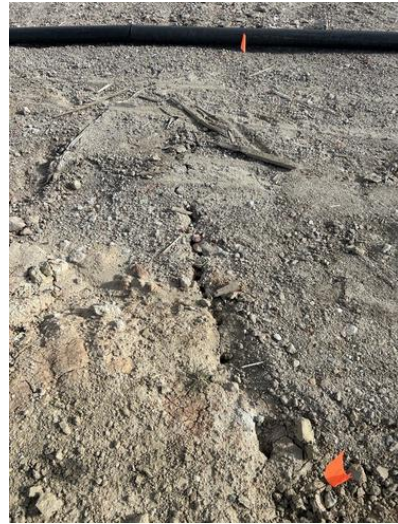
83

Multiple cracks in a 11ft x 16ft area

Cracks were track walked.

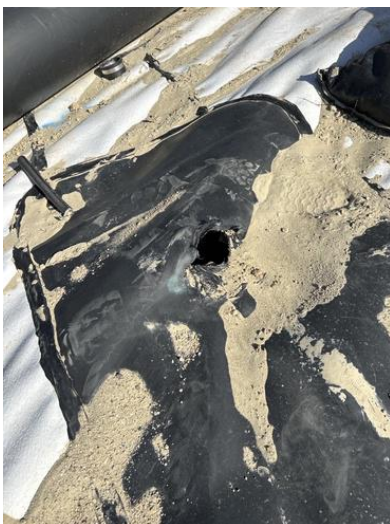
Photo 1

Hole where a pole was removed needs to be patched and extrusion welded.

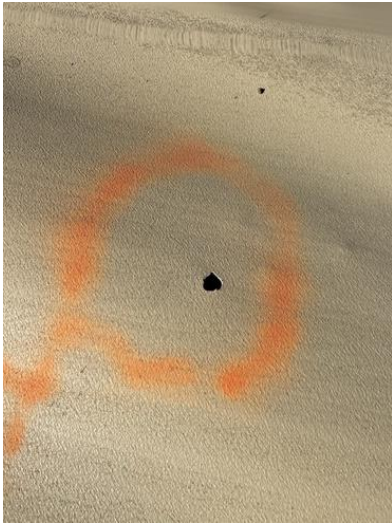
Photo 4

Hole in liner needs to be patched/extrusion welded.

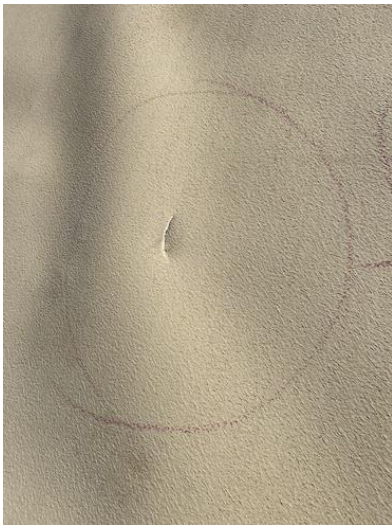
Photo 7

Tear in liner needs to be patched/extrusion welded.

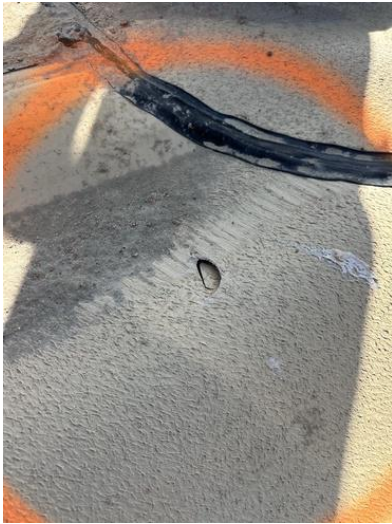
Photo 10

Hole in liner needs to be patched and extrusion welded.

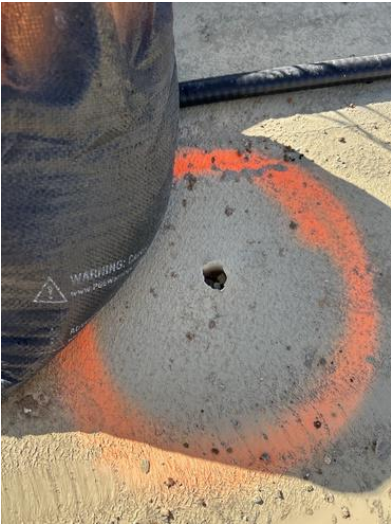
Photo 13

Hole in liner needs to be patched/extrusion welded.

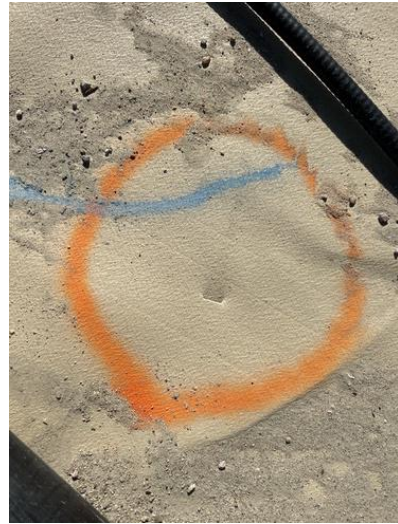
Photo 17

Two small tears in liner near each other need to be extrusion welded.

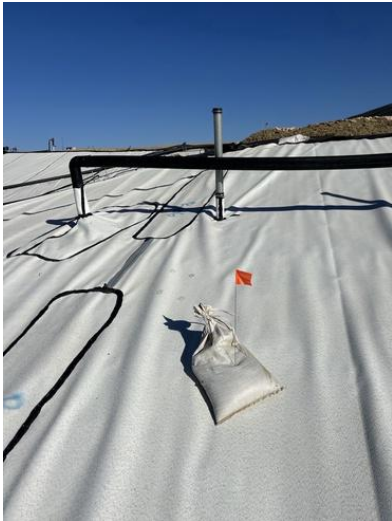
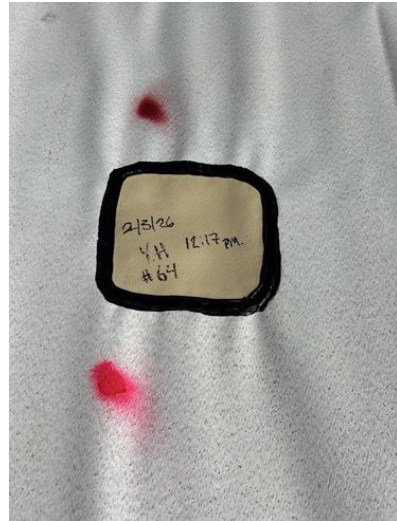
Patch photo states repair was on 2/3 but was actually conducted on 2/4

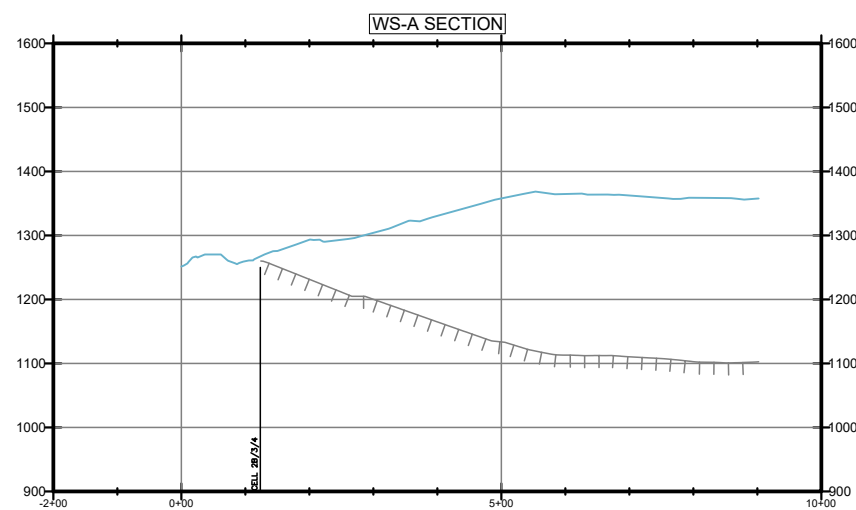
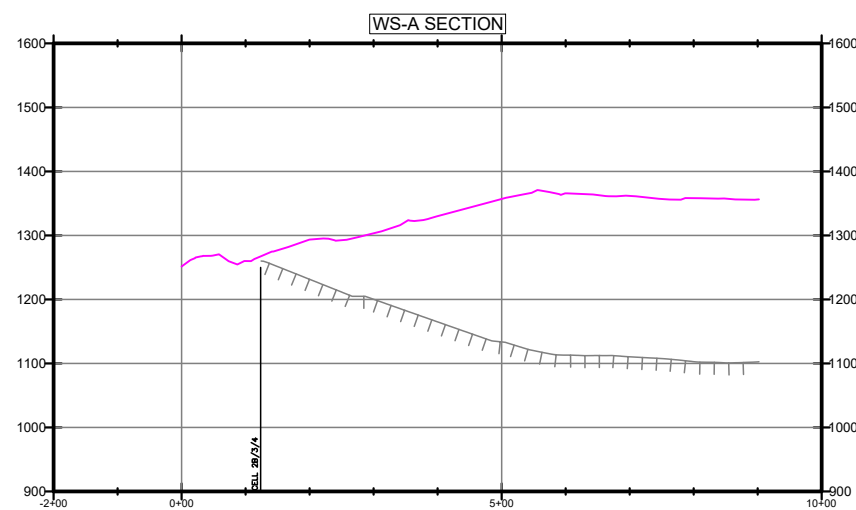
FIGURE 2A

All the cracks identified in Table 1 and summarized above were repaired. Cross sections that compare December 30, 2025 and January 28, 2026 topography are shown in Figures 2A through 2E. The locations of these cross sections are shown in Figure 1. The sections show no significant differences in slope or evidence of instability between the December 2025 and January 2026 profiles, which is consistent with the observational records summarized in Tables 1 and 2.
