Re: Chiquita Canyon, LLC's Weekly Leachate Inspection Report for Stipulated Order for Abatement (Case No. 6177-4), Condition 27(c)

Attachment: Leachate Inspection Logs from February 2, 2026 – February 8, 2026

4050 - Chiquita Leachate Seep/Pooling Inspection

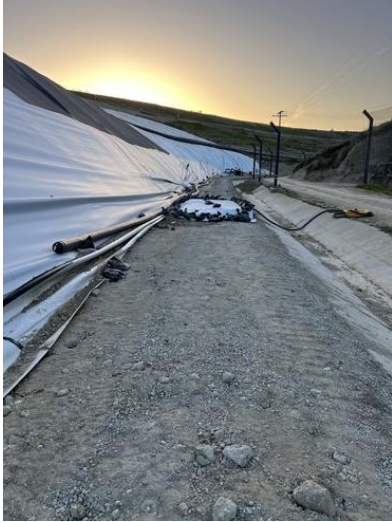
Photo 1

No

Westside perimeter road.

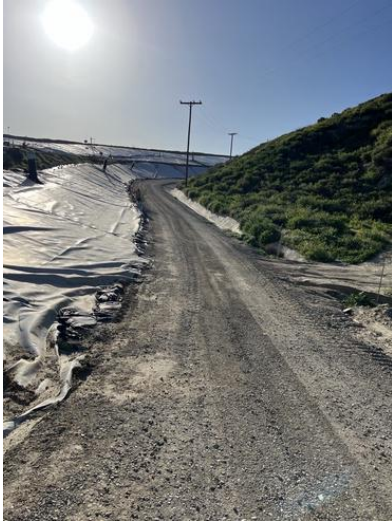
Photo 1

No

North perimeter road.

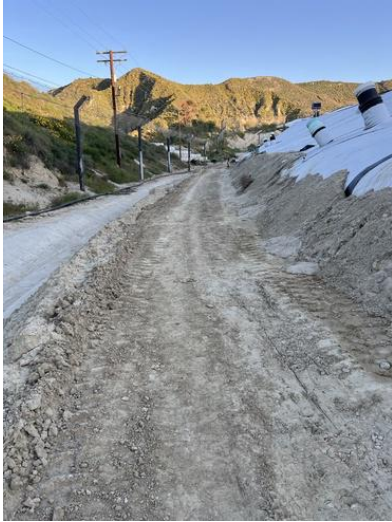
Photo 1

No

Westside perimeter road.

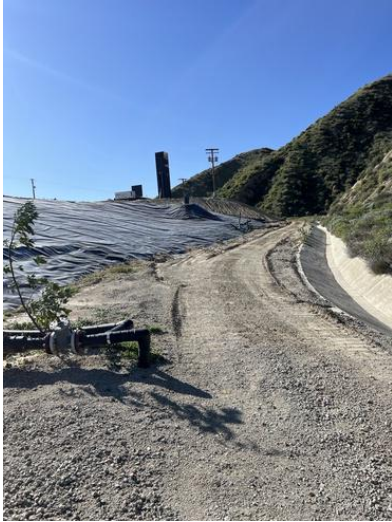
Photo 1

No

North perimeter road.

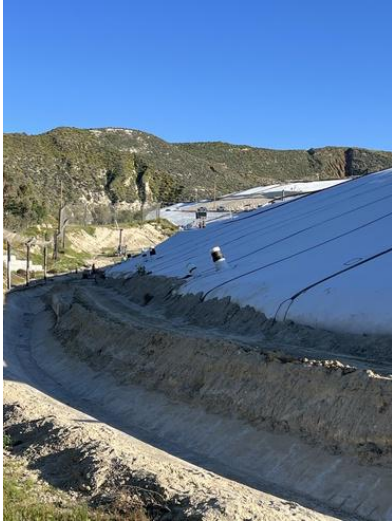
Photo 1

No

Westside perimeter road.

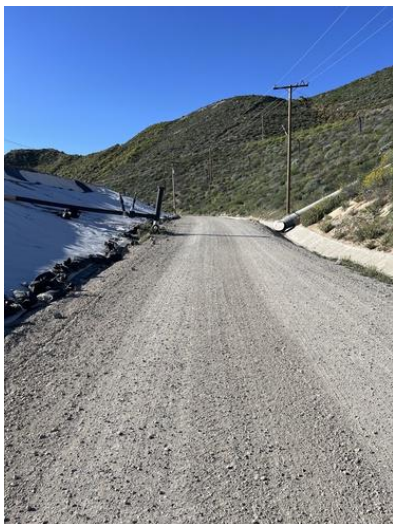
Photo 1

No

North perimeter road.

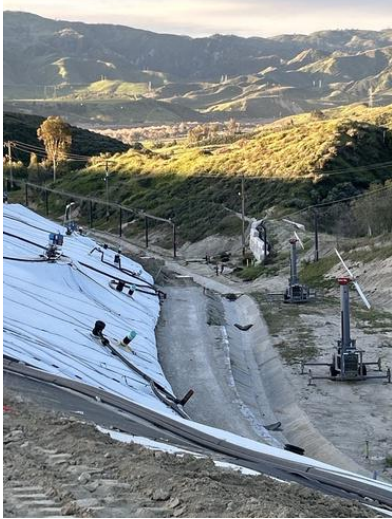
Photo 1

No

West side perimeter road

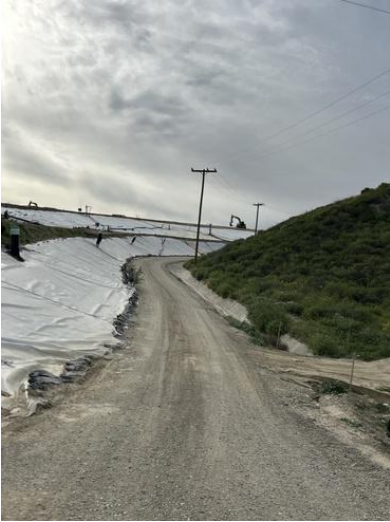
Photo 1

No

North side perimeter road

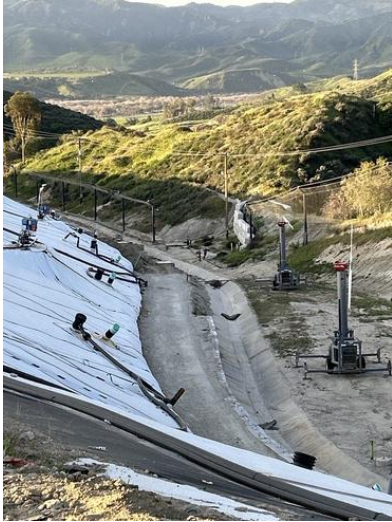
Photo 1

No

West side perimeter road

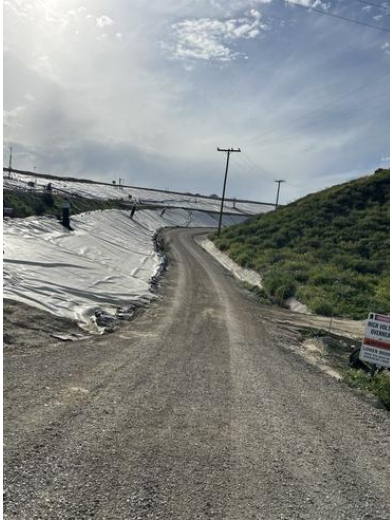
Photo 1

No

North side perimeter road

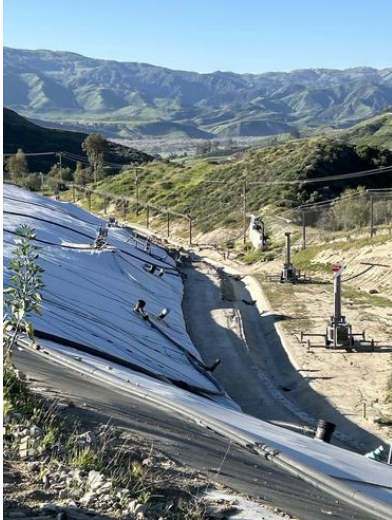
Photo 1

No

West side perimeter road

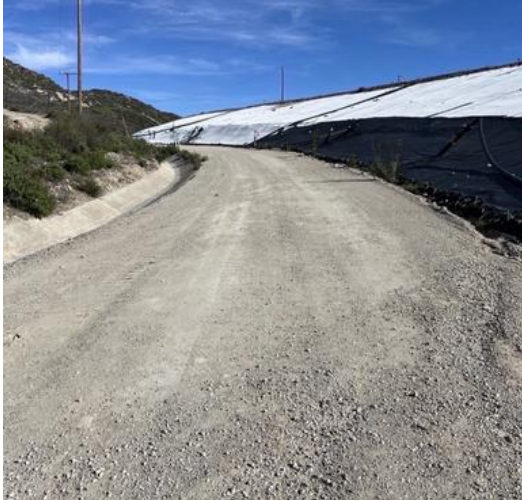
Photo 1

No

North side perimeter road

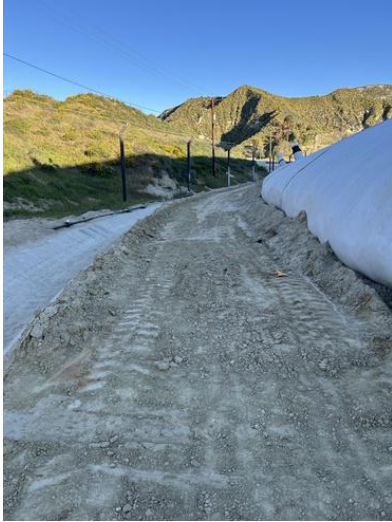
Photo 1

No

Westside perimeter road.

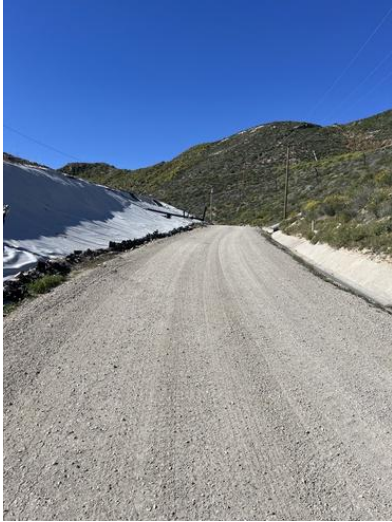
Photo 1

No

North perimeter road.
