CHIQUITA CANYON
A Waste Connections Company

February 12, 2026

**Subject: Leachate Spill Report
Chiquita Canyon Landfill
File No. 67-020**

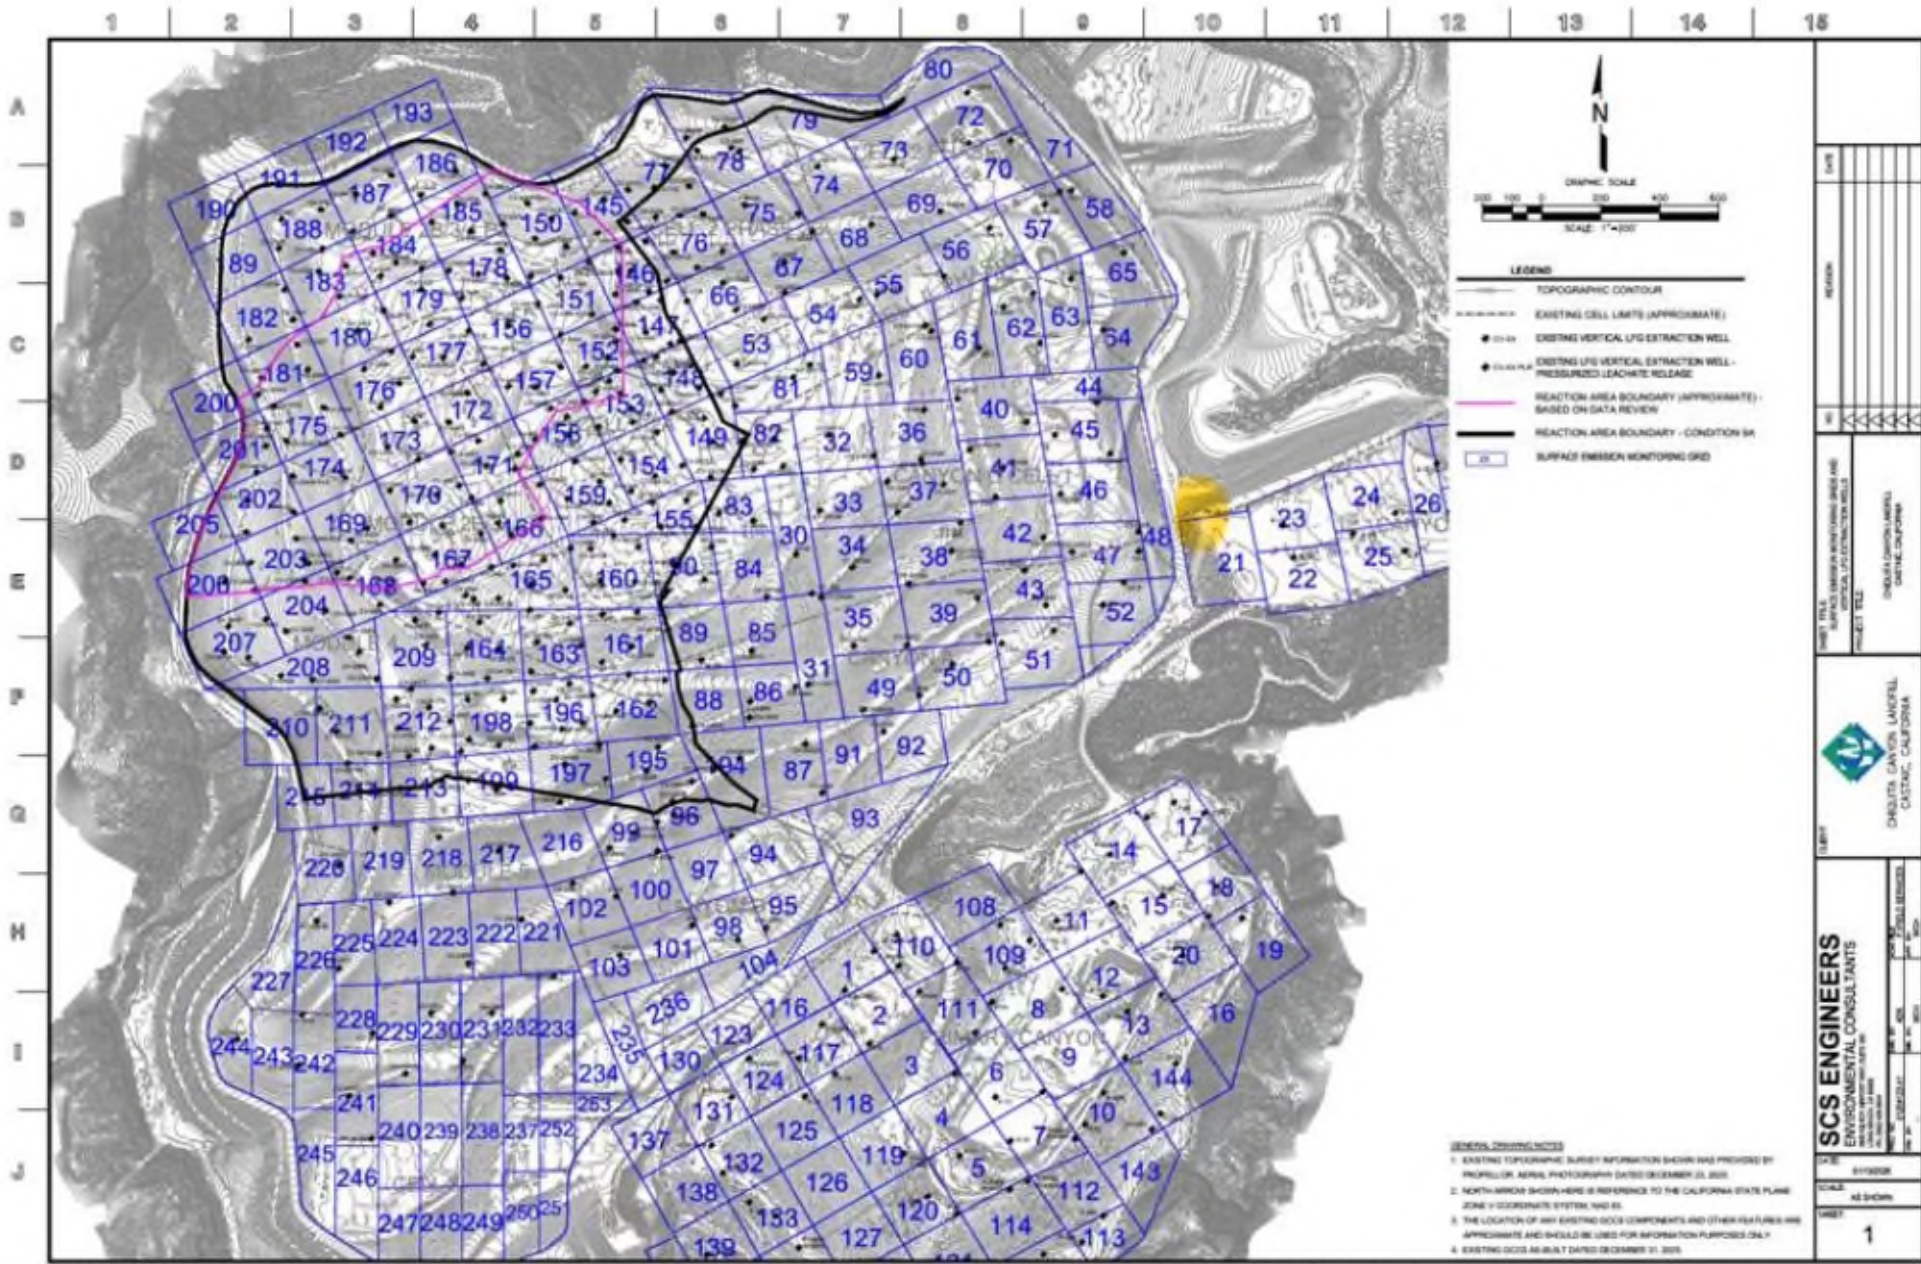
Attachments:
Attachment A – Map depicting the location of the spill

The spill occurred north of grid 21 – as depicted in **Attachment A**.
