CHIQUITA CANYON
A Waste Connections Company

Re: Chiquita Canyon, LLC's Weekly Report on the Documentation and Tracking of Cover Issues

Attachment: February 17, 2026 Weekly Cover Issues Report

4050 - Chiquita Reaction Area Tracking of Fissures and Tension Cracks

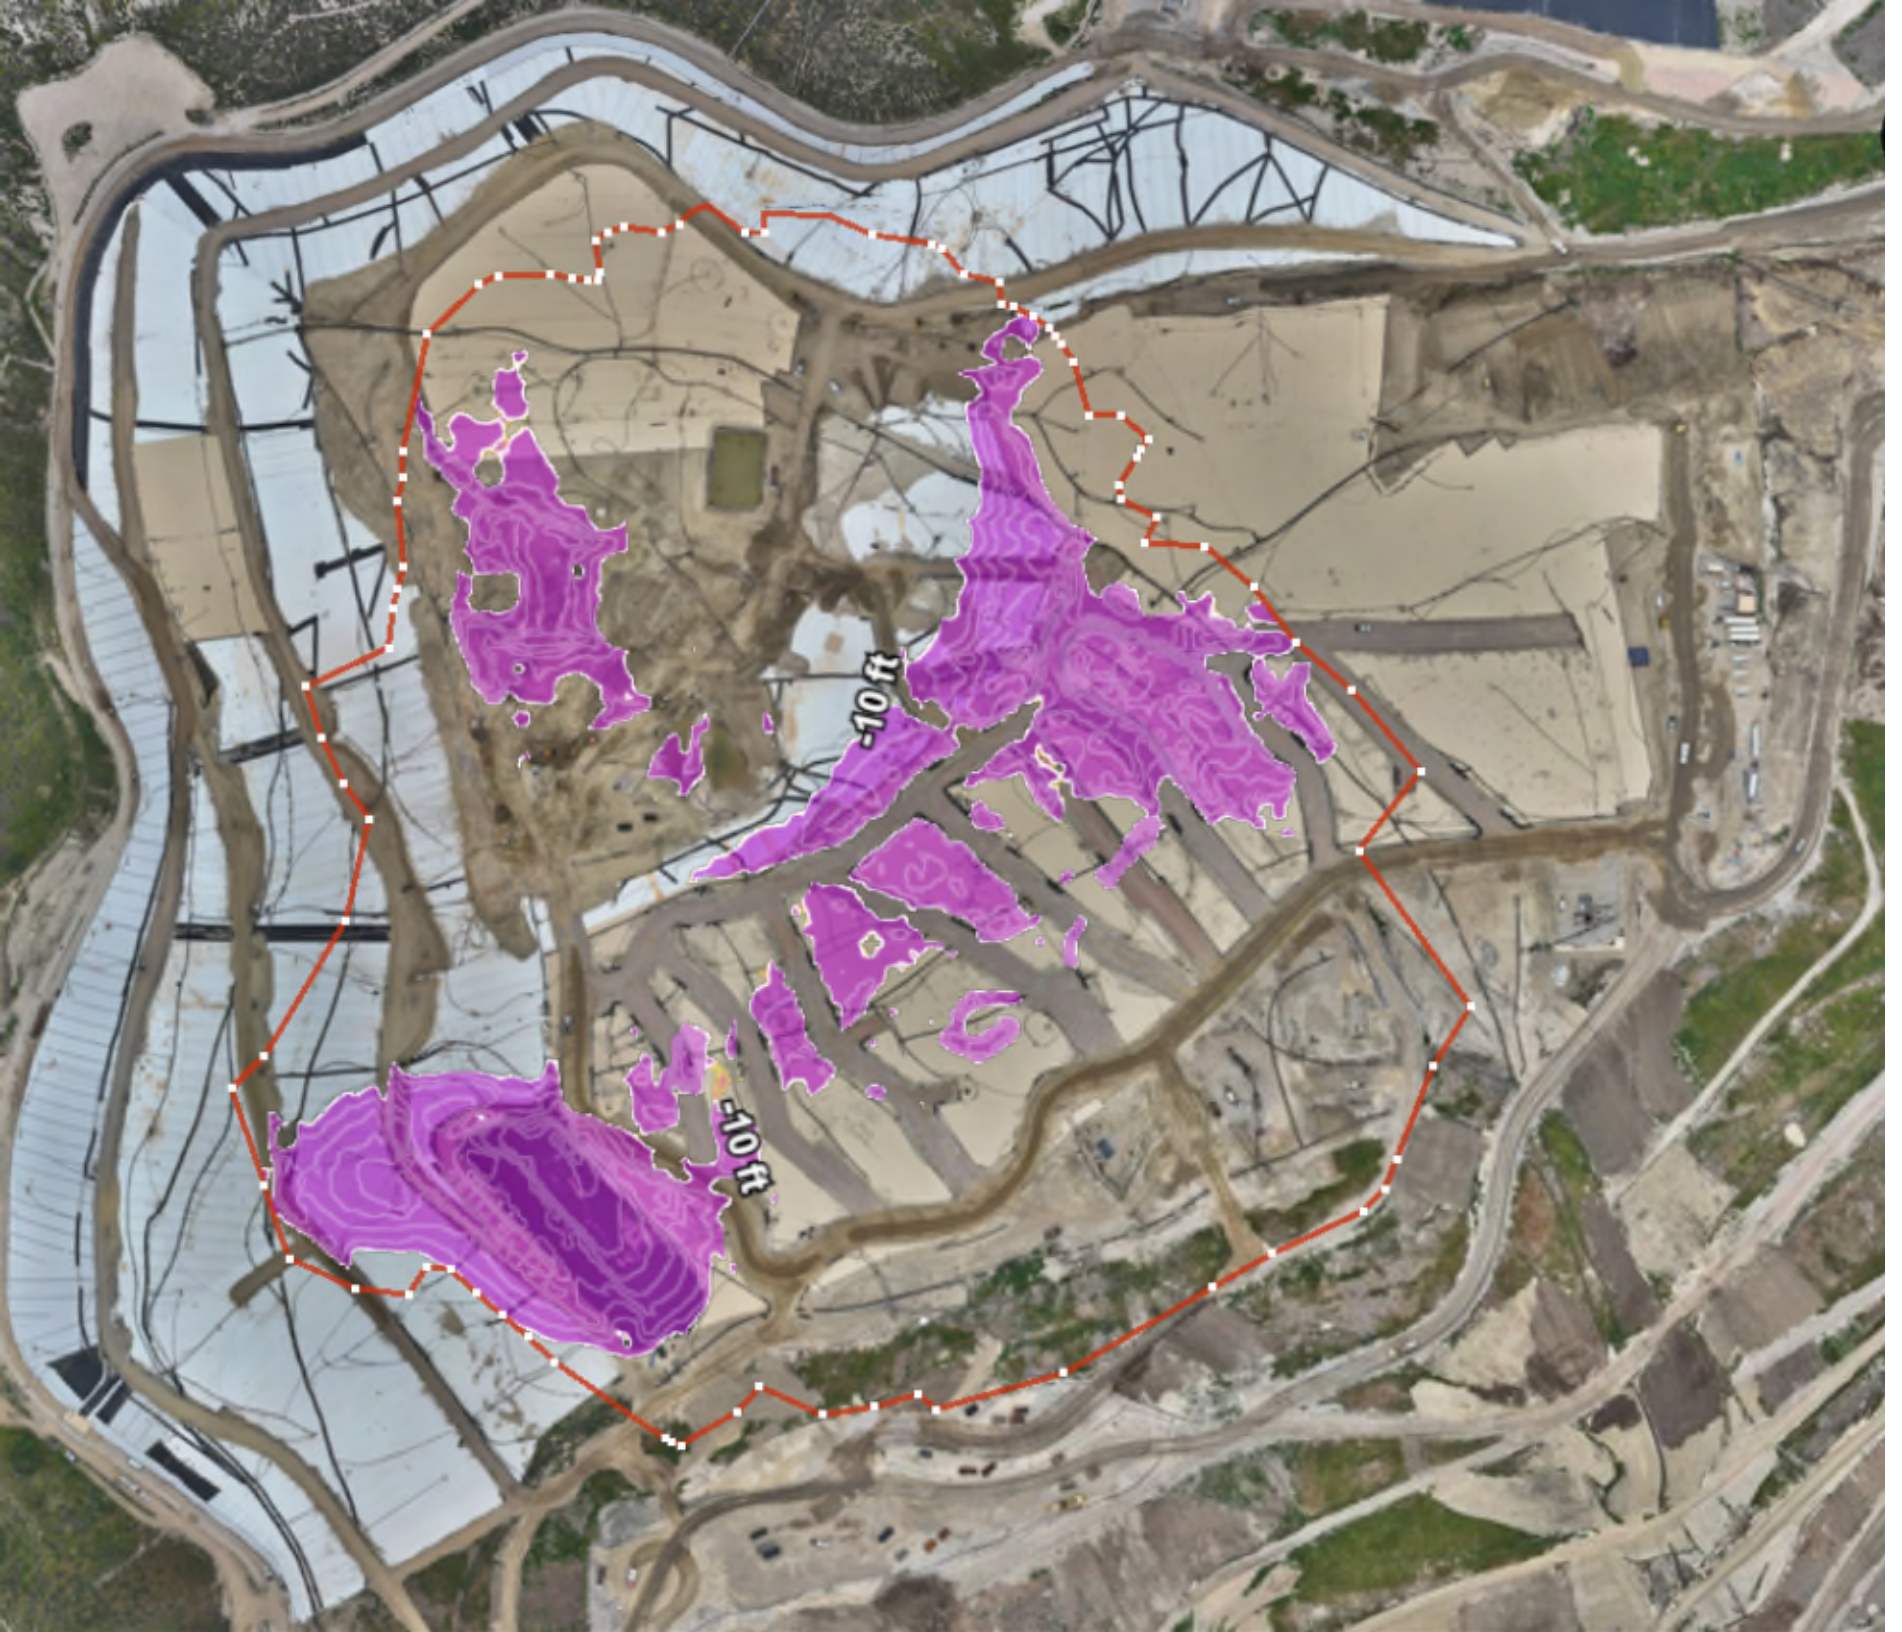
- The map shows the area between 2/6/2025 and 2/10/2026 where the grades have changed more than 10 feet. A typical MSW strain rate is 3% per year - for a landfill with a 300-foot waste column, this would be 9 feet per year.

- On January 16, 2026, all three flares went offline as a result of high temperatures at Flares 1 and 3, and a blower failure at Flare 2. Due to the decrease in landfill gas collection, landfill gas temporarily accumulated under the geomembrane cover creating a “ballooning” effect. This ballooning effect disrupted the drone’s ability to accurately capture the amount of settlement – making it appear as though more settlement had occurred. Flares 1, 2, and 3 were initially brought back online by January 23, 2026. There have been subsequent downtimes associated with Flares 2 and 3 as described in the downtime alerts posted to Chiquita’s public website. Chiquita anticipates that the imaging, and settlement results, will return to normal by the time of the next flyover event.

- Recently, Castaic, California has experienced atypical amounts of rainfall resulting in standing stormwater across the landfill. As the water evaporates and the levels of standing water decrease, the evaporation manifests as increased settlement in the drone flyovers, although no such settlement has occurred. Chiquita anticipates that the imaging, and settlement results, will return to normal once the stormwater has fully evaporated.

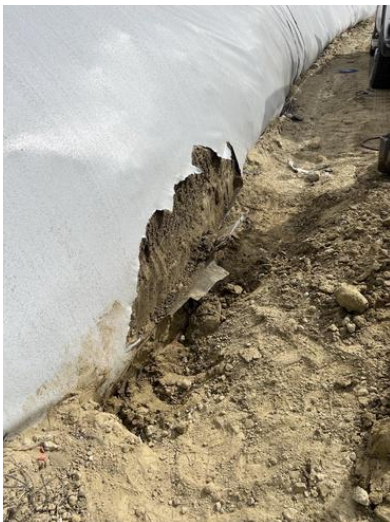
Photo 1

Tear in liner needs to be patched and extrusion welded.

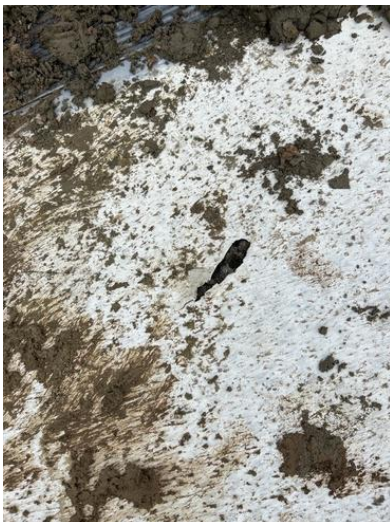
Photo 1

Small tear in liner. Needs to be patched and extrusion welded
