Re: Chiquita Canyon, LLC's Weekly Leachate Inspection Report for Stipulated Order for Abatement (Case No. 6177-4), Condition 27(c)

4050 - Chiquita Leachate Seep/Pooling Inspection

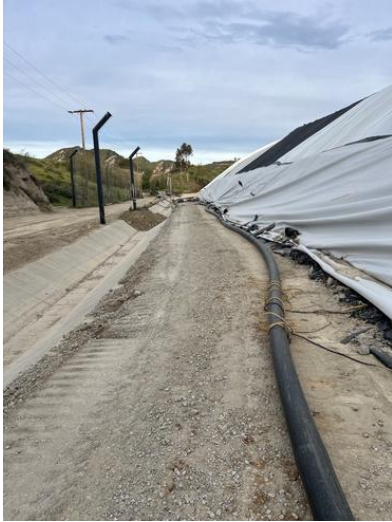
Photo 1

No

Westside perimeter road.

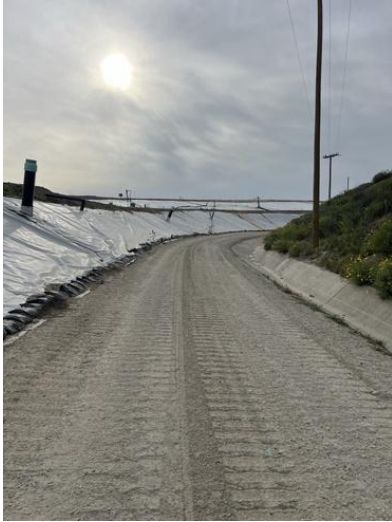
Photo 1

No

North perimeter road.

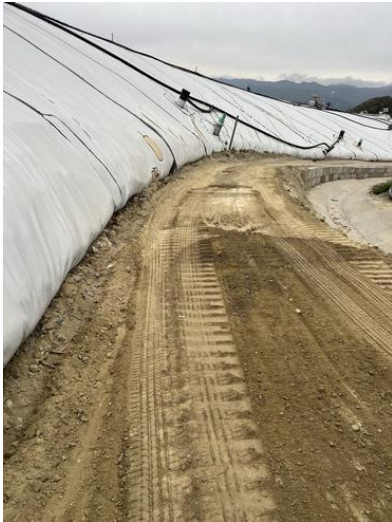
Photo 1

No

Westside perimeter road.

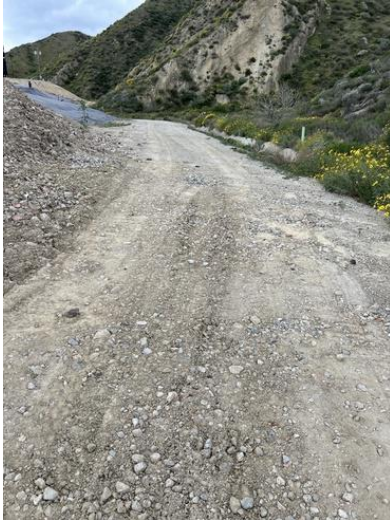
Photo 1

No

North side perimeter road

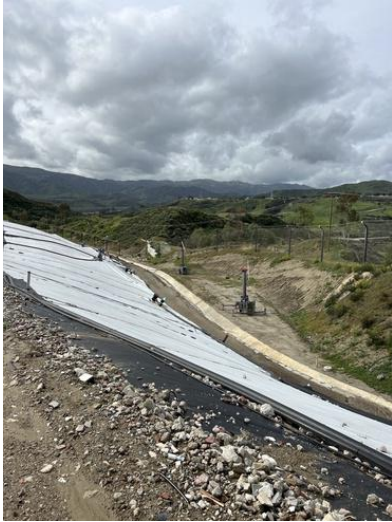
Photo 1

No

West side perimeter road

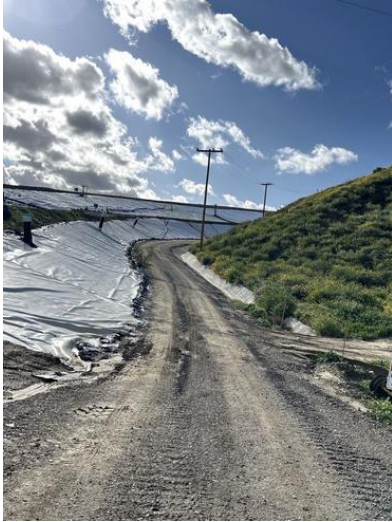
Photo 1

No

North side perimeter road

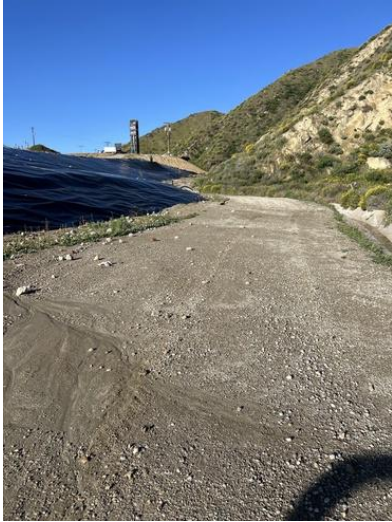
Photo 1

No

Northside perimeter road

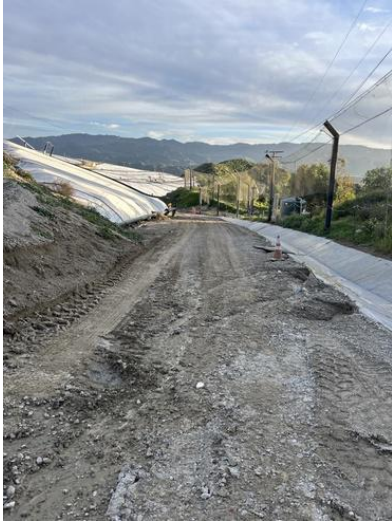
Photo 1

No

West side perimeter road

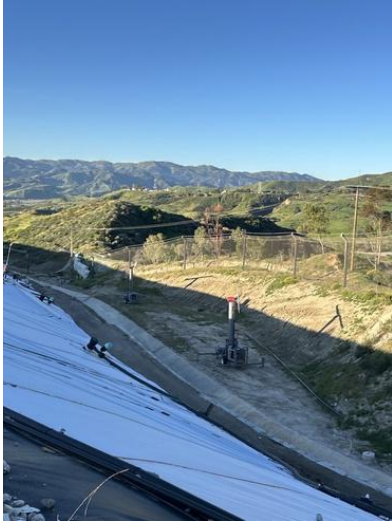
Photo 1

No

West side perimeter road

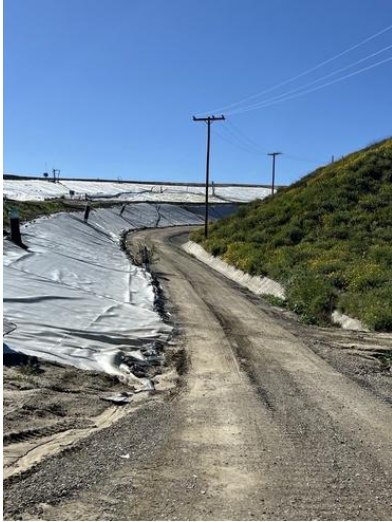
Photo 1

No

North side perimeter road

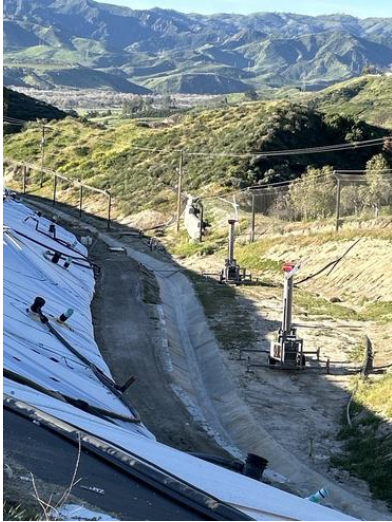
Photo 1

No

West side perimeter road

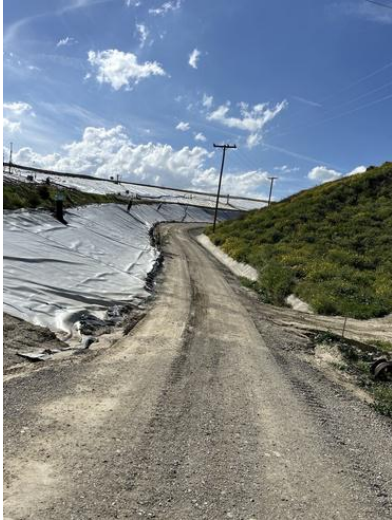
Photo 1

No

North side perimeter road

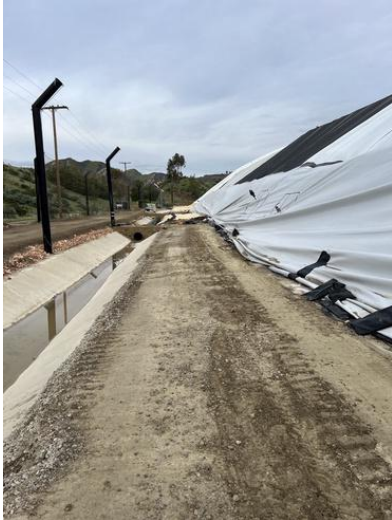
Photo 1

No

Westside perimeter road.

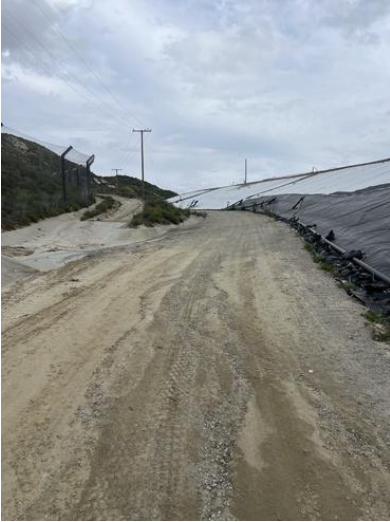
Photo 1

No

North perimeter road.
