Re: Chiquita Canyon, LLC's Weekly Leachate Inspection Report for Stipulated Order for Abatement (Case No. 6177-4), Condition 27(c)

Attachment: Leachate Inspection Logs from February 16, 2026 – February 22, 2026

4050 - Chiquita Leachate Seep/Pooling Inspection

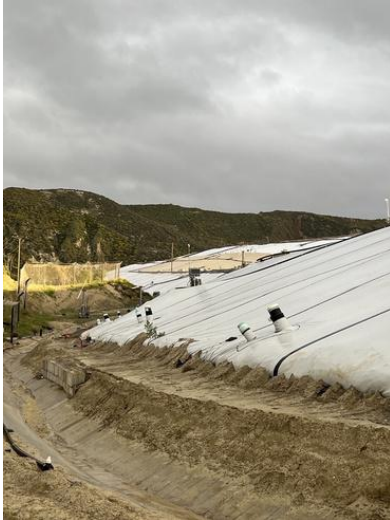
Photo 1

No

Westside perimeter road.

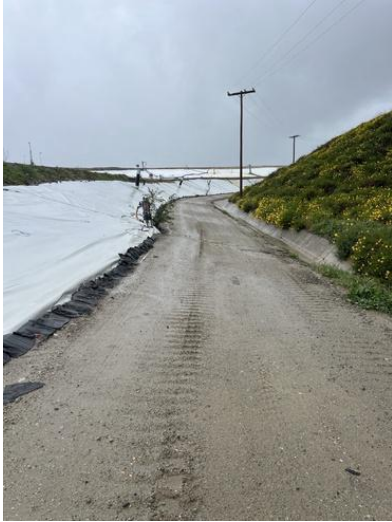
Photo 1

No

North perimeter road.

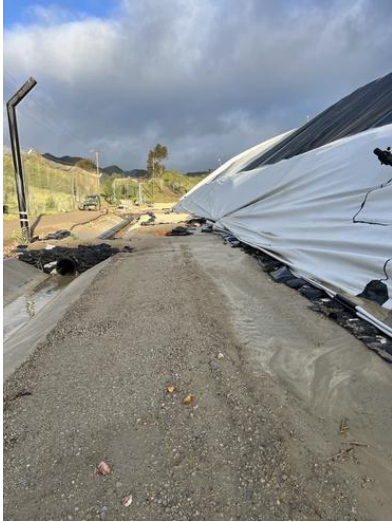
Photo 1

No

Westside perimeter road.

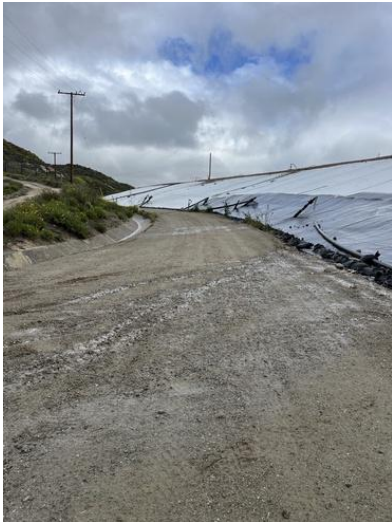
Photo 1

No

North perimeter road.

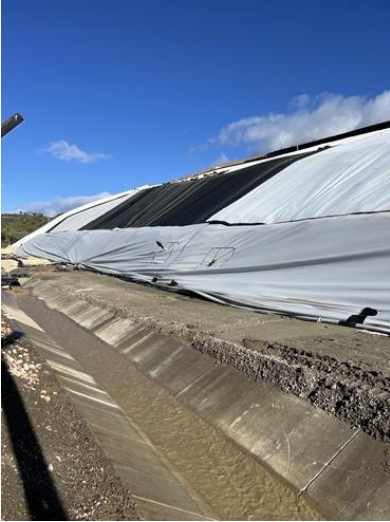
Photo 1

No

Westside perimeter road.

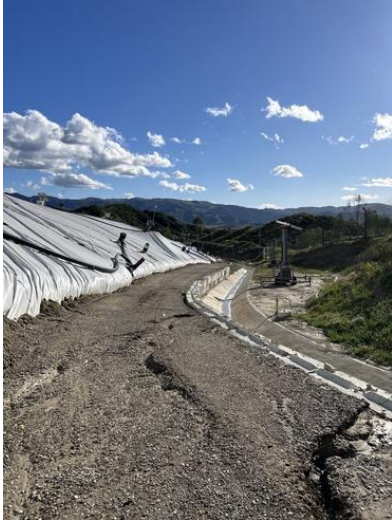
Photo 1

No

West side perimeter road

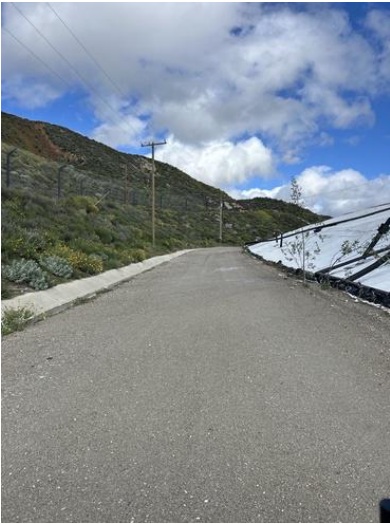
Photo 1

The seep from the morning inspection was not observed at this time

North side perimeter road

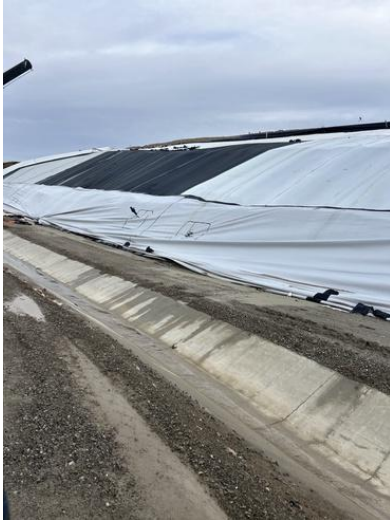
Photo 1

No

West side perimeter road

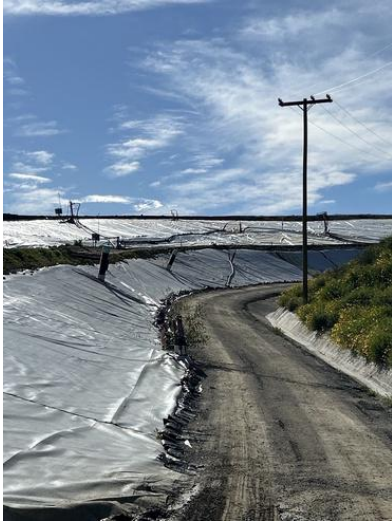
Photo 1

No

North side perimeter road

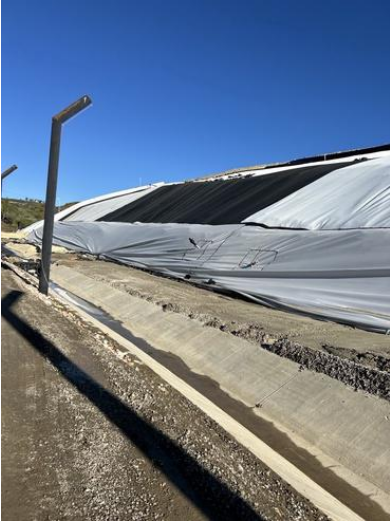
Photo 1

No

West side perimeter road

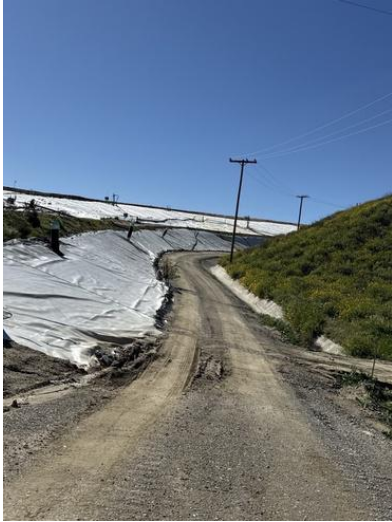
Photo 1

No

North side perimeter road

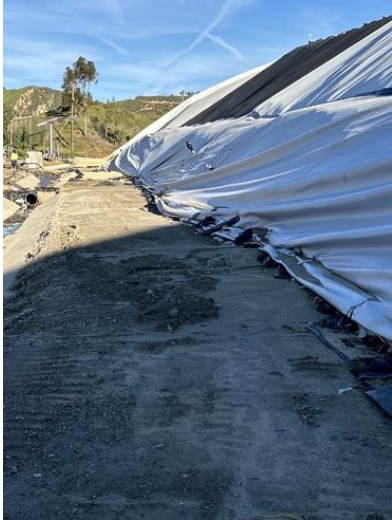
Photo 1

No

Westside perimeter road.

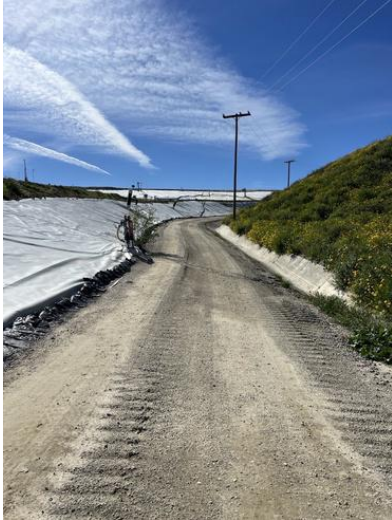
Photo 1

No

North perimeter road.
