Re: Chiquita Canyon, LLC's Weekly Report on the Documentation and Tracking of Cover Issues

4050 - Chiquita Reaction Area Tracking of Fissures and Tension Cracks

4050 - Geosynthetic Cover Inspection

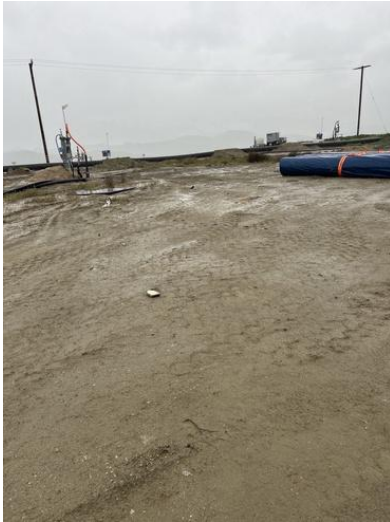
Photo 1

Fissure or Tension Crack Found?

No

Grid 160

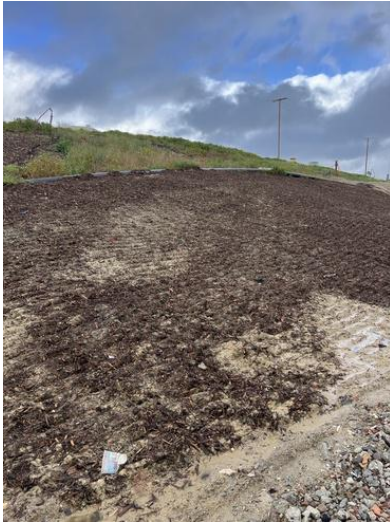
Photo 1

Fissure or Tension Crack Found?

No

Grid 163

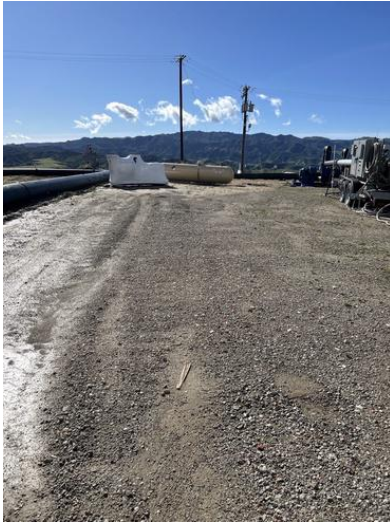
Photo 1

Fissure or Tension Crack Found?

No

Grid 90

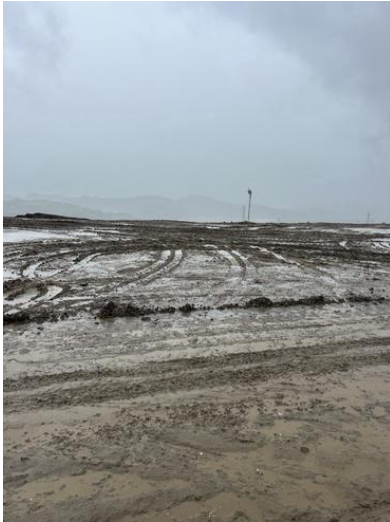
Photo 1

Fissure or Tension Crack Found?

No

Grid 198

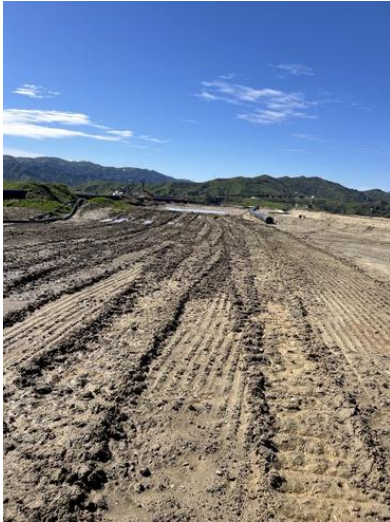
Photo 1

Fissure or Tension Crack Found?

No

Grid 160

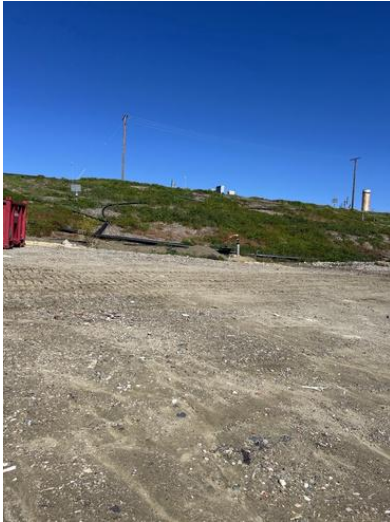
Photo 1

Fissure or Tension Crack Found?

No

Grid 196

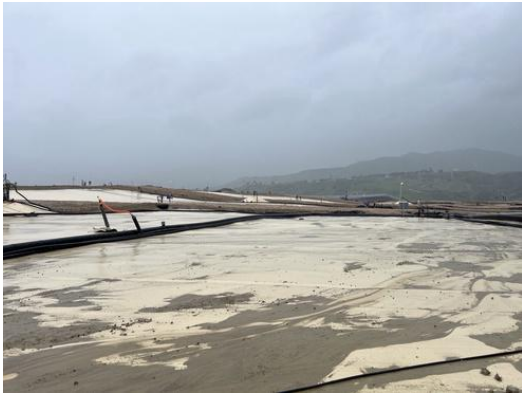
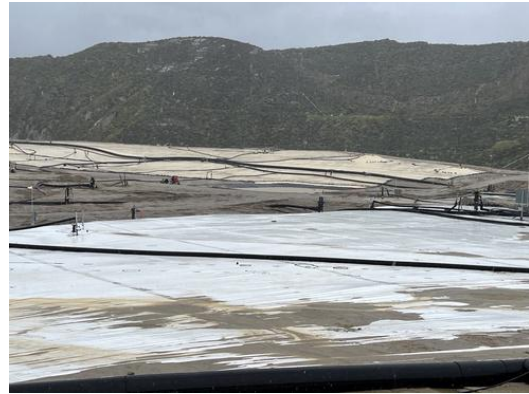
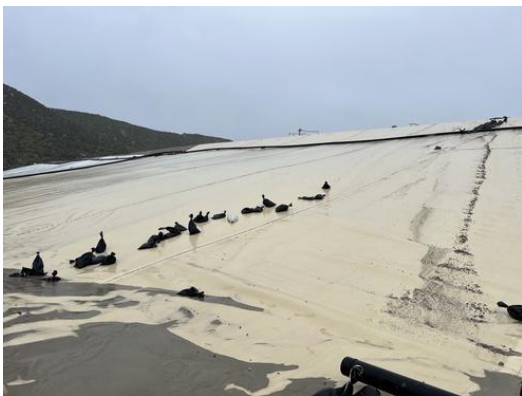
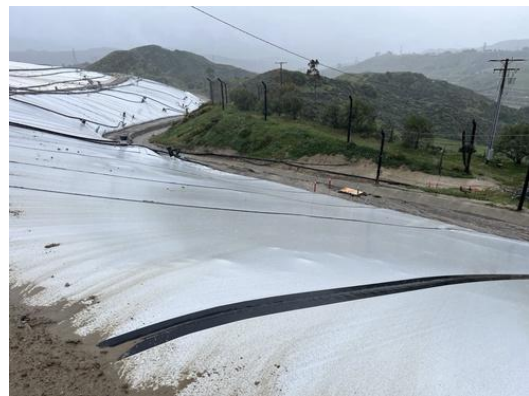
Are there any issues with the geosynthetic cover?

No

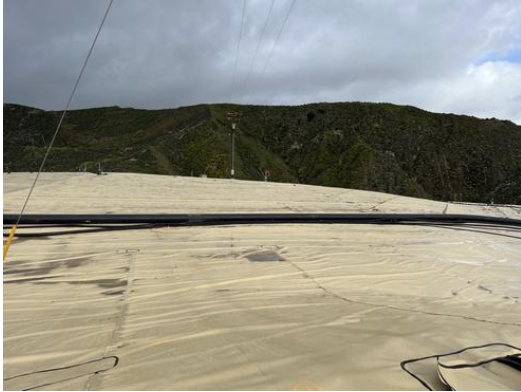
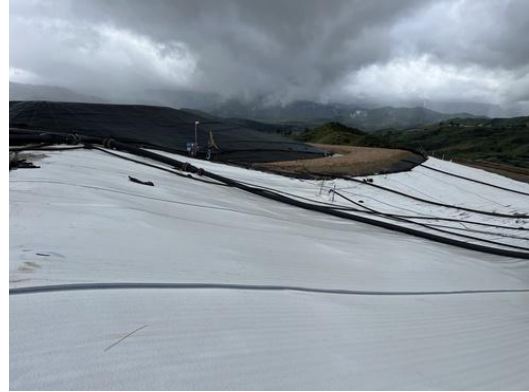
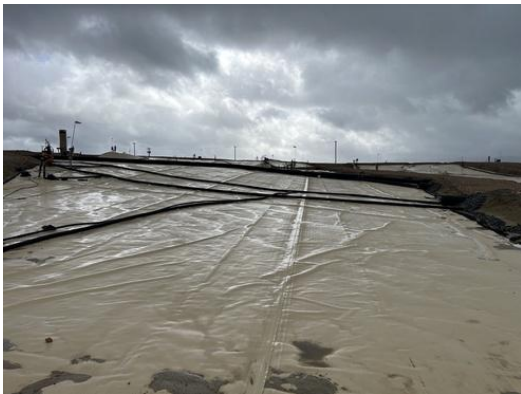
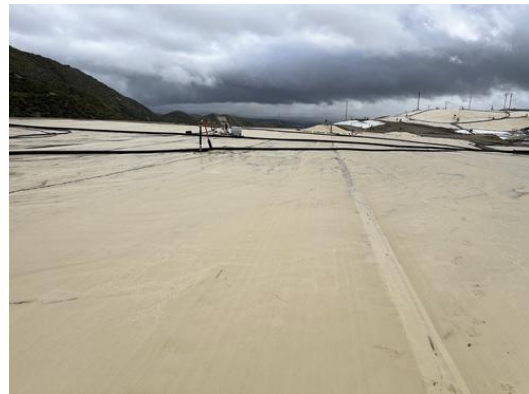
Are there any issues with the geosynthetic cover?

No

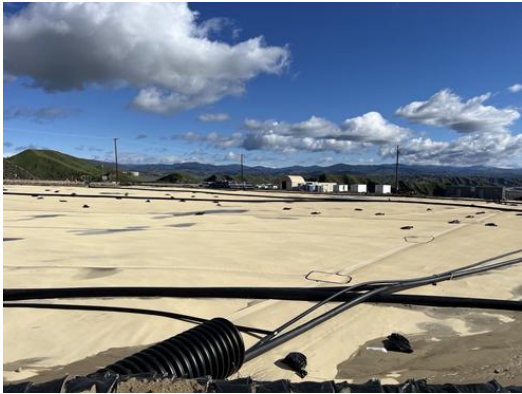
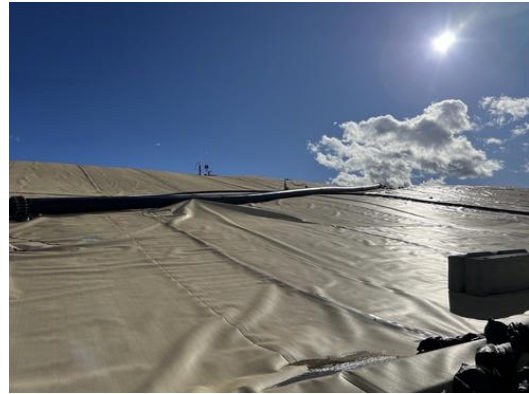
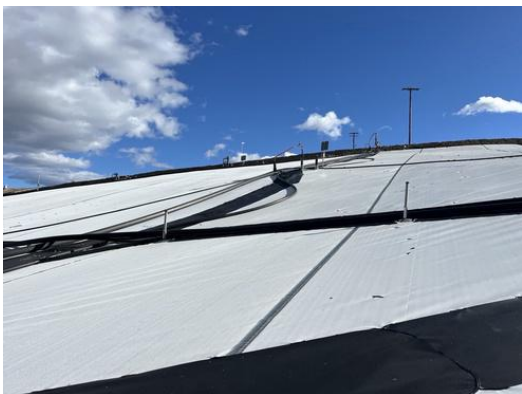
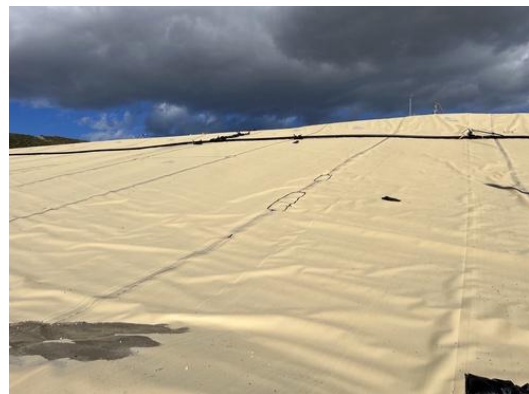
Are there any issues with the geosynthetic cover?

No

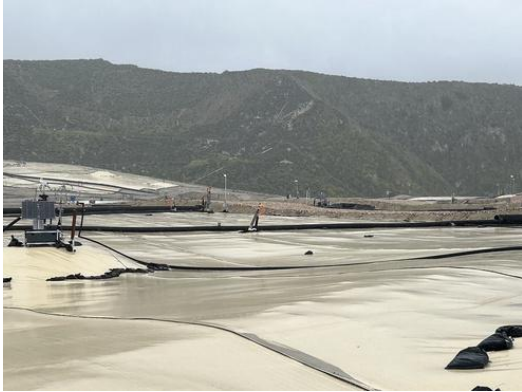
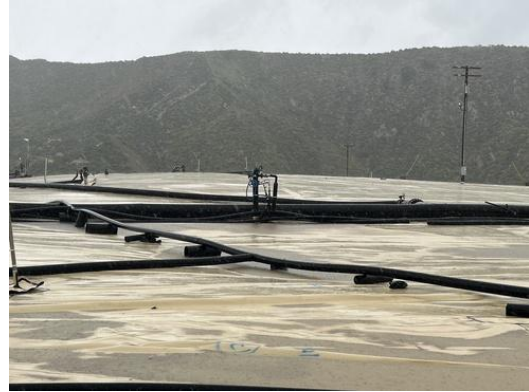
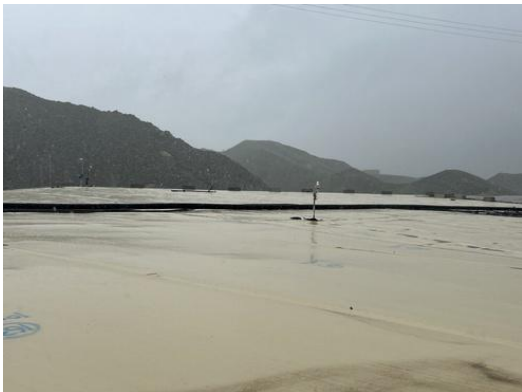
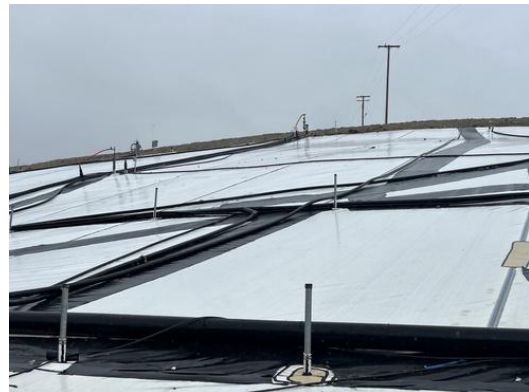
Are there any issues with the geosynthetic cover?

No

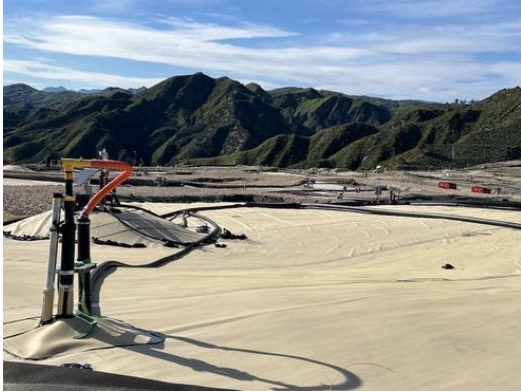
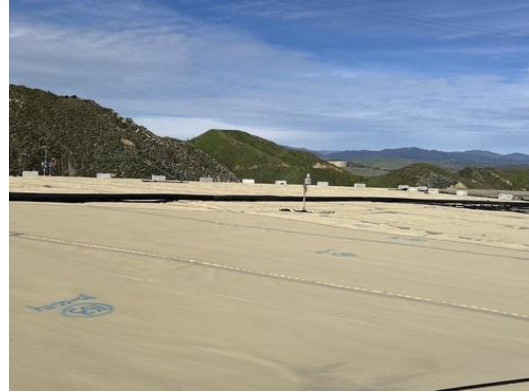
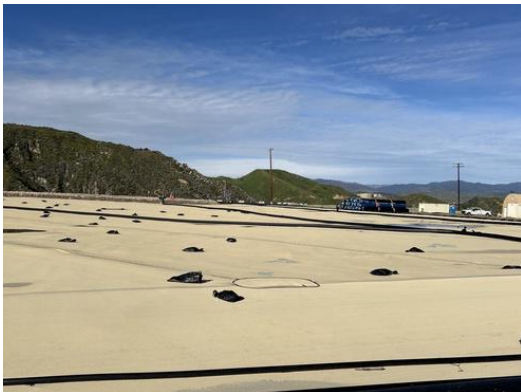
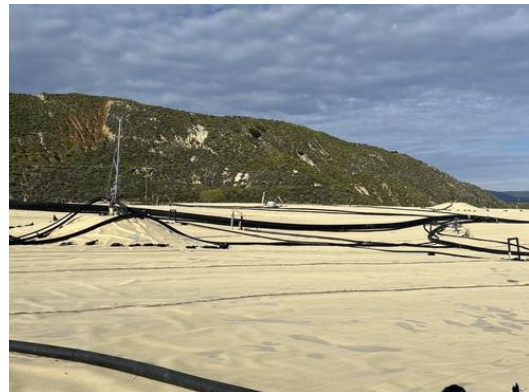
Are there any issues with the geosynthetic cover?

No

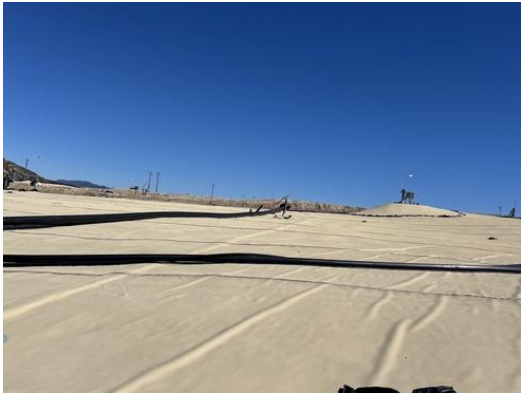
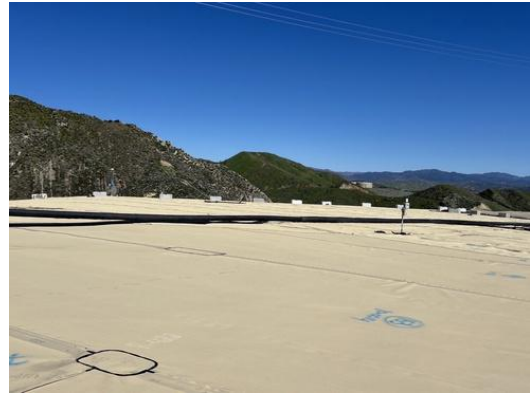
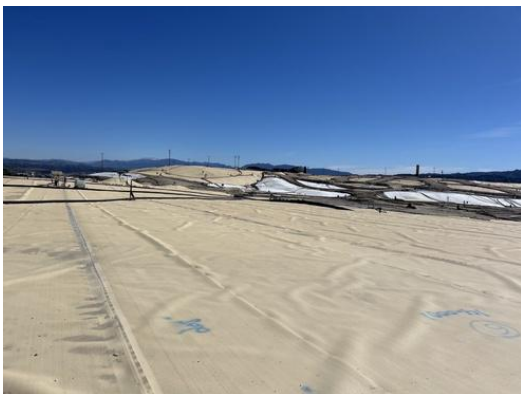
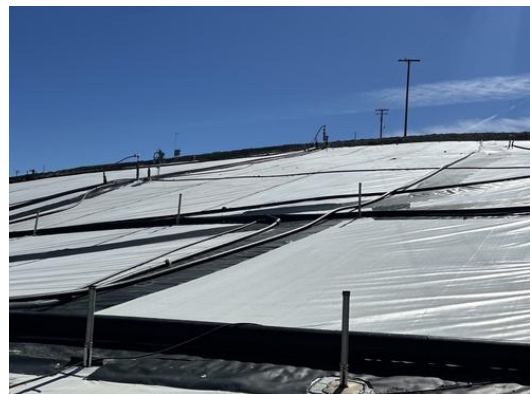
Are there any issues with the geosynthetic cover?

No
