Re: Chiquita Canyon, LLC's Weekly Leachate Inspection Report for Stipulated Order for Abatement (Case No. 6177-4), Condition 27(c)

Pursuant to Condition 27(c) of the Stipulated Order for Abatement with the South Coast Air Quality Management District in Case No. 6177-4 (the "Order"), Chiquita Canyon, LLC ("Chiquita") encloses a compilation of the twice daily leachate seep inspection logs for the dates of February 23, 2026 through March 1, 2026.

4050 - Chiquita Leachate Seep/Pooling Inspection

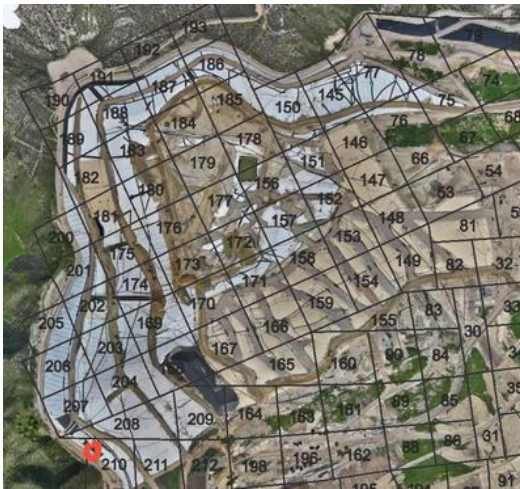
Adjacent to 210

20 sq ft at location of seep and
approximately 3,000 ft of
stormwater channel.

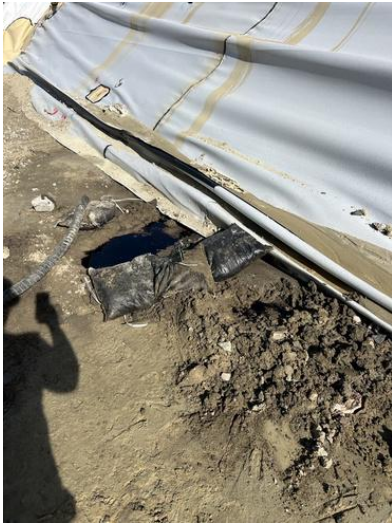
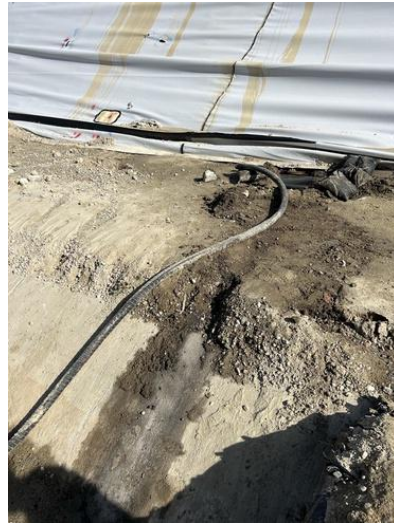
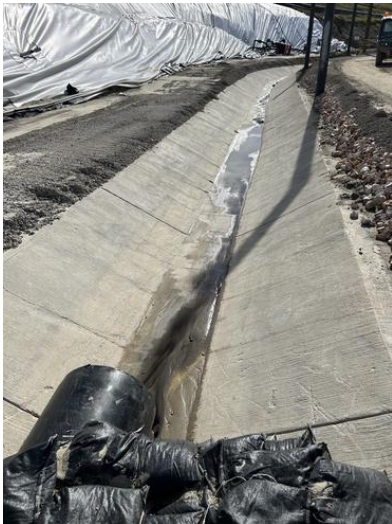
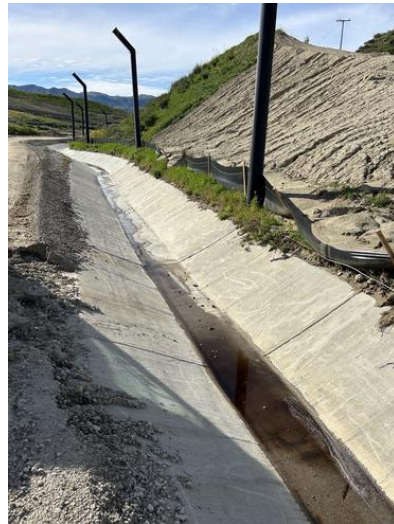
>150 gallons

4 - Strong Odor

Standing free liquid

Berm placed around seep. Leachate being vacuumed out throughout day to minimize pooling. Stormwater channel pressure washed and liquid vacuumed out. Check dams put in place in stormwater channel.

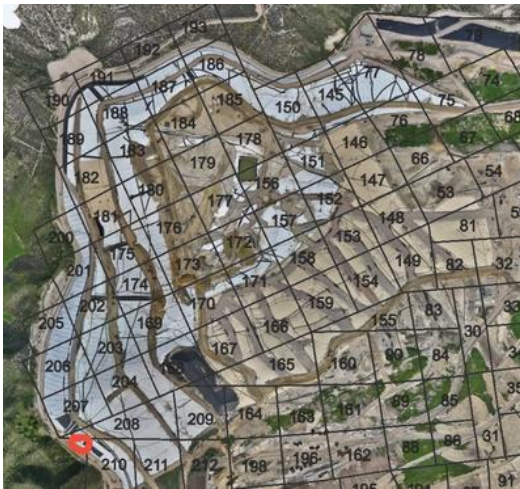
Adjacent to 210

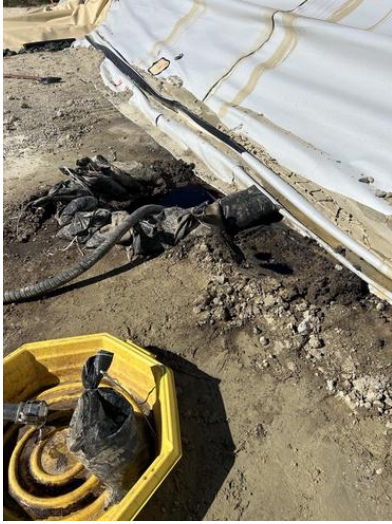
Photo 1

>150 gallons

20 sq ft

3 - Moderate Odor

Standing free liquid

Berm placed around seep. Leachate being vacuumed out throughout day to minimize pooling. Stormwater channel pressure washed and liquid vacuumed out. Check dams put in place in stormwater channel. No additional liquid reached the stormwater channel following the morning inspection.

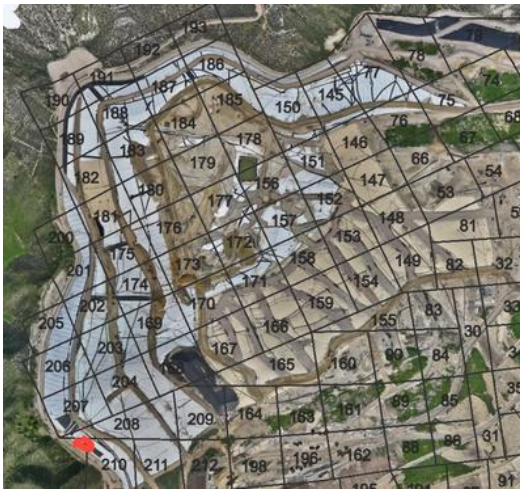
Adjacent to 210

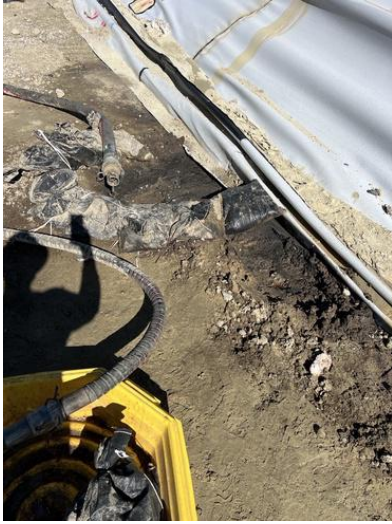
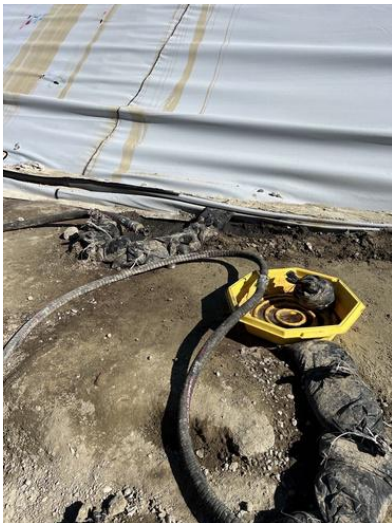
>150 gallons

20 sq ft

2 - Light Odor Detected

Saturated

Berm placed around seep. Leachate being vacuumed out throughout day to minimize pooling. Stormwater channel pressure washed and liquid vacuumed out. Check dams put in place in stormwater channel.

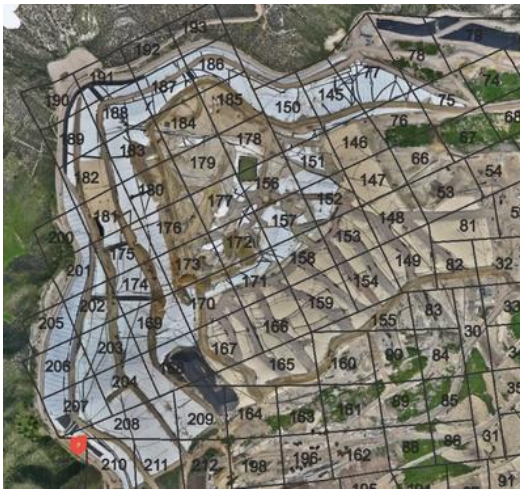
Adjacent to 210

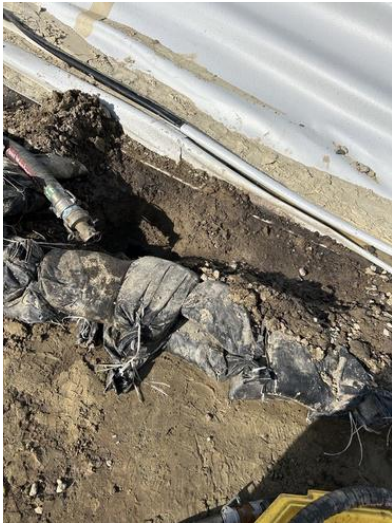
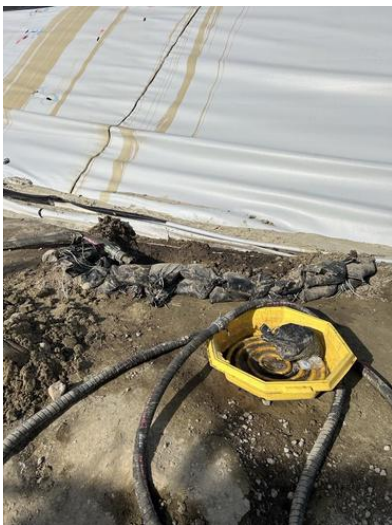
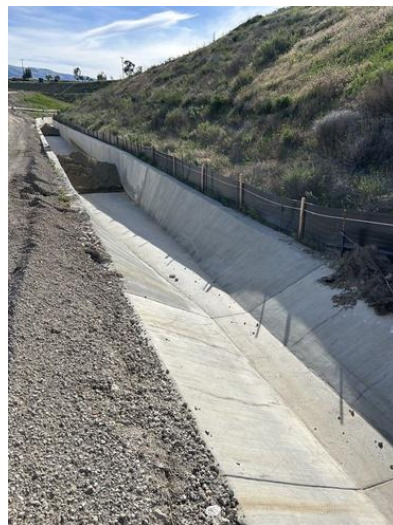
>150 gallons

20 sq ft

2 - Light Odor Detected

Saturated

Berm placed around seep. Leachate being vacuumed out throughout day to minimize pooling. Stormwater channel pressure washed and liquid vacuumed out. Check dams put in place in stormwater channel. Work to repair seep schedule to begin 2/25/26.

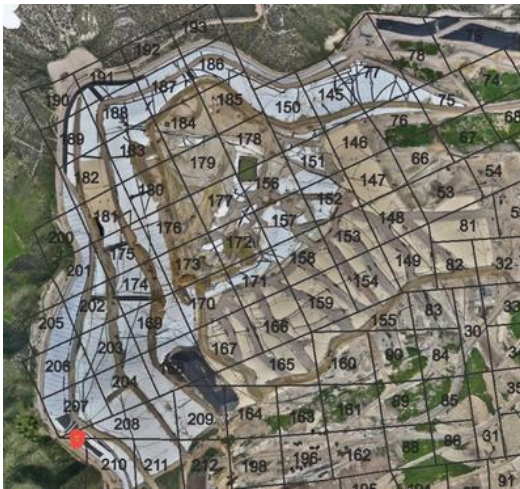
Adjacent to 210

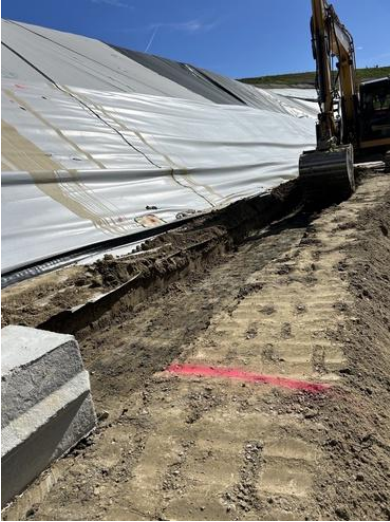
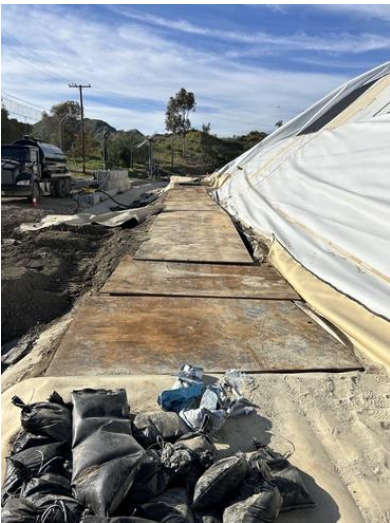
21-50 gallons

1 - Very Light Odor Detected

Semi-dry

Repairs began before picture could be taken.

Berm was constructed to contain seep.
Construction work to repair the seep is ongoing.

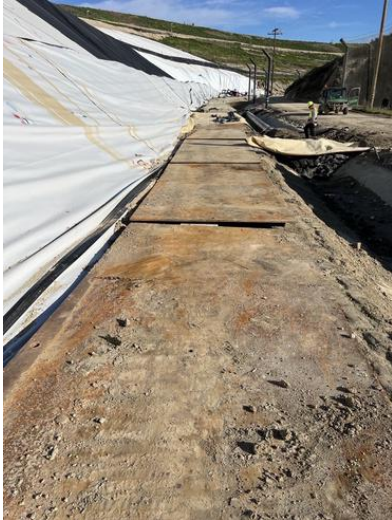
Photo 1

Westside perimeter road. Seep from morning inspection was not observed. Trench was dug to contain leachate and steel plates were placed on top. Leachate is periodically vacuumed out. Construction is ongoing to further contain the area.

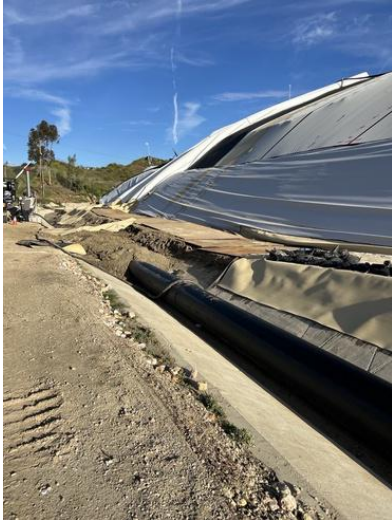
Photo 1

Seep starting on 2/23/26 was not observed. Trench was dug to contain leachate and steel plates were placed on top. Leachate is periodically vacuumed out. Construction is ongoing to further contain the area.

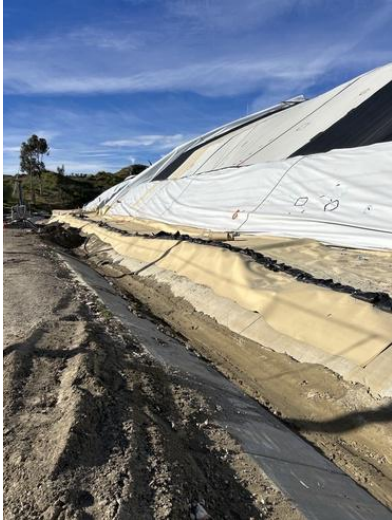
Photo 1

The seep starting on 2/23/26 was not observed. Trench was dug to contain leachate, steel plates and liner were placed ovetop to prevent atmospheric exposure. Leachate is periodically vacuumed out. Construction is ongoing to further contain the area.

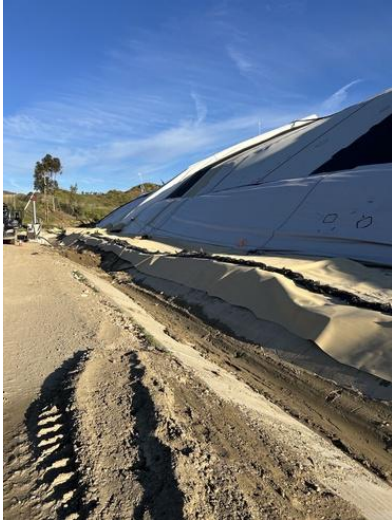
Photo 1

The seep starting on 2/23/26 was not observed. Trench was dug to contain leachate, steel plates and liner were placed ovetop to prevent atmospheric exposure. Leachate is periodically vacuumed out. Construction is ongoing to further contain the area.

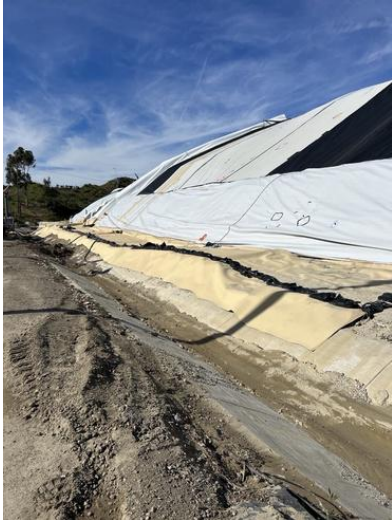
Photo 1

The seep starting on 2/23/26 was not observed. Trench was dug to contain leachate, steel plates and liner were placed ovetop to prevent atmospheric exposure. Leachate is periodically vacuumed out. Construction is ongoing to further contain the area.

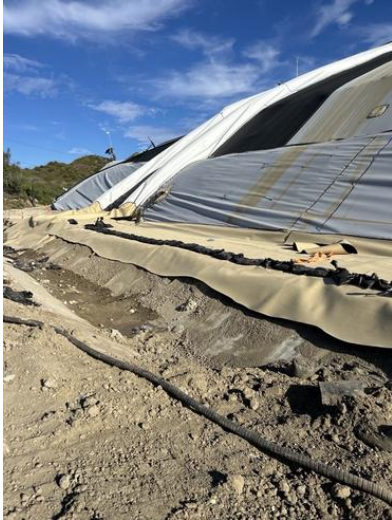
Photo 1

The seep starting on 2/23/26 was not observed. Trench was dug to contain leachate, steel plates and liner were placed overtop to prevent atmospheric exposure. Leachate is periodically vacuumed out. Construction is ongoing to further contain the area.

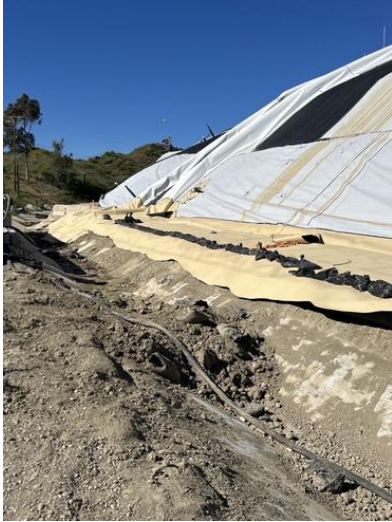
Photo 1

The seep starting on 2/23/26 was not observed. Trench was dug to contain leachate, steel plates and liner were placed ovetop to prevent atmospheric exposure. Leachate is periodically vacuumed out. Construction is ongoing to further contain the area.

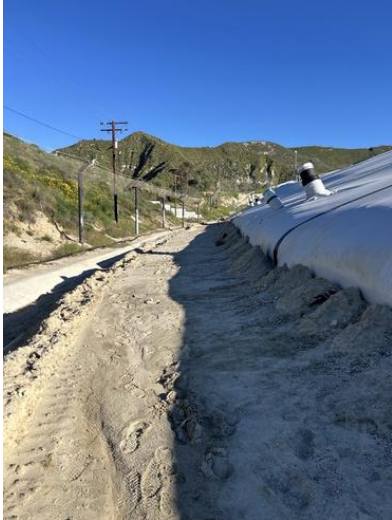
Photo 1

Westside perimeter road. The seep starting on 2/23/26 was not observed. Trench was dug to contain leachate, steel plates and liner were placed overtop to prevent atmospheric exposure. Leachate is periodically vacuumed out. Construction is ongoing to further contain the area.
