Re: Chiquita Canyon, LLC's Weekly Report on the Documentation and Tracking of Cover Issues

4050 - Chiquita Reaction Area Tracking of Fissures and Tension Cracks

4050 - Geosynthetic Cover Inspection

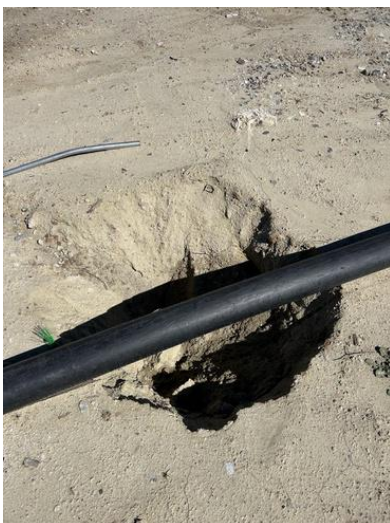
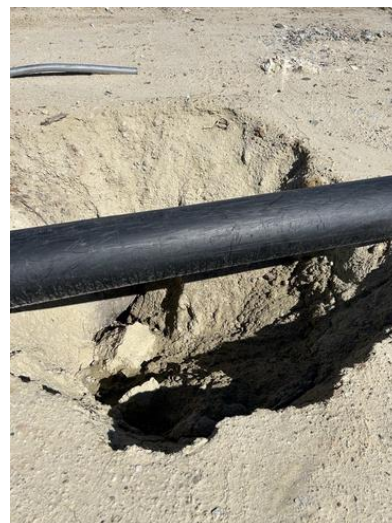
approximately 3ft x 3ft rainfall-related depression with an

approximately 1ft crack at the bottom of the depression

Large >4" in width

While the rainfall-related depression was greater than 4" in width, the width of the crack at the bottom of the depression was less than 1"

Extra small <0.5" in height

NE to SW

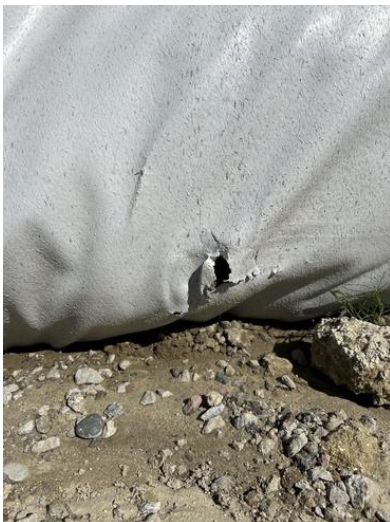
Photo 1

Tear in liner needs to be patched and extrusion welded.

Permanent repair scheduled for 3/2/26

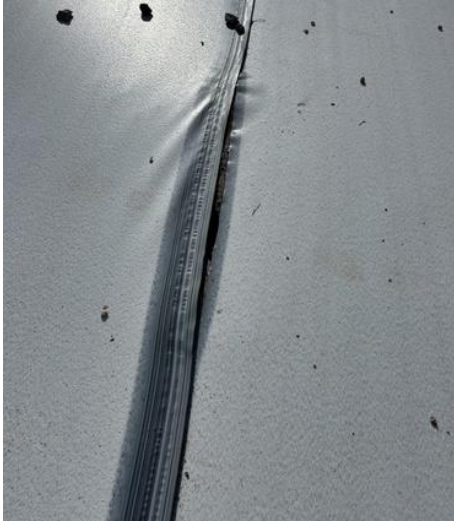
Photo 3

Tear at seam in liner, needs to be patched and extrusion welded.

Permanent repairs scheduled for 3/2/26

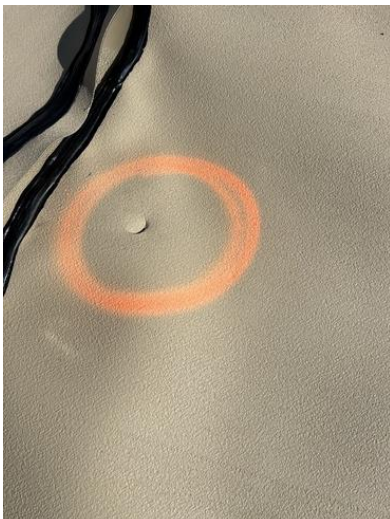
Photo 1

Tear in liner needs to be patched and extrusion welded.

Permanent repairs scheduled for 3/2/26

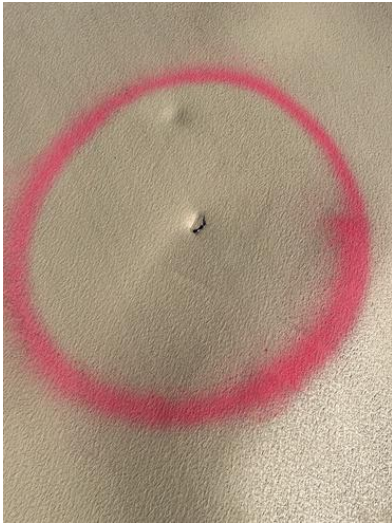
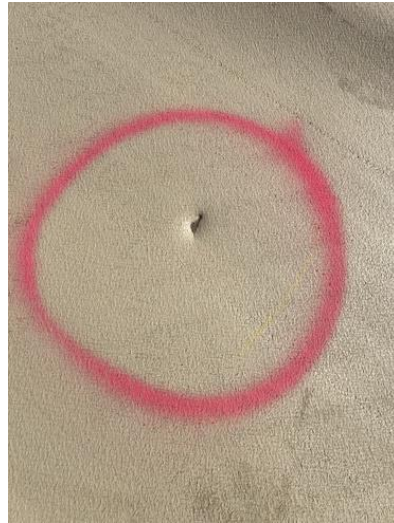
Two tears in liner in close proximity need to be extrusion welded.

Permanent repairs scheduled for 3/2/26
