CHIQUITA CANYON
A Waste Connections Company

Re: Chiquita Canyon, LLC's Weekly Report on the Documentation and Tracking of Cover Issues, Monthly Summary and Monthly Isopach Map

Attachment: March 10, 2026 Weekly Cover Issues Report, Monthly Summary, and Monthly Isopach Map

FEBRUARY 2026 FISSURE AND TENSION CRACK MONITORING SUMMARY
CHIQUITA CANYON LANDFILL
CASTAIC, CALIFORNIA

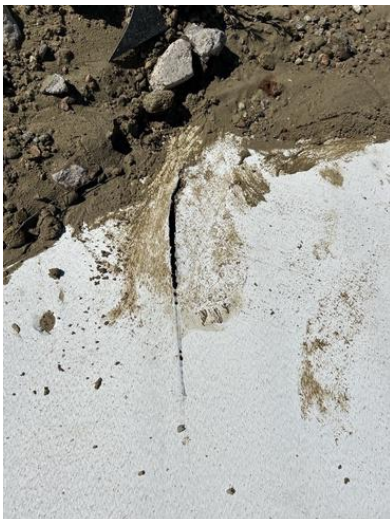
Photo 1

Tear in liner needs to be patched/extrusion welded

Tear taped and sandbagged upon discovery and later patched and extrusion welded

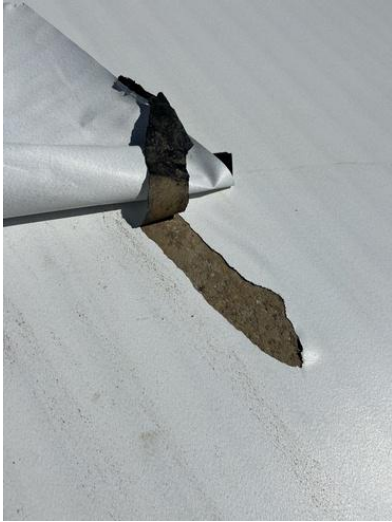
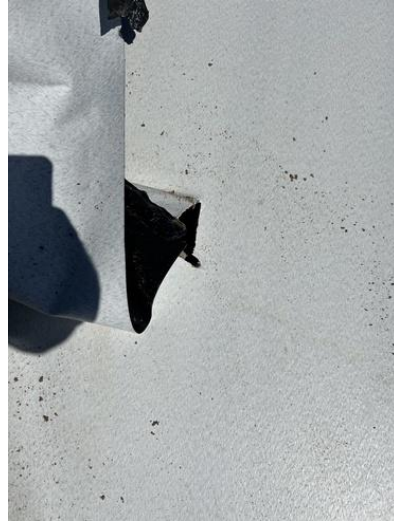
Tears in liner needs to be patched/extrusion welded.

Tears taped and sandbagged upon discovery and later patched and extrusion welded.

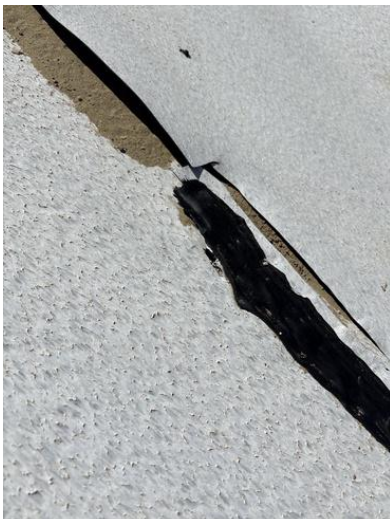
Photo 1

Small tear in liner above existing extrusion weld, needs to be extrusion welded

Tear taped and sandbagged upon discovery and later extrusion welded

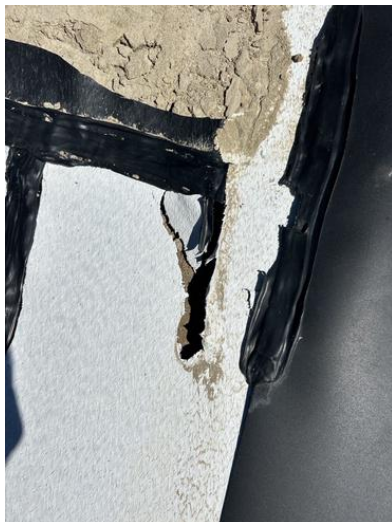
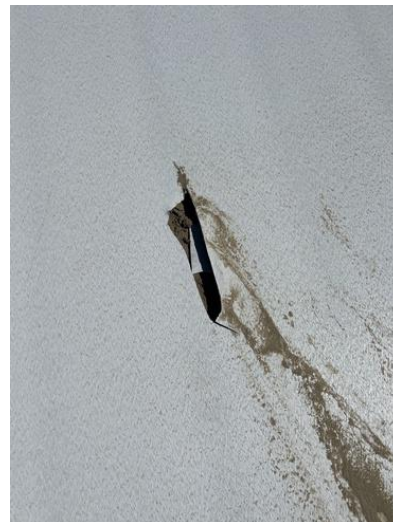
Liner torn, needs to be patched and extrusion welded

Liner tears taped and sandbagged upon discovery

Permanent repairs are scheduled for 3/11/26

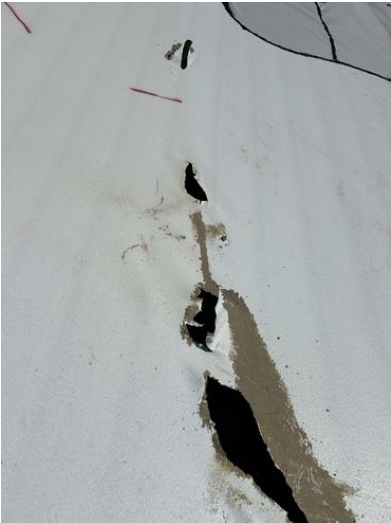
Photo 8

Liner torn. Needs to be patched and extrusion welded

Due to safety concerns in the area tape was not able to be placed over tears upon discovery

Permanent repairs are scheduled for 3/11/26

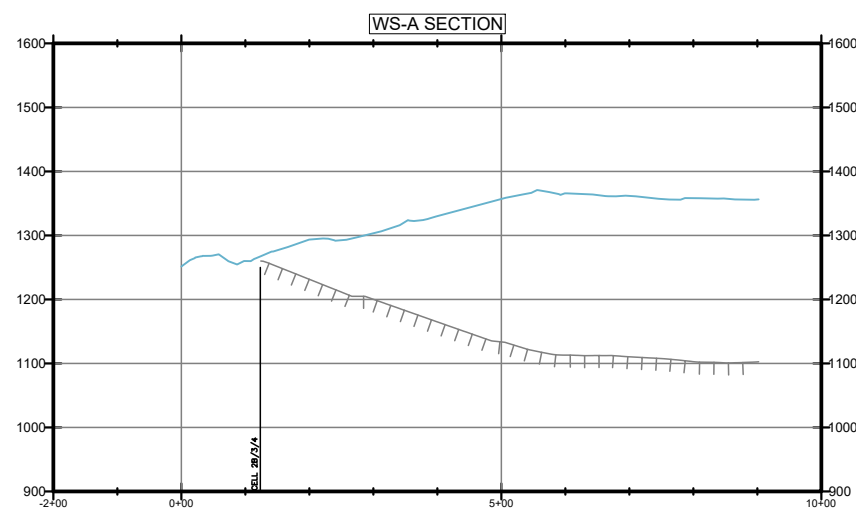
FIGURE 2A

All the cracks identified in Table 1 were repaired. Cross sections that compare January 28, 2026 and February 25, 2026 topography are shown in Figures 2A through 2E. The locations of these cross sections are shown in Figure 1. The sections show no significant differences in slope or evidence of instability between the January 2026 and February 2026 profiles, which is consistent with the observational records summarized in Tables 1 and 2.
