**Re: Chiquita Canyon, LLC's Weekly Leachate Inspection Report for Stipulated Order for Abatement (Case No. 6177-4), Condition 27(c)**

# 4050 - Chiquita Leachate Seep/Pooling Inspection

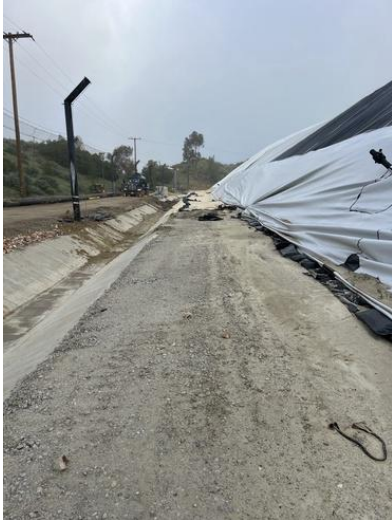
Photo 1

No

Westside perimeter road.

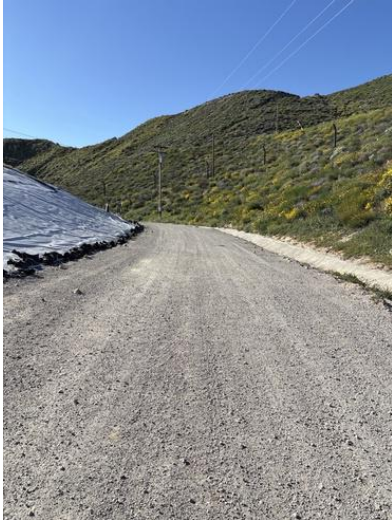
Photo 1

No

North perimeter road.

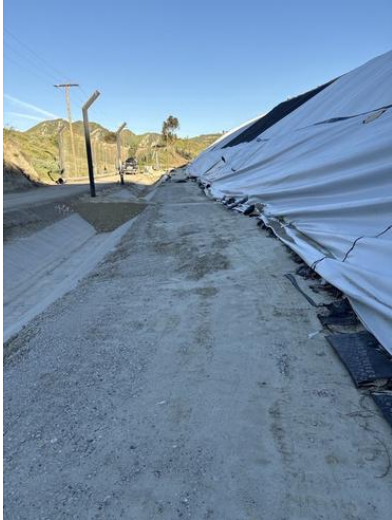
Photo 1

No

Westside perimeter road.

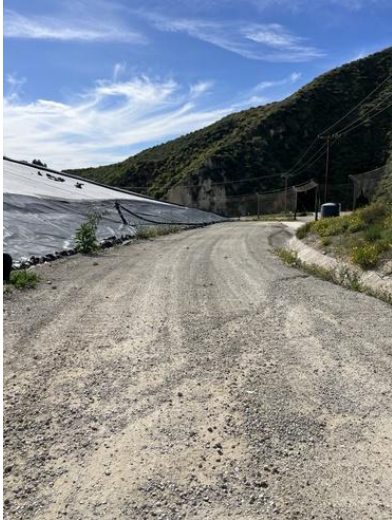
Photo 1

No

North perimeter road.

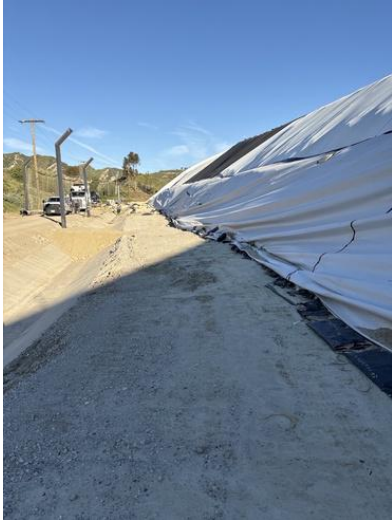
Photo 1

No

Westside perimeter road.

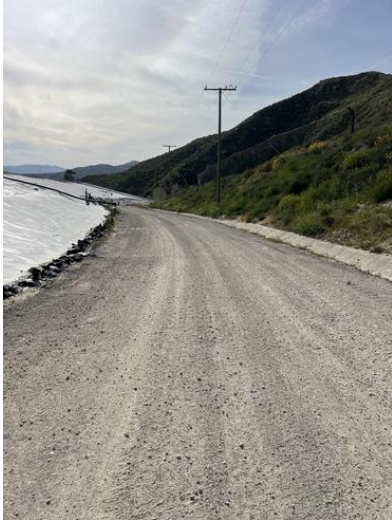
Photo 1

No

North perimeter road.

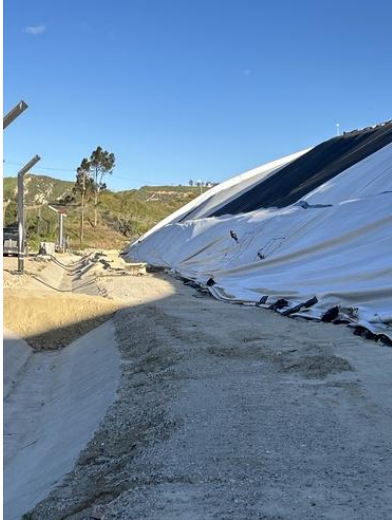
Photo 1

No

Westside perimeter road. The seep starting on 3/5/26 at 1:30am was not observed at this time. Containment in the area was expanded to keep liquids contained and covered. Area is being monitored and vacuumed out regularly

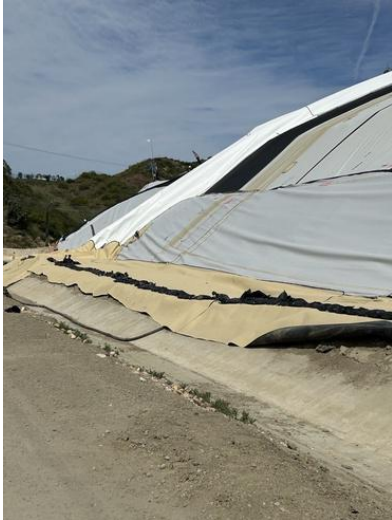
Photo 1

No

Westside perimeter road. The seep starting on 3/5/26 at 1:30am was not observed at this time. Containment in the area was expanded to keep liquids contained and covered. Area is being monitored and vacuumed out regularly

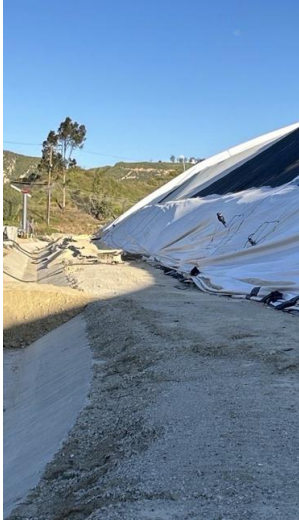
Photo 1

No

Westside perimeter road. The seep starting on 3/5/26 at 1:30am was not observed at this time. Containment in the area was expended to keep liquids contained and covered. Area is being monitored and vacuumed out regularly

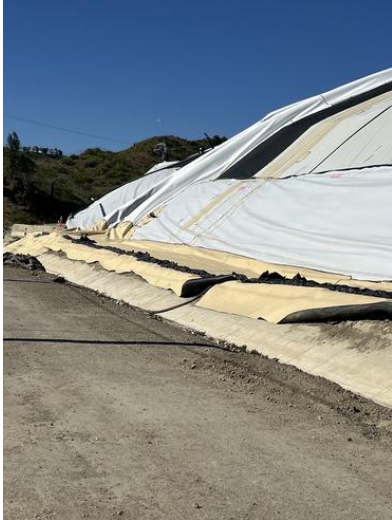
Photo 1

No

Westside perimeter road. The seep starting on 3/5/26 was not observed. Containment in the area was expanded to keep liquids contained and covered. Area is being monitored and vacuumed out regularly

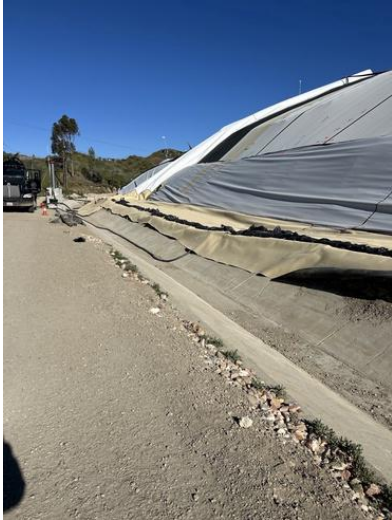
Photo 1

No

Westside perimeter road. The seep starting on 3/5/26 was not observed. Containment in the area was expanded to keep liquids contained and covered. Area is being monitored and vacuumed out regularly

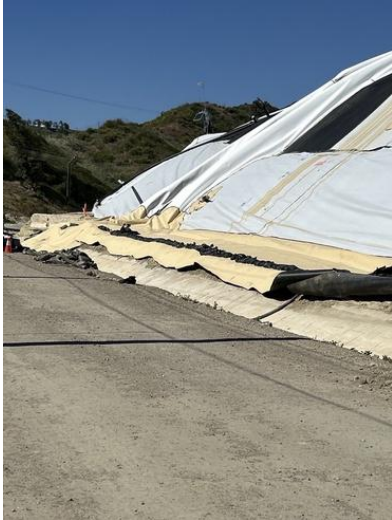
Photo 1

No

Westside perimeter road. The seep starting on 3/5/26 was not observed. Containment in the area was expanded to keep liquids contained and covered. Area is being monitored and vacuumed out regularly

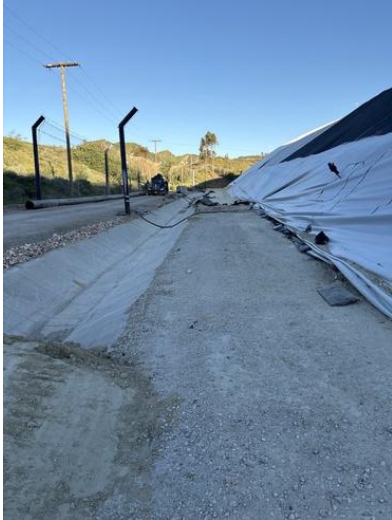
Photo 1

No

Westside perimeter road. The seep reported on 3/5/26 was not observed. Containment in the area was expanded to keep liquids contained and covered. Area is being monitored and vacuumed out regularly.

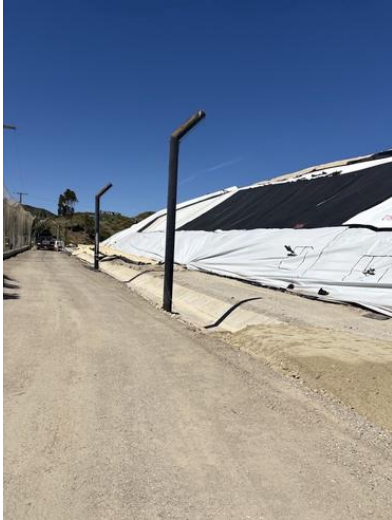
Photo 1

No

Westside perimeter road. The seep reported on 3/5/26 was not observed. Containment in the area was expanded to keep liquids contained and covered. Area is being monitored and vacuumed out regularly.
