Re: Chiquita Canyon, LLC's Weekly Leachate Inspection Report for Stipulated Order for Abatement (Case No. 6177-4), Condition 27(c)

Pursuant to Condition 27(c) of the Stipulated Order for Abatement with the South Coast Air Quality Management District in Case No. 6177-4 (the "Order"), Chiquita Canyon, LLC ("Chiquita") encloses a compilation of the twice daily leachate seep inspection logs for the dates of March 9, 2026 through March 15, 2026.

4050 - Chiquita Leachate Seep/Pooling Inspection

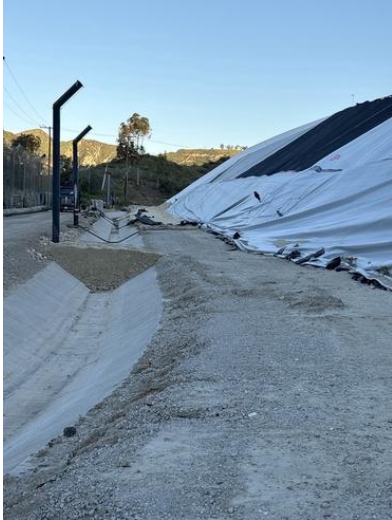
Photo 1

Westside perimeter road. The seep reported on 3/5/26 was not observed. Containment in the area was expanded to keep liquids contained and covered. Area is being monitored and vacuumed out regularly.

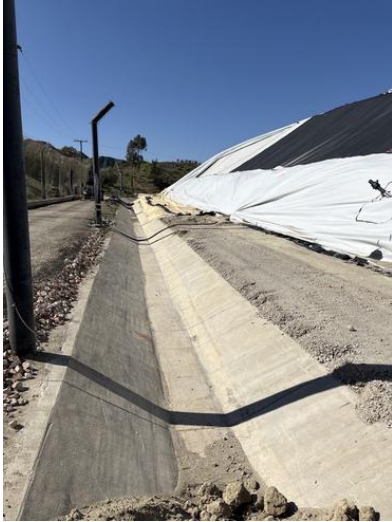
Photo 1

Westside perimeter road. The seep reported on 3/5/26 was not observed. Containment in the area was expanded to keep liquids contained and covered. Area is being monitored and vacuumed out regularly.

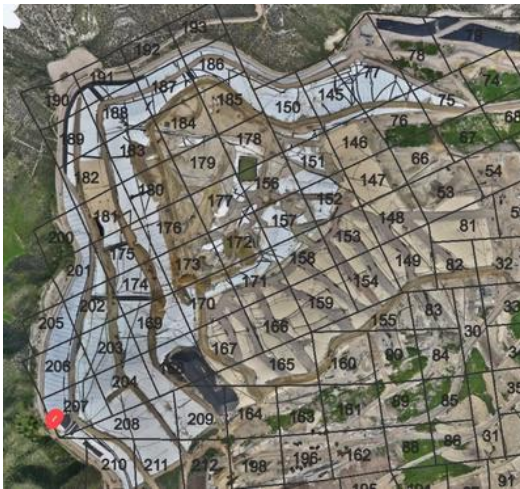
207

(34.43291873892952,
-118.65196019486159)

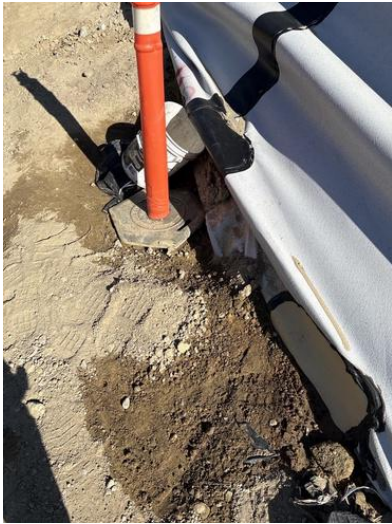
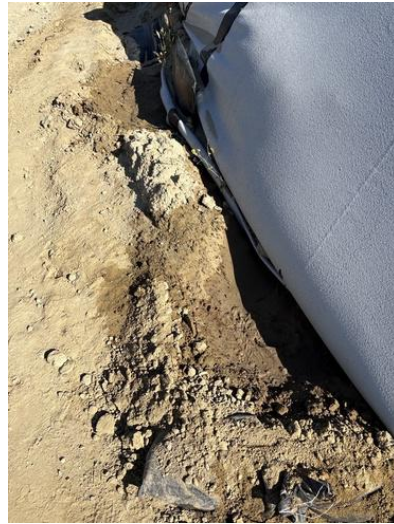
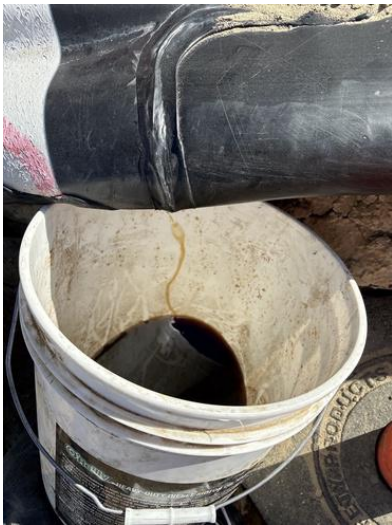
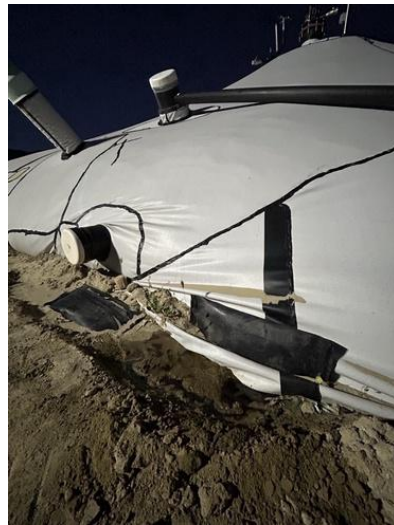
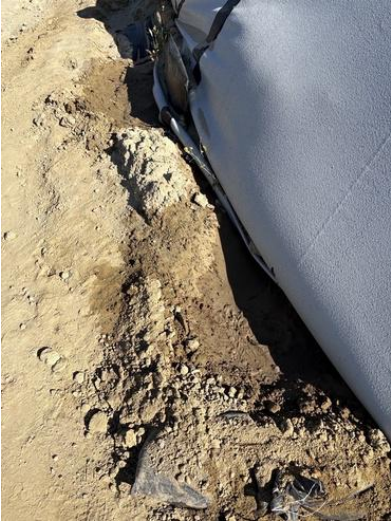
Seep initially found at 7:45pm on 3/9

14 hours

28 gallons. Based on approximately 2 gallons per hour that marksman is collecting.

35 sq ft

Standing free liquid

Seeping has stopped from the ground locations but continues to flow from a small hole in the liner. Liquid temporarily being contained in buckets and sealed with lid while being walked over to the truck to be vacuumed out.

Berms created around seep points. Area is being monitored and liquid vacuumed out if needed to prevent pooling.

Containment construction scheduled for 3/11/26

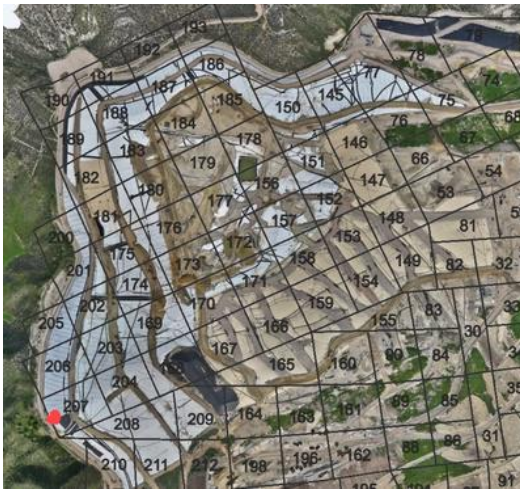
207

(34.432436367528915,
-118.65189766522371)

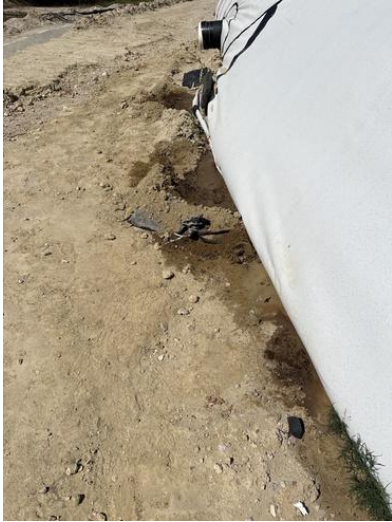
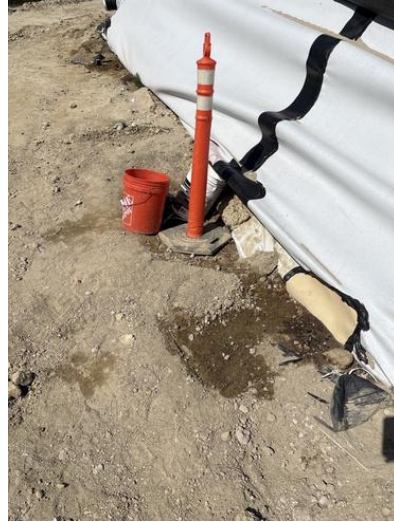
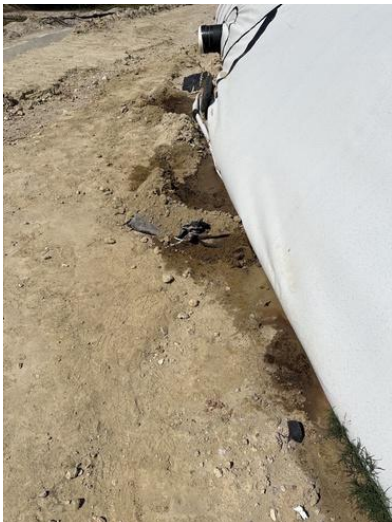
38 gallons. Based on approximately 2 gallons per hour that marksman is collecting.

Semi-dry

Seeping has stopped from the ground locations but continues to flow from a small hole in the liner. Liquid temporarily being contained in buckets and sealed with lid while being walked over to the truck to be vacuumed out.

Berms created around seep points. Area is being monitored and liquid vacuumed out if needed to prevent pooling.

Containment construction scheduled to begin on 3/11/26

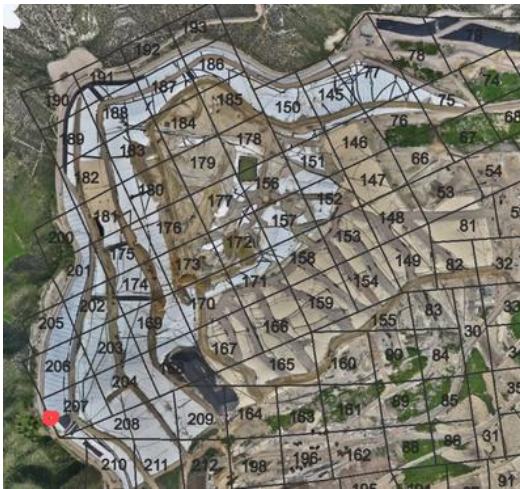
207

(34.43253602835772,
-118.65191099244977)

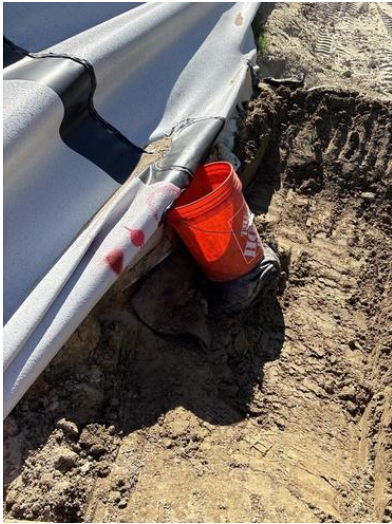
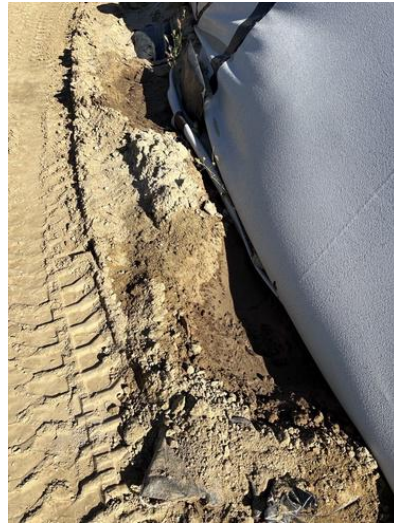
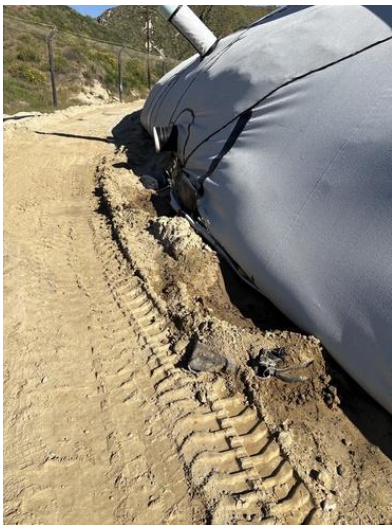
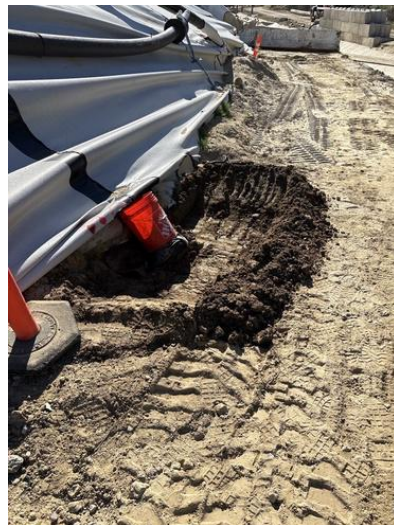
78 gallons. Based on approximately 2 gallons per hour that marksman is collecting.

Semi-dry

Berms created around seep points. Larger containment constructed around main leak point. Area is being monitored and liquid vacuumed out if needed to prevent pooling. No leachate was observed coming from hole in liner or the ground during this inspection, but leachate is continuing to be collected and vacuumed out periodically.

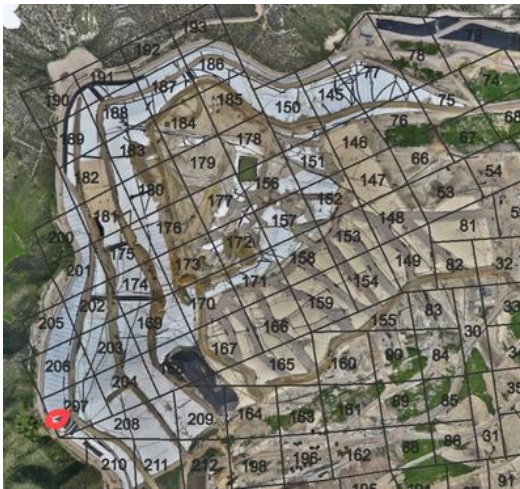
207

(34.432337235988925,
-118.65135458700856)

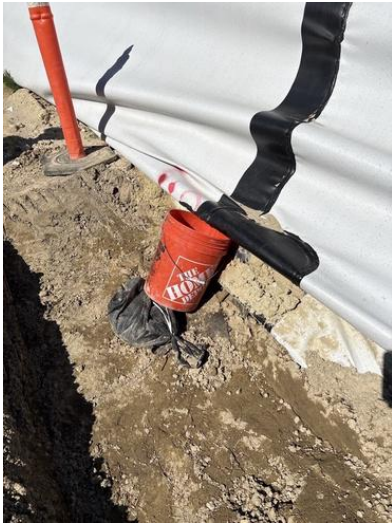
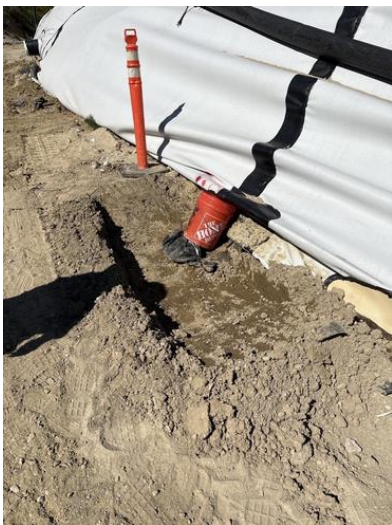
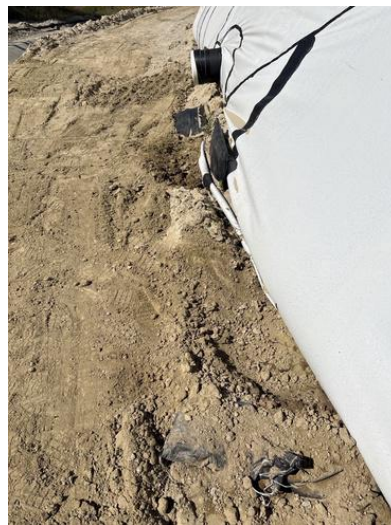
88 gallons.

Dry

No leachate was observed coming from the ground points during this inspection.

Berms created around seep points. Area is being monitored and liquid vacuumed out if needed to prevent pooling.

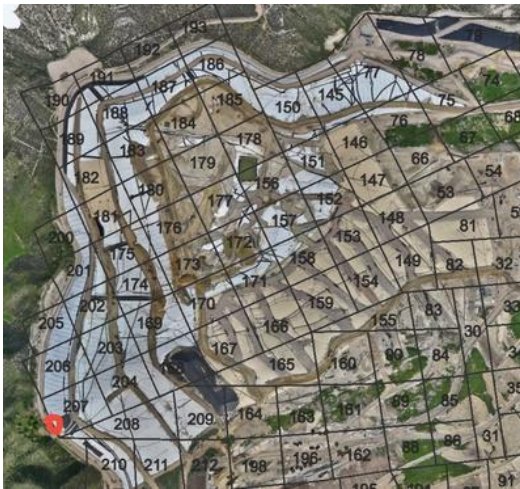
207

Castaic CA 91384
United States
(34.43235203271443,
-118.65197896529543)

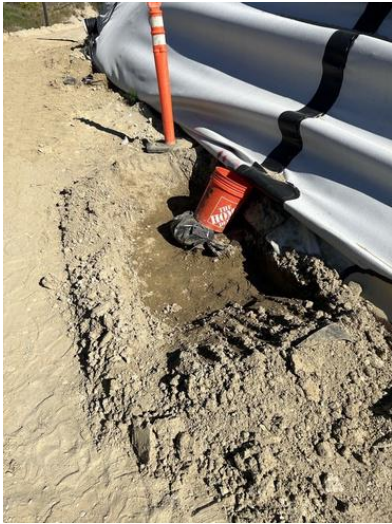
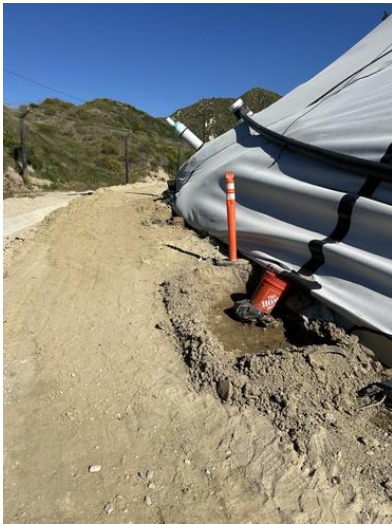
81-100 gallons

Dry

Berms created around seep point. Area is being monitored and liquid vacuumed out if needed to prevent pooling
No leachate was observed coming from the ground points during this inspection

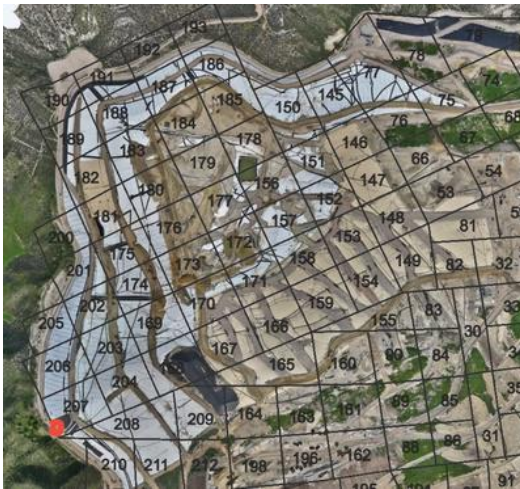
207

(34.43247701487178,
-118.65186004006972)

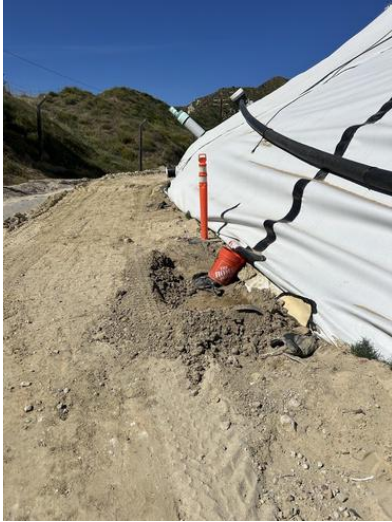
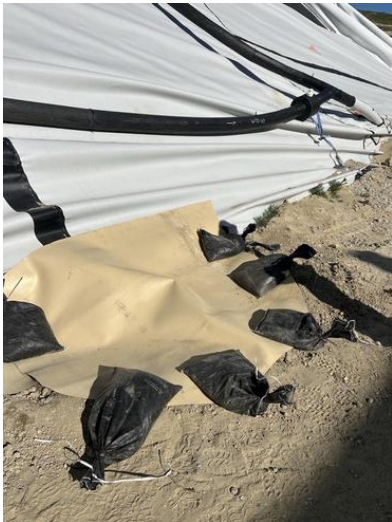
101-150 gallons

Dry

Berms created around seep point, liner placed and sand bagged to prevent atmospheric exposure. Area is being monitored and liquid vacuumed out if needed to prevent pooling
No leachate was observed coming from the ground points during this inspection

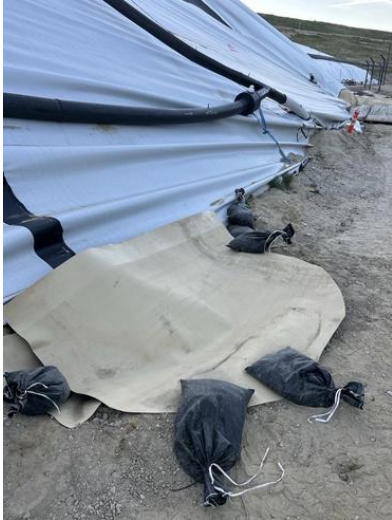
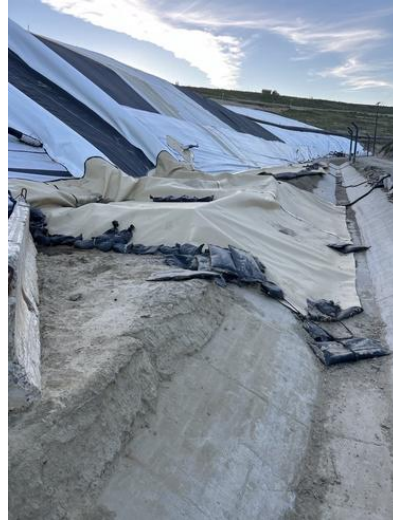
Westside perimeter road. The seep beginning on 3/10/26 was not observed at the time of this inspection. A berm was created around seep point, liner placed and sand bagged to prevent atmospheric exposure. Area is being monitored and liquid vacuumed out if needed to prevent pooling.

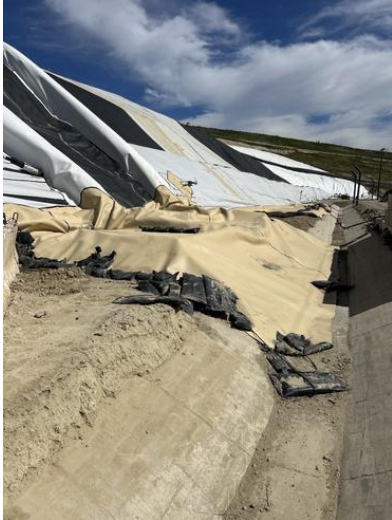
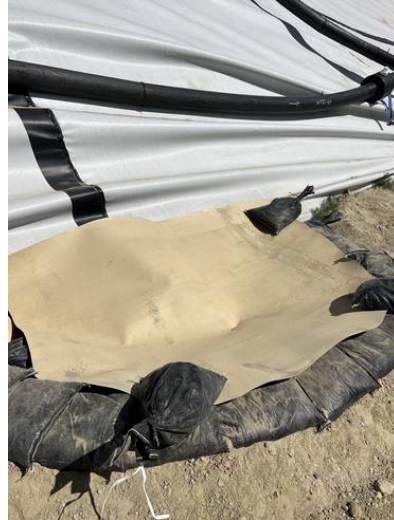
Westside perimeter road. The seep beginning on 3/10/26 was not observed at the time of this inspection. A berm was created around seep point, liner placed and sand bagged to prevent atmospheric exposure. Area is being monitored and liquid vacuumed out if needed to prevent pooling.

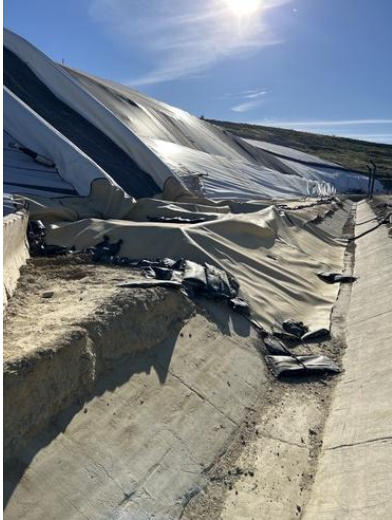
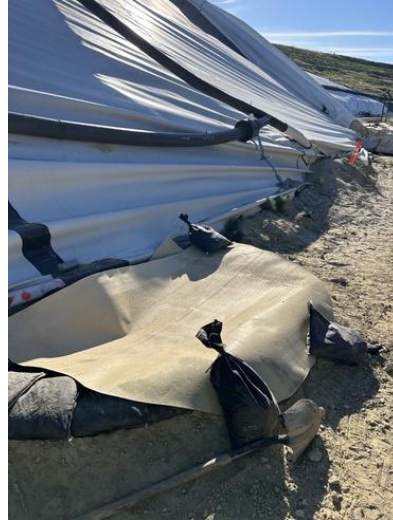
Westside perimeter road. The seep beginning on 3/10/26 was not observed at the time of this inspection. A berm was created around seep point, liner placed and sand bagged to prevent atmospheric exposure. Area is being monitored and liquid vacuumed out if needed to prevent pooling.

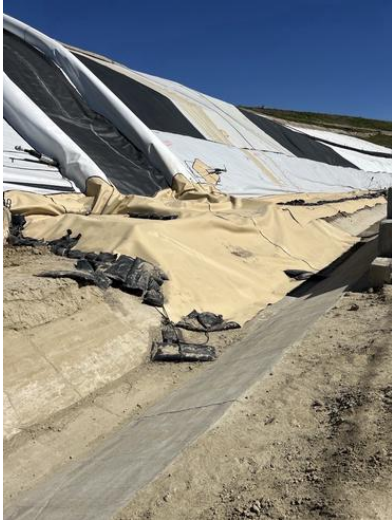
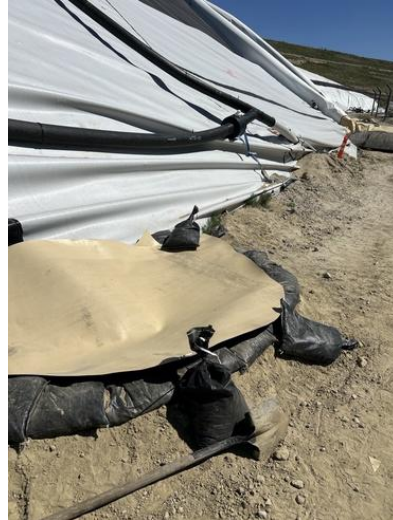
Westside perimeter road. The seep beginning on 3/10/26 was not observed at the time of this inspection. A berm was created around seep point, liner placed and sand bagged to prevent atmospheric exposure. Area is being monitored and liquid vacuumed out if needed to prevent pooling.

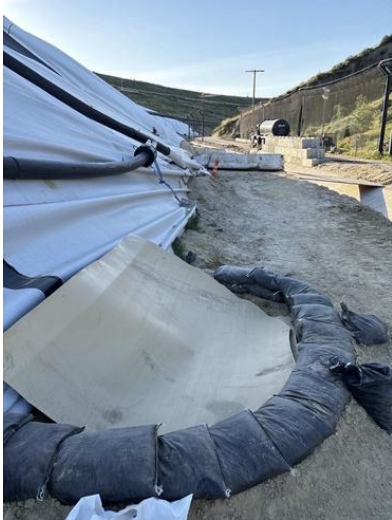
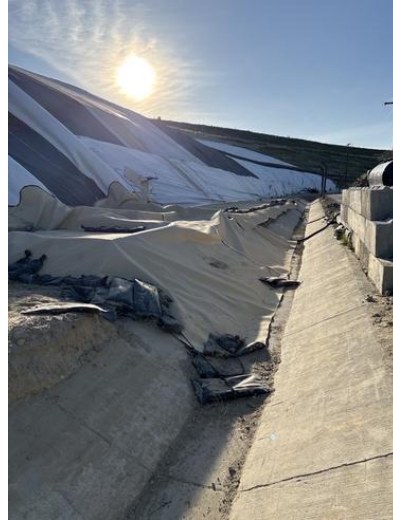
Westside perimeter road. The seep beginning on 3/10/26 was not observed at the time of this inspection. A berm was created around seep point, liner placed and sand bagged to prevent atmospheric exposure. Area is being monitored and liquid vacuumed out if needed to prevent pooling.

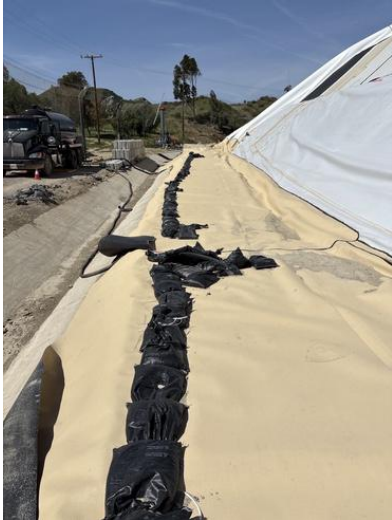
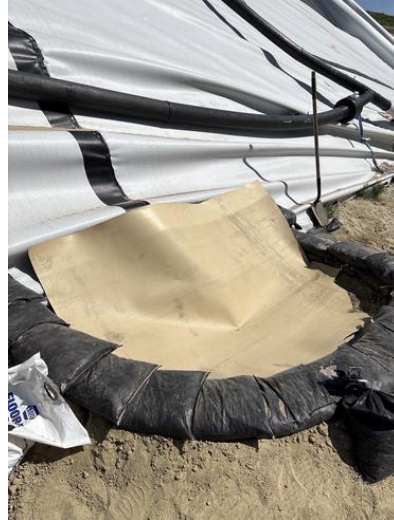
Westside perimeter road. The seep beginning on 3/10/26 was not observed at the time of this inspection. A berm was created around seep point, liner placed and sand bagged to prevent atmospheric exposure. Area is being monitored and liquid vacuumed out if needed to prevent pooling.
