March 17, 2026

Re: Chiquita Canyon, LLC's Weekly Report on the Documentation and Tracking of Cover Issues

4050 - Chiquita Reaction Area Tracking of Fissures and Tension Cracks

4050 - Geosynthetic Cover Inspection

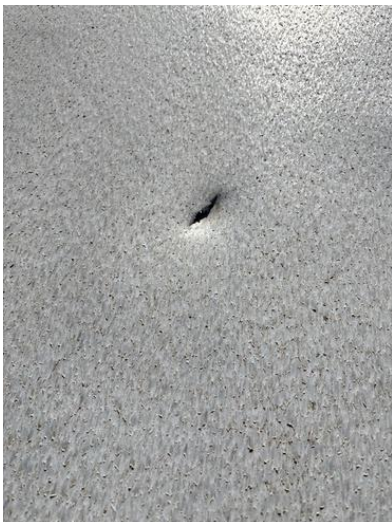
Photo 1

Tear in liner needs to be patched/extrusion welded.

Tear taped and sandbagged upon discovery and later extrusion welded.

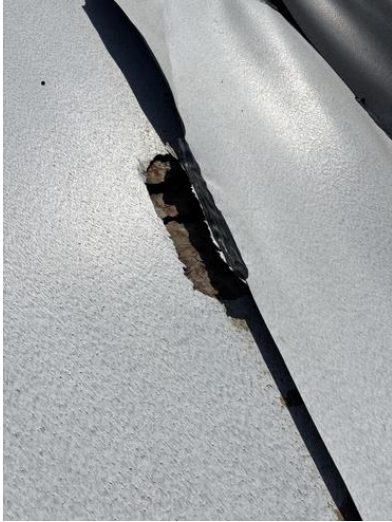
Photo 4

Tear in liner needs to be patched/extrusion welded.

Tear taped and sandbagged upon discovery and later patched and extrusion welded.
