**Re: Chiquita Canyon, LLC's Weekly Leachate Inspection Report for Stipulated Order for Abatement (Case No. 6177-4), Condition 27(c)**

Pursuant to Condition 27(c) of the Stipulated Order for Abatement with the South Coast Air Quality Management District in Case No. 6177-4 (the "Order"), Chiquita Canyon, LLC ("Chiquita") encloses a compilation of the twice daily leachate seep inspection logs for the dates of March 16, 2026 through March 22, 2026.

# 4050 - Chiquita Leachate Seep/Pooling Inspection

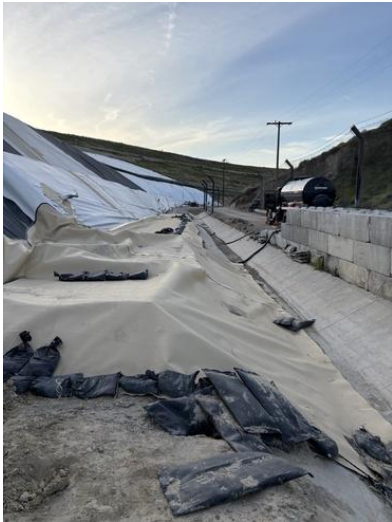
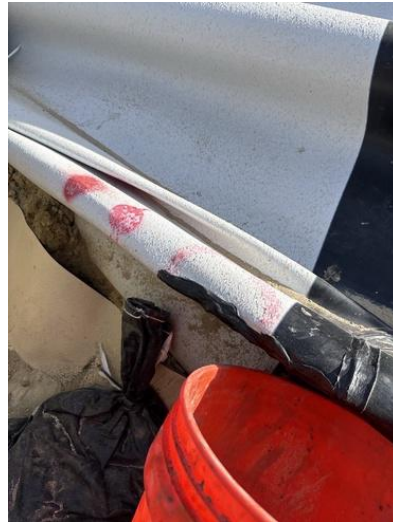
Westside perimeter road. The seep beginning on 3/09/26 was not observed at the time of this inspection. A berm was created around seep point, liner placed and sand bagged to prevent atmospheric exposure. The hole in the liner where liquid was dripping from was extrusion welded. Some leachate continues to seep in to containment. Area continues to be monitored and vacuumed out as needed to prevent pooling.

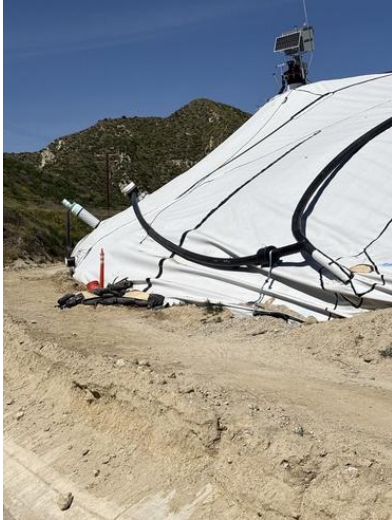
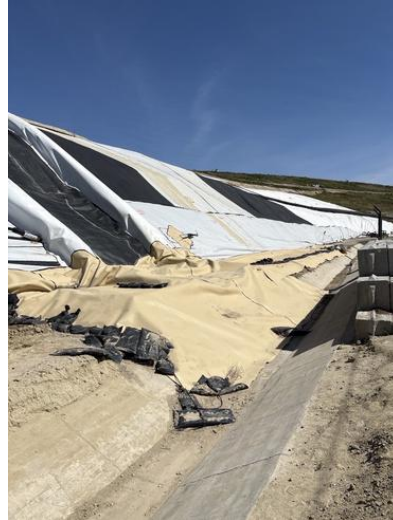
Westside perimeter road. The seep beginning on 3/09/26 was not observed at the time of this inspection. A berm was created around seep point, liner placed and sand bagged to prevent atmospheric exposure. The hole in the liner where liquid was dripping from was extrusion welded. Some leachate continues to seep in to containment. Area continues to be monitored and vacuumed out as needed to prevent pooling.

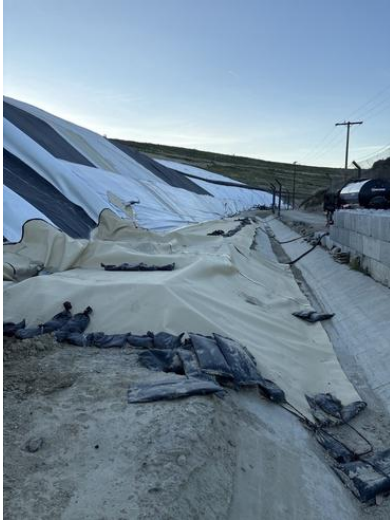
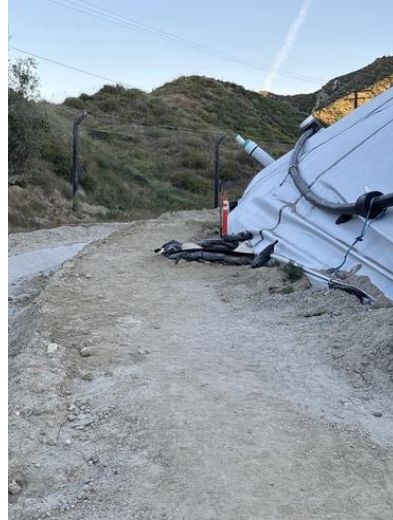
Westside perimeter road. The seep beginning on 3/9/26 was not observed at the time of this inspection. Some leachate continues to seep into containment. Area continues to be monitored and vacuumed out as needed to prevent pooling.

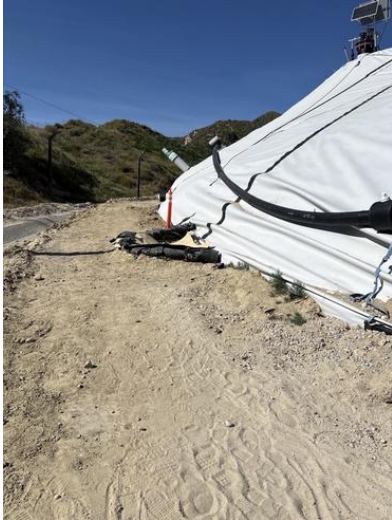
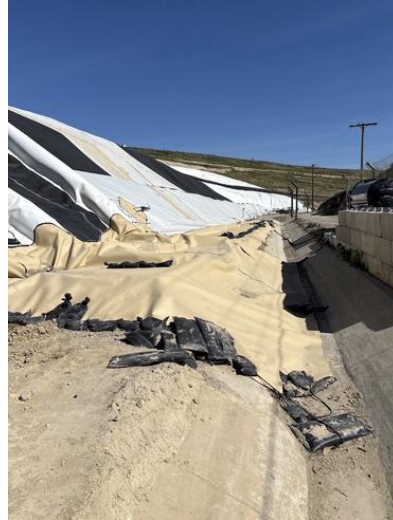
Westside perimeter road. The seep beginning on 3/9/26 was not observed at the time of this inspection. Some leachate continues to seep into containment. Area continues to be monitored and vacuumed out as needed to prevent pooling.

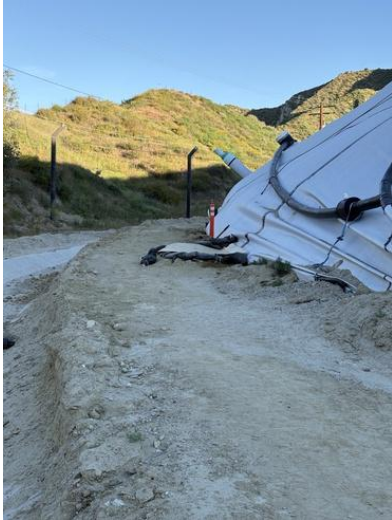
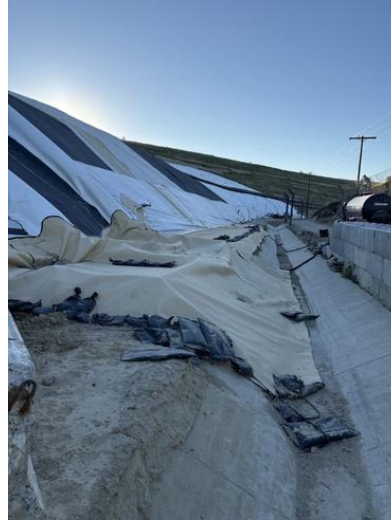
Westside perimeter road. The seep beginning on 3/9/26 was not observed at the time of this inspection. Some leachate continues to seep into containment. Area continues to be monitored and vacuumed out as needed to prevent pooling.

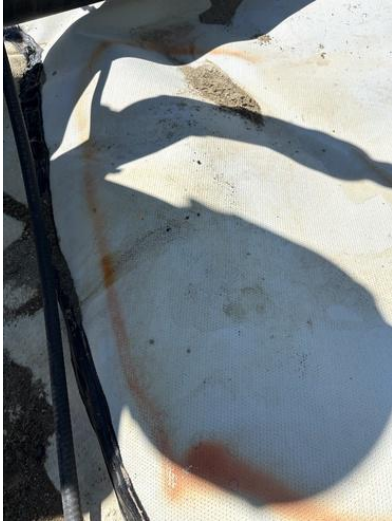
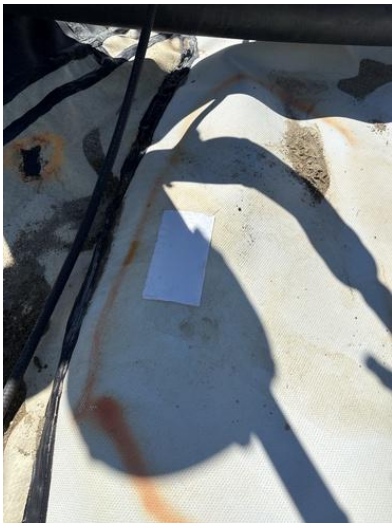
During this week, pooling condensate was observed on March 18, 2026, at approximately 11:10 a.m., in grid 150 at the Chiquita Canyon Landfill (the "Landfill"). The exact location of this condensate is set forth in the maps included in the attachment. The liquid was clear and is believed to be condensate formed between two layers of geomembrane cover. Liquid from the condensate did not reach the stormwater channel or either sedimentation basin. Upon discovery, Chiquita taped the hole in the geomembrane cover. Chiquita cleaned up any standing liquid with absorbent rags, which were then placed into a container for proper disposal. Cleanup was completed on March 23, 2026, at approximately 8:50 a.m. Chiquita patched and welded the geomembrane cover on March 23, 2026, at approximately 8:58 a.m. Chiquita considers this issue to be corrected. The total approximate amount of condensate was less than one gallon. The extent of the area impacted was approximately two square feet. The odor type was "Condensate," and the odor intensity was "Very Strong." The saturation of the soil was "Standing Free Liquid."

Liquid was clear and believed to be condensation between the 2 layers of liner.

2 sq ft

5 - Very Strong Odor

Standing free liquid

Hole in liner taped to prevent more liquid from escaping. Standing liquid cleaned up with absorbent towels and disposed of in appropriate bin. Vacuum truck to remove liquid and liner repair scheduled for 3/23/26

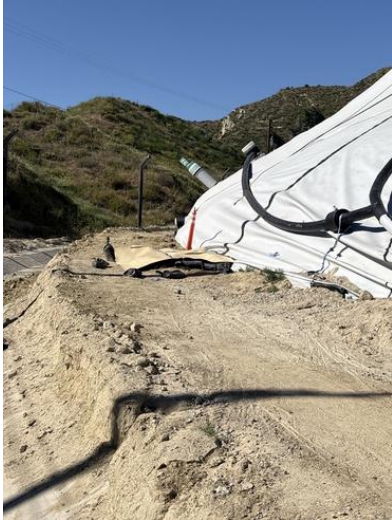
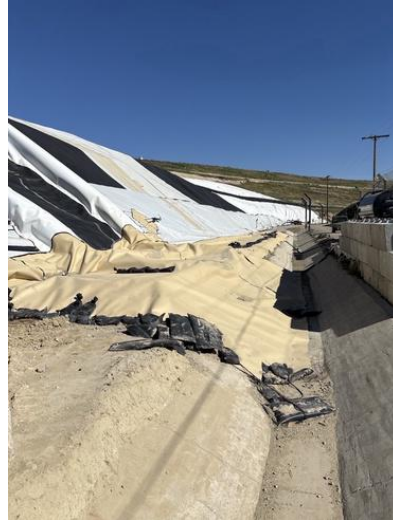
Westside perimeter road. The seeps beginning on 3/9/26 and observed in the morning were not observed at the time of this inspection. Area continue to be monitored and vacuumed out as needed to prevent pooling.

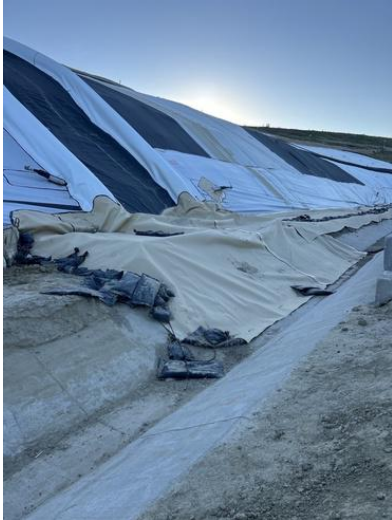
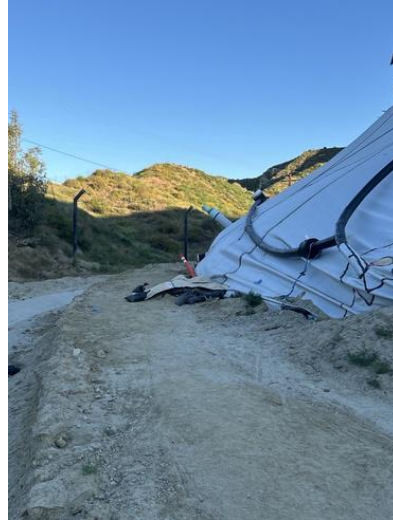
Westside perimeter road. The seeps beginning on 3/9/26 and observed the morning of 3/18/26 were not observed at the time of this inspection. Area continue to be monitored and vacuumed out as needed to prevent pooling.

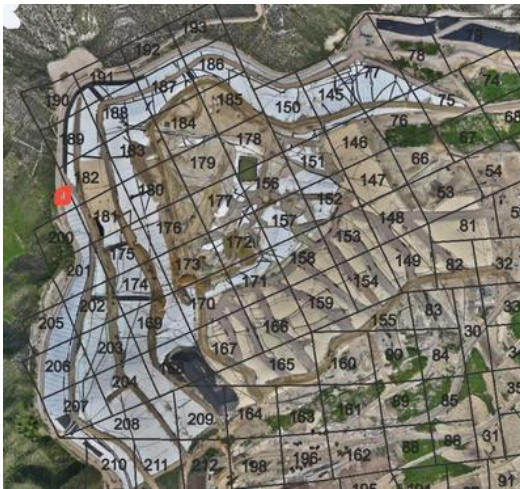
North of grid 200

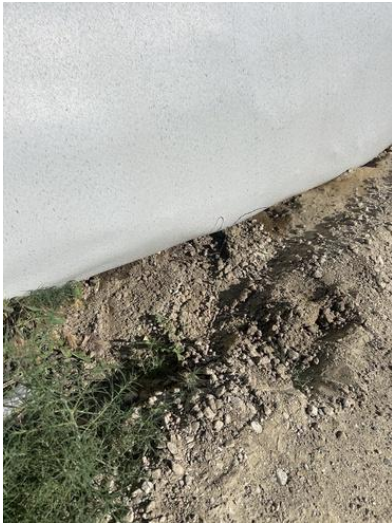
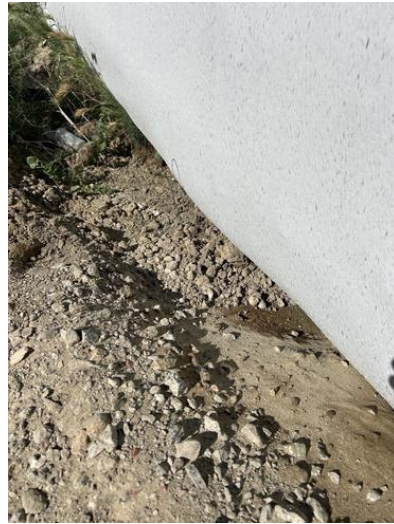
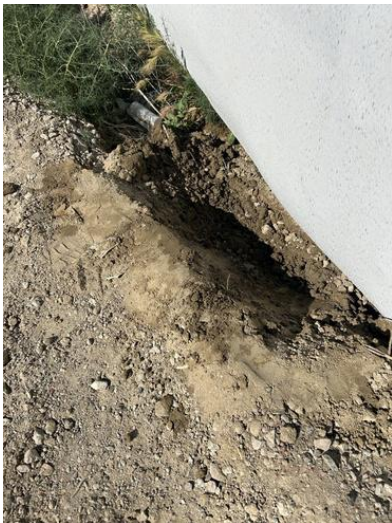
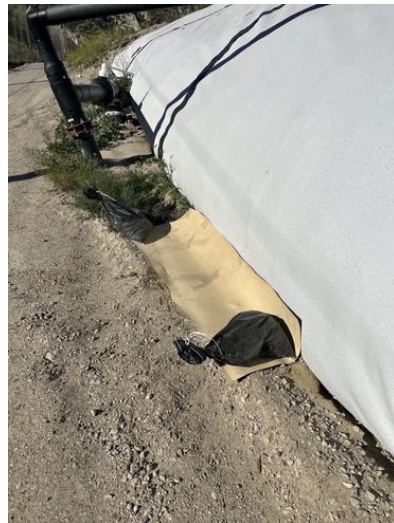
In addition, during this week, a seep was observed on March 19, 2026, at approximately 7:55 a.m., north of grid 200. The exact location of this seep is set forth in the maps included in the attachment. Liquid from the seep reached the perimeter road, but did not reach the stormwater channel or either sedimentation basin. Upon discovery of the seep, Chiquita created a berm and added soil to the area. Chiquita covered the containment area with a liner and sandbags to prevent potential emissions. Cleanup was completed the morning of March 19, 2026, and the seep was no longer visible; accordingly, it was not observed at this location during the afternoon inspection on March 19, 2026, or during inspections later that week. Chiquita is monitoring the area. The total

approximate amount of leachate from this seep was less than one gallon. The extent of the area impacted by the seep was approximately one square foot. No odor associated with this seep was detected. The saturation of the soil was "Semi-Dry."

<1 gallons

1sq ft

Semi-dry

hole dug down with a small berm created. Liner piece placed and sand bagged to limit atmospheric exposure. Ongoing event that will be monitored routinely

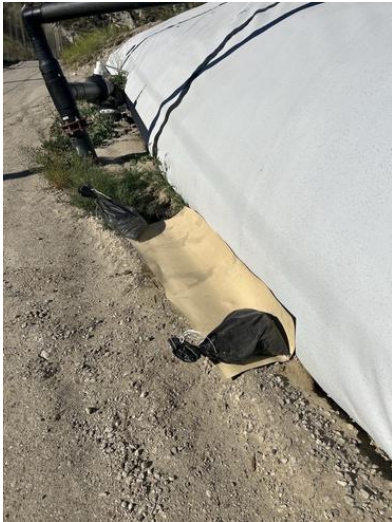
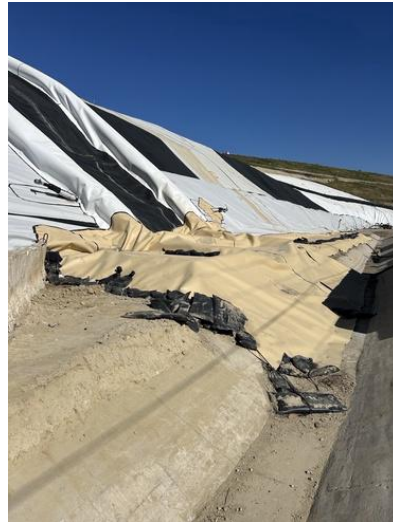
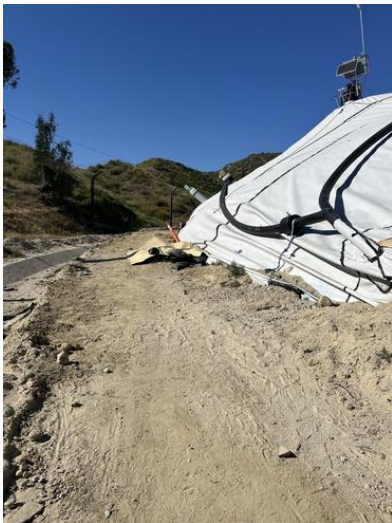
Westside perimeter road. The seeps beginning on 3/9/26 and observed the morning of 3/18/26 were not observed at the time of this inspection. Area continue to be monitored and vacuumed out as needed to prevent pooling.

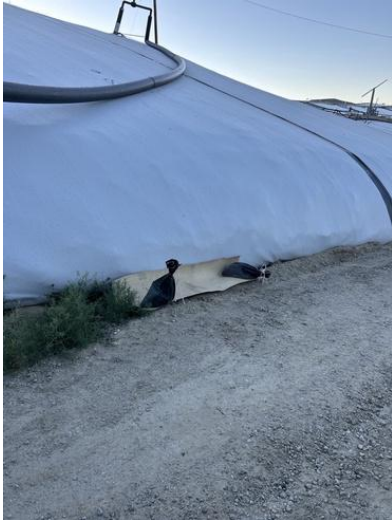
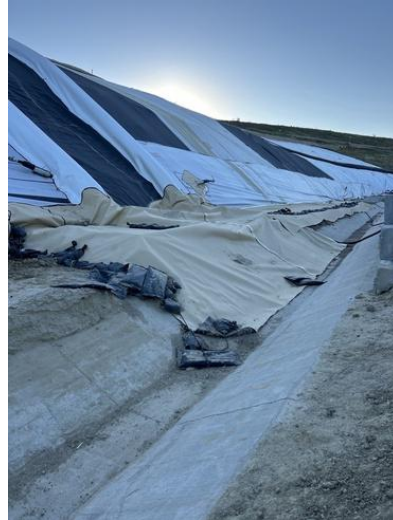
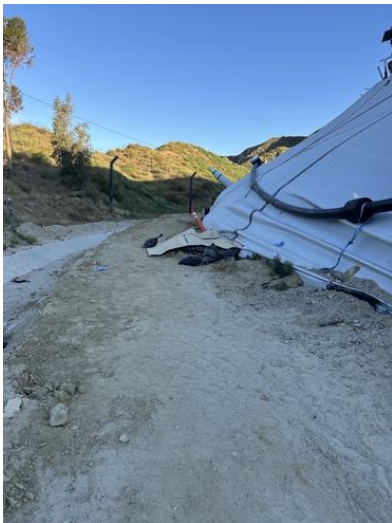
Westside perimeter road. None of the seeps that occurred in this area were observed at the time of this inspection. Area continues to be monitored and vacuumed out as needed to prevent pooling

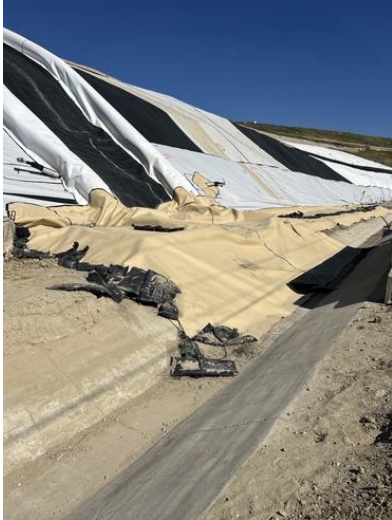
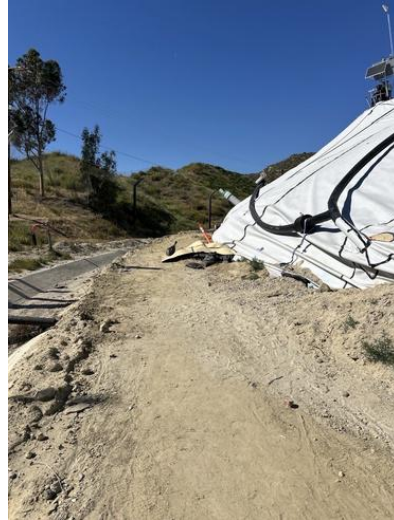
Westside perimeter road. None of the seeps that occurred in this area were observed at the time of this inspection. Area continues to be monitored and vacuumed out as needed to prevent pooling

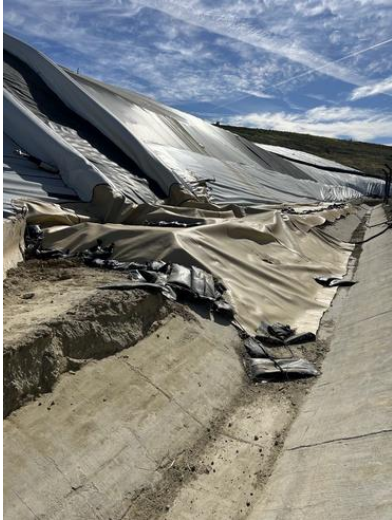
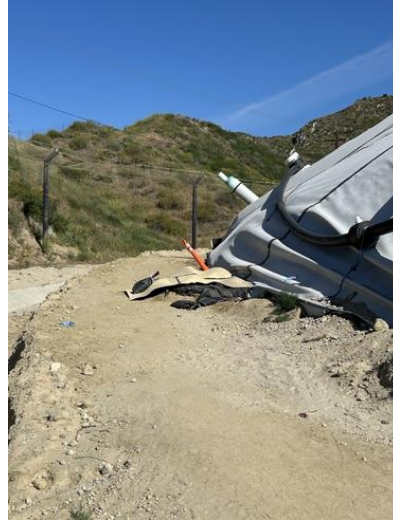
Westside perimeter road. None of the seeps that occurred in this area were observed at the time of this inspection. Area continues to be monitored and vacuumed out as needed to prevent pooling

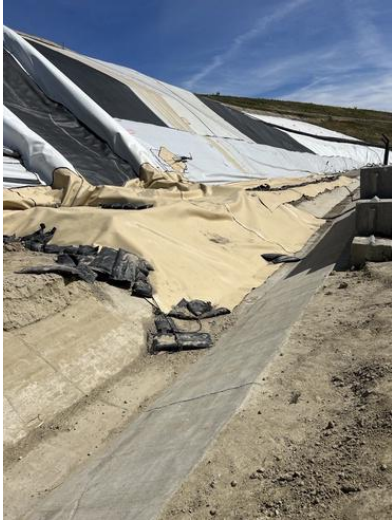
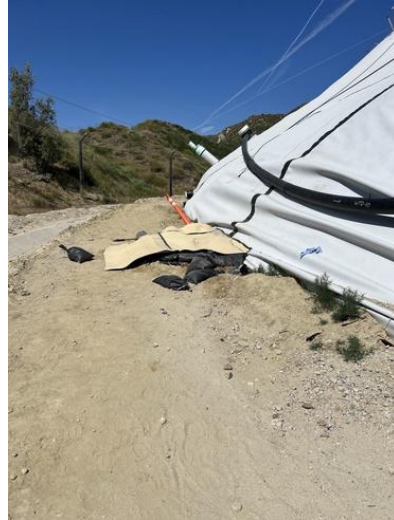
Westside perimeter road. None of the seeps that occurred in this area were observed at the time of this inspection. Area continues to be monitored and vacuumed out as needed to prevent pooling

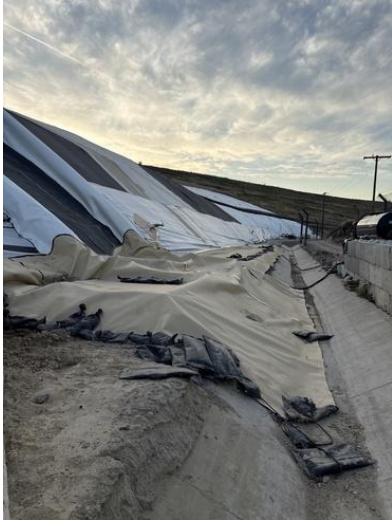
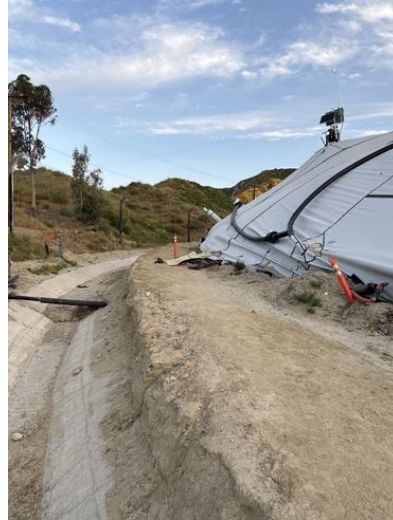
Westside perimeter road. None of the seeps that occurred in this area were observed at the time of this inspection. Area continues to be monitored and vacuumed out as needed to prevent pooling

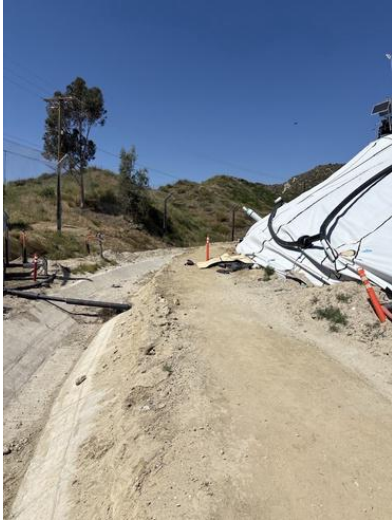
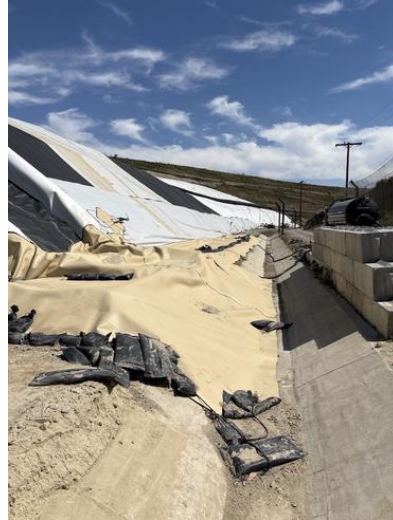
Westside perimeter road. None of the seeps that occurred in this area were observed at the time of this inspection. Area continues to be monitored and vacuumed out as needed to prevent pooling
