**CHIQUITA CANYON**  
*A Waste Connections Company*

**Re: Chiquita Canyon, LLC's Weekly Report on the Documentation and Tracking of Cover Issues**

# 4050 - Chiquita Reaction Area Tracking of Fissures and Tension Cracks

# 4050 - Geosynthetic Cover Inspection

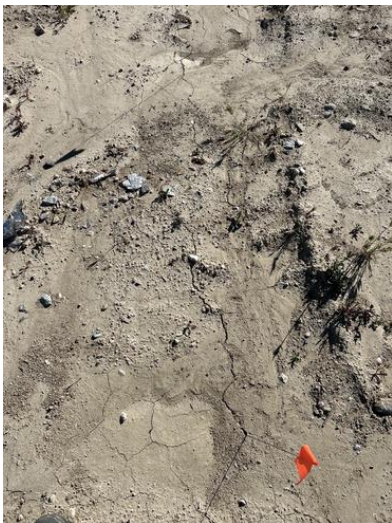
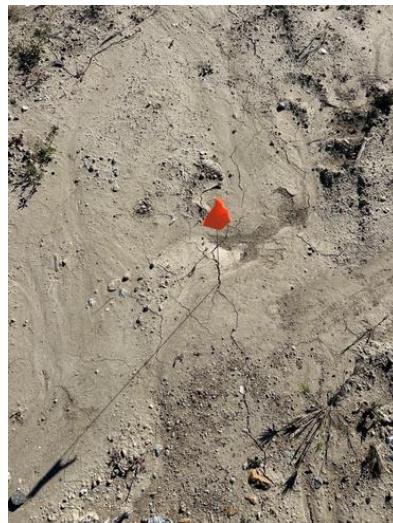
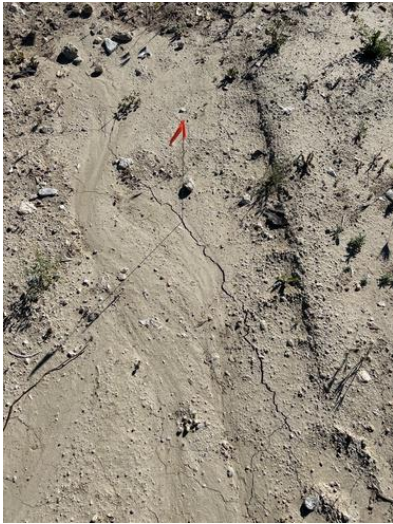
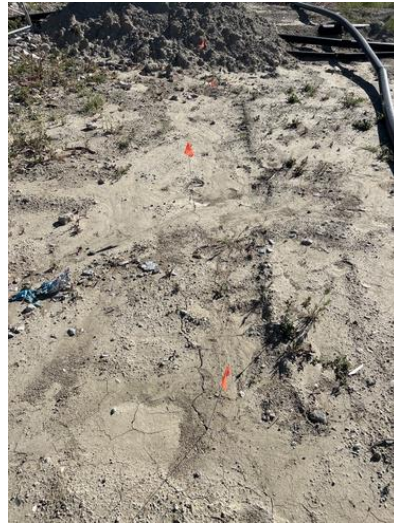
Yes

168

**Length of crack (ft) or area containing multiple cracks (ft x ft)** 13ft

**Horizontal Offset (width)** Extra Small <0.5 in width

**Vertical Offset (height)** Extra small <0.5" in height

**Orientation (direction)** E to W

**Description of repairs** Cracks were track walked.

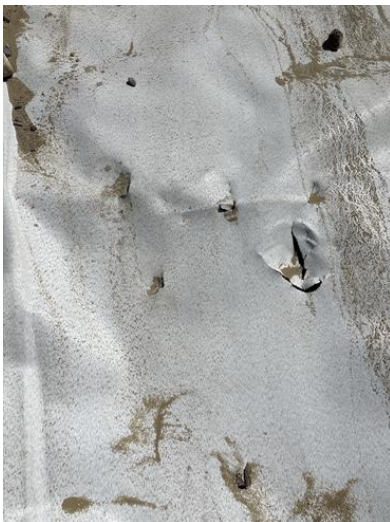
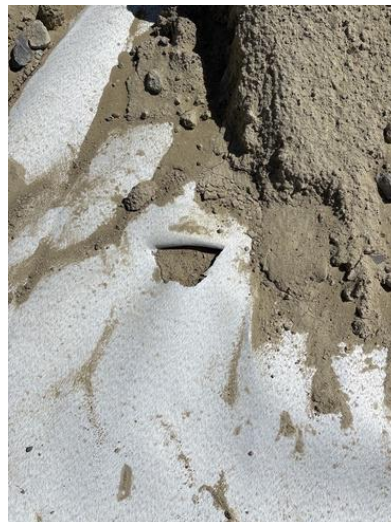
A few tears in liner need to be patched and extrusion welded.

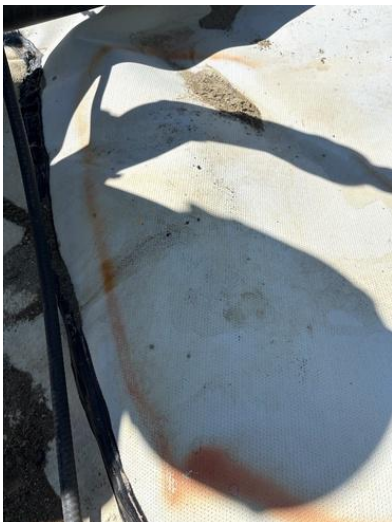
Photo 1

Small hole in liner needs to be patched and extrusion welded.

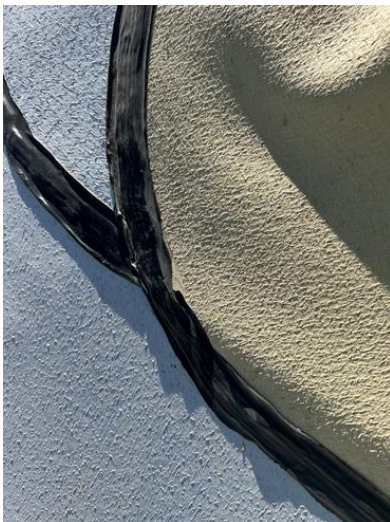
Photo 1

Small separation of liner at weld
