Re: Chiquita Canyon, LLC's Weekly Leachate Inspection Report for Stipulated Order for Abatement (Case No. 6177-4), Condition 27(c)

Attachment: Leachate Inspection Logs from March 23 – March 29, 2026

4050 - Chiquita Leachate Seep/Pooling Inspection

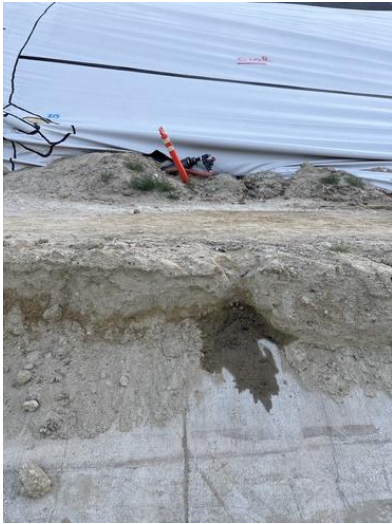
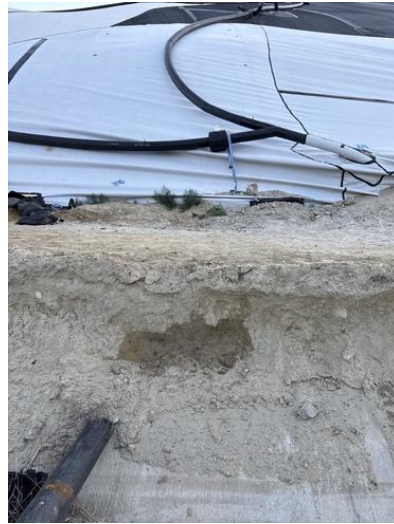
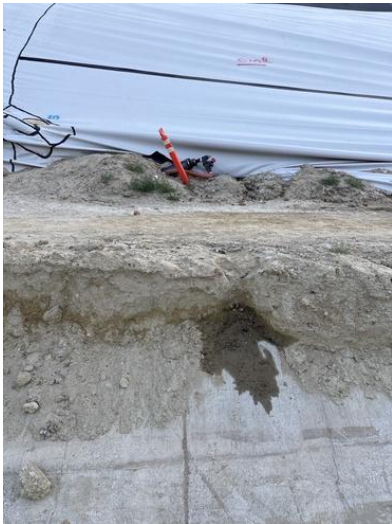
Yes

207

10 hrs

6-10 gallons

3 sq ft

1 - Very Light Odor Detected

Saturated

Seep was monitored to ensure it did not spread or pool.

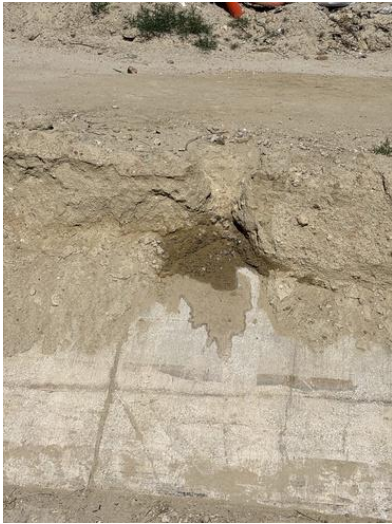
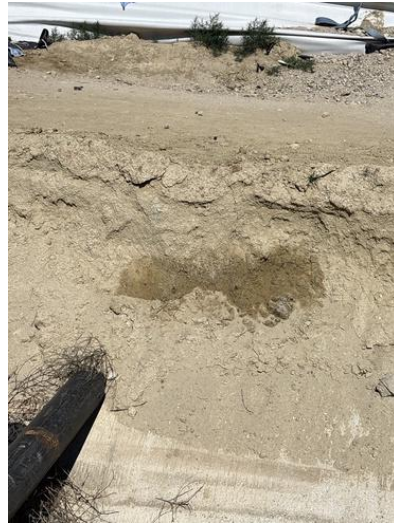
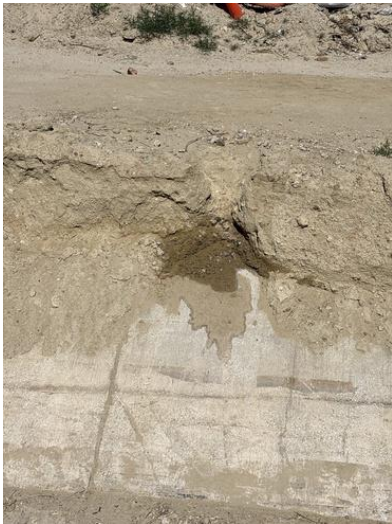
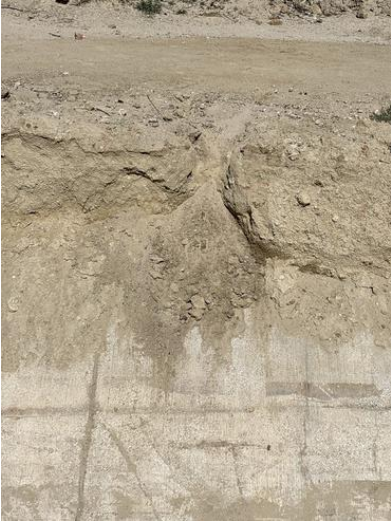
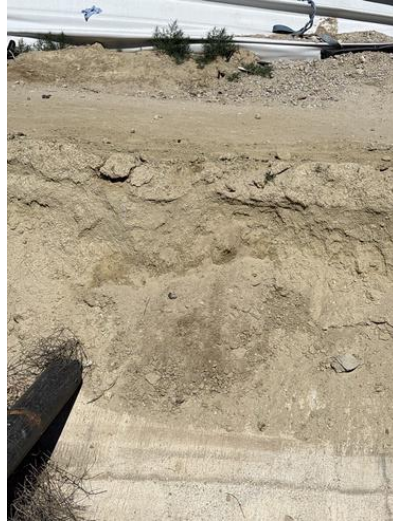
1-5 gallons

3 sq ft

1 - Very Light Odor Detected

Semi-dry

Yes

Dirt added to cover seep and limit exposure to the atmosphere.

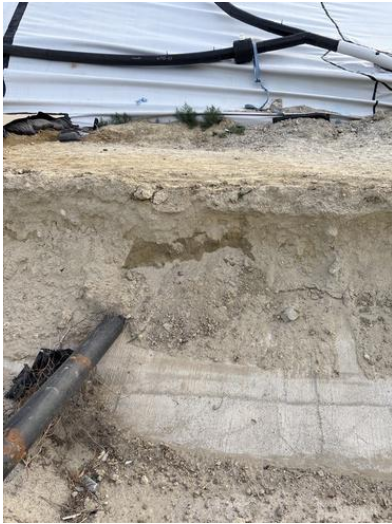
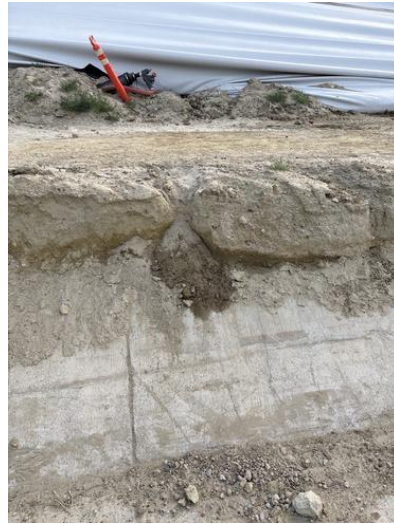
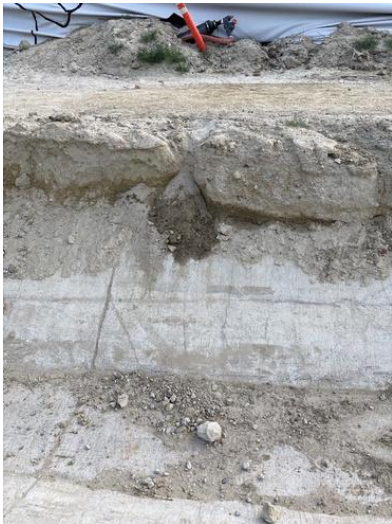
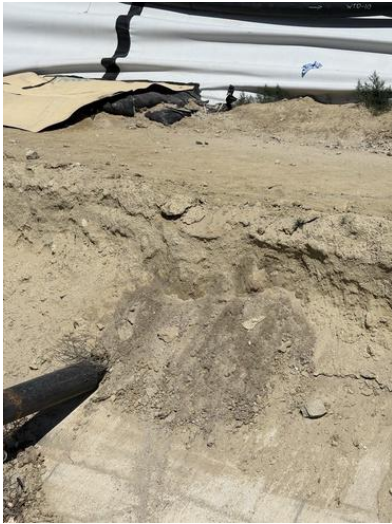
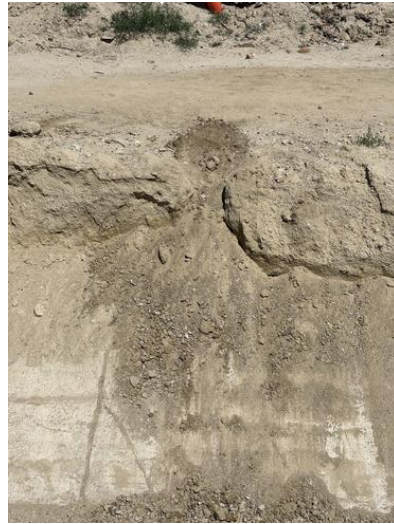
1-5 gallons

3 sq ft

2 - Light Odor Detected

Saturated

Yes

Dirt added to cover seep and limit exposure to the atmosphere.

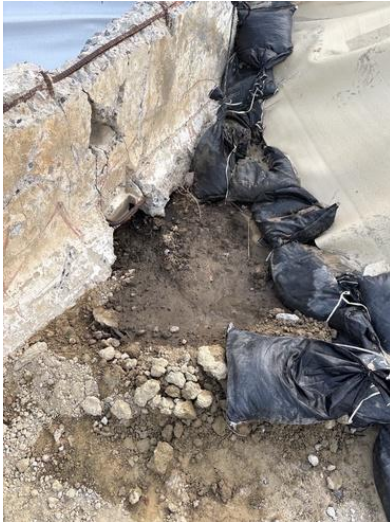
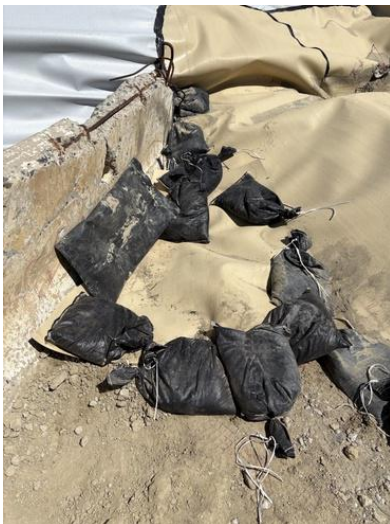
1-5 gallons

5 sq ft

3 - Moderate Odor

Saturated

No

Area covered with liner and sandbagged to limit exposure to the atmosphere. Area is monitored and vacuumed out periodically to prevent pooling.

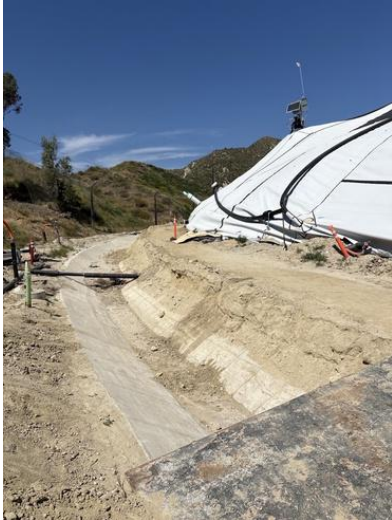
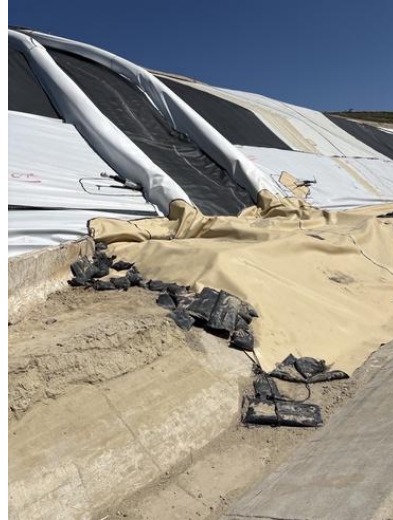
Westside perimeter road. The seeps that were observed this morning were not observed during this inspection.

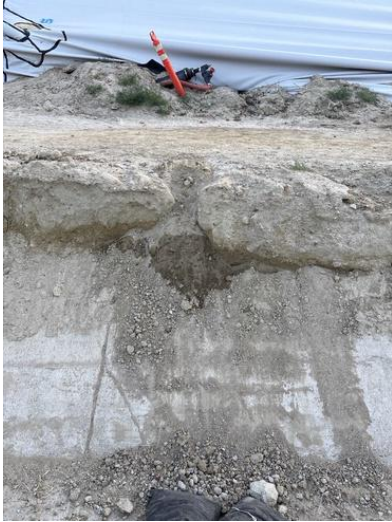
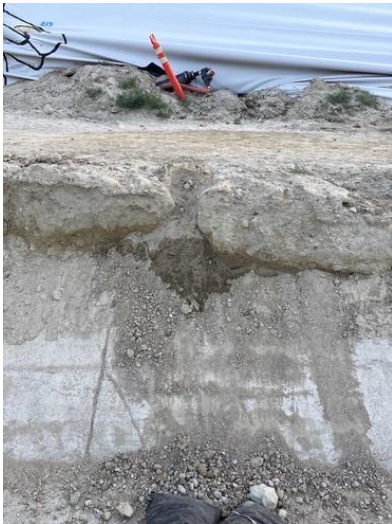
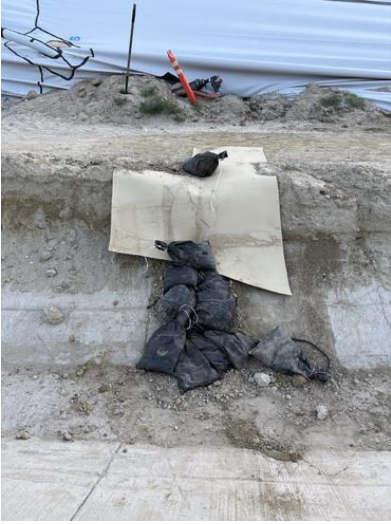
1-5 gallons

2 sq ft

0 - No Odor Detected

Semi-dry

Yes

Sandbags built up the edge of channel and dirt added to cover and contain seep. A piece of geosynthetic cover added to minimize exposure to atmosphere.

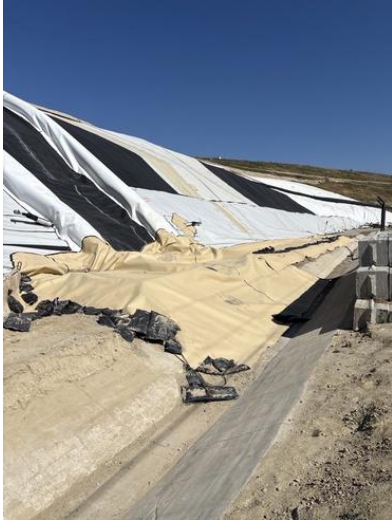
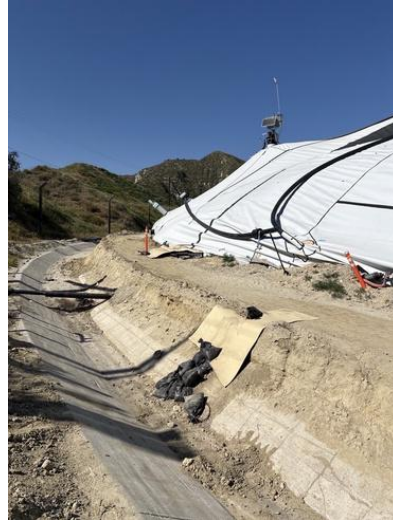
Westside perimeter road. None of the seeps that occurred in this area were observed at the time of this inspection. Area continues to be monitored and vacuumed out as needed to prevent pooling.

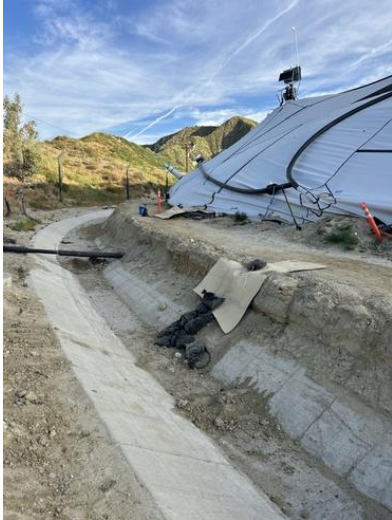
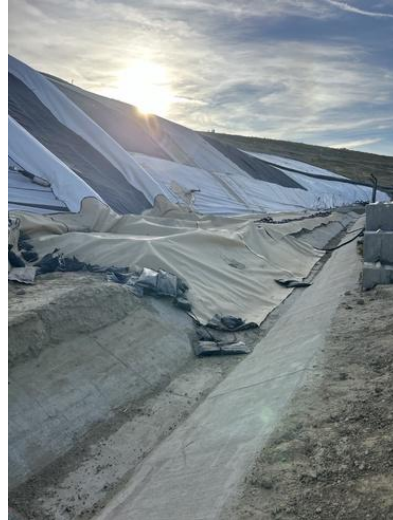
Westside perimeter road. None of the seeps that occurred in this area were observed at the time of this inspection. Area continues to be monitored and vacuumed out as needed to prevent pooling.

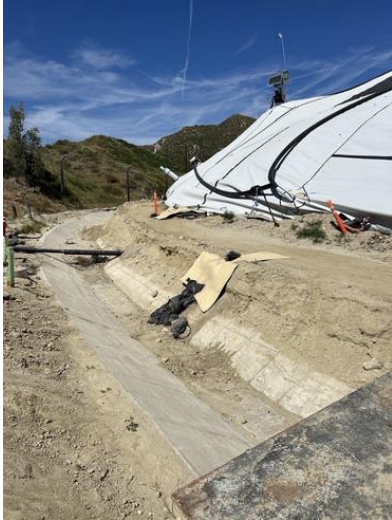
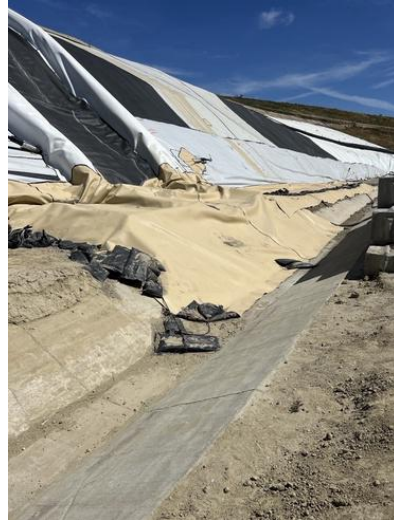
Westside perimeter road. None of the seeps that occurred in this area were observed at the time of this inspection. Area continues to be monitored and vacuumed out as needed to prevent pooling.

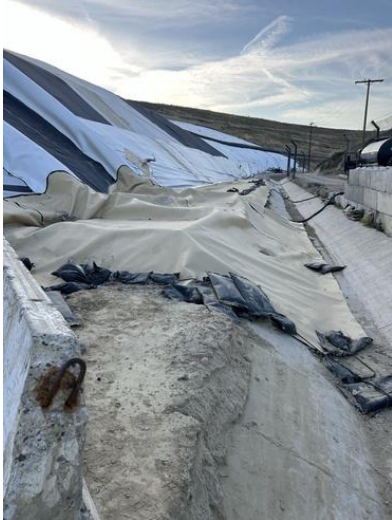
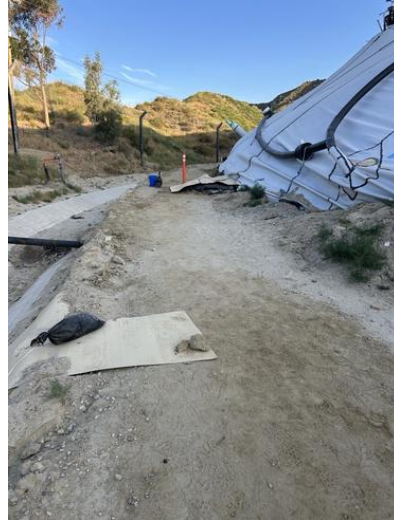
Westside perimeter road. None of the seeps that occurred in this area were observed at the time of this inspection. Area continues to be monitored and vacuumed out as needed to prevent pooling

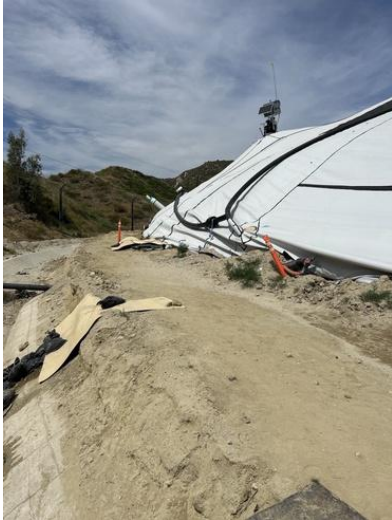
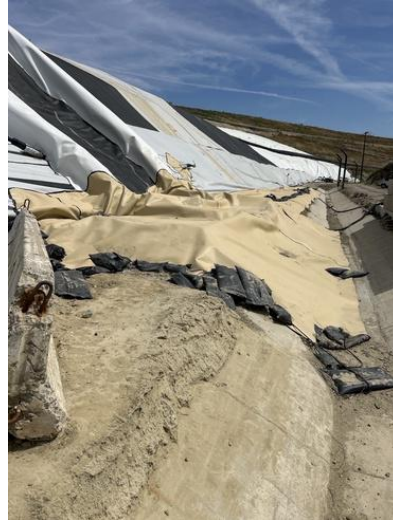
Westside perimeter road. None of the seeps that occurred in this area were observed at the time of this inspection. Area continues to be monitored and vacuumed out as needed to prevent pooling

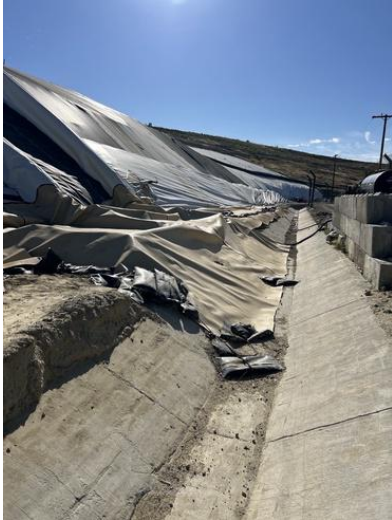
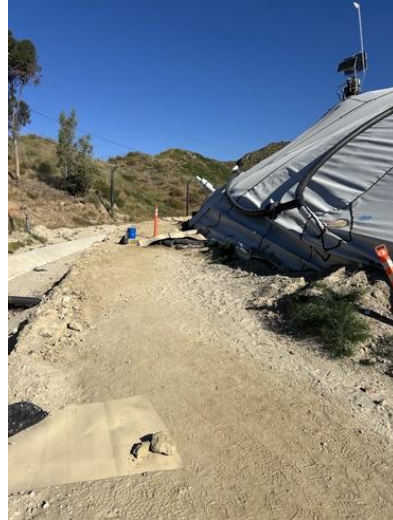
Westside perimeter road. None of the seeps that occurred in this area were observed at the time of this inspection. Area continues to be monitored and vacuumed out as needed to prevent pooling

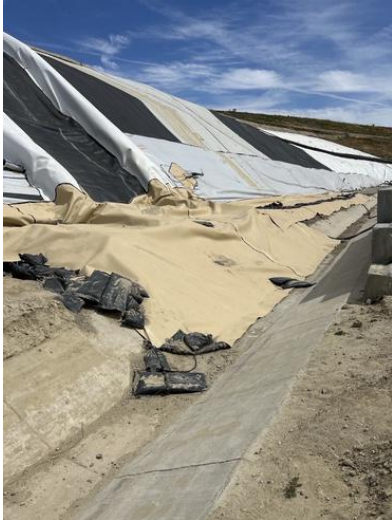
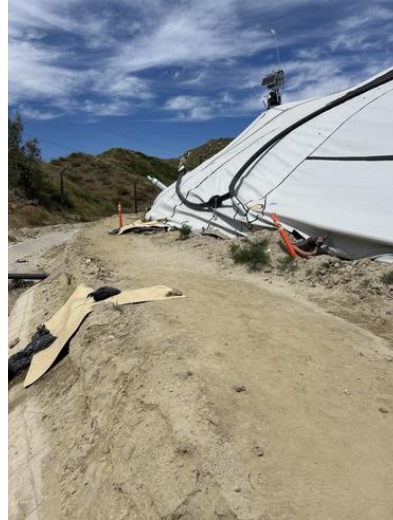
Westside perimeter road. None of the seeps that occurred in this area were observed at the time of this inspection. Area continues to be monitored and vacuumed out as needed to prevent pooling

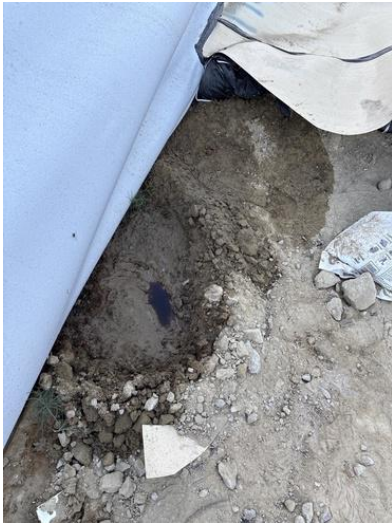
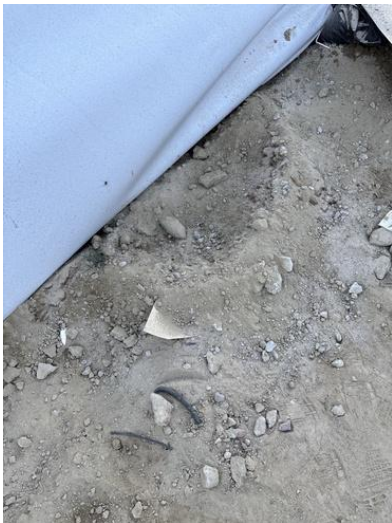
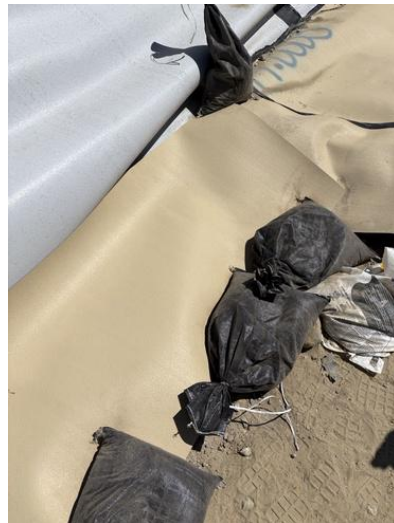
1-5 gallons

6 sq ft

1 - Very Light Odor Detected

Standing free liquid

No

Berm created and fresh soil added to cover and contain seep. Area covered by liner to prevent exposure to atmosphere.

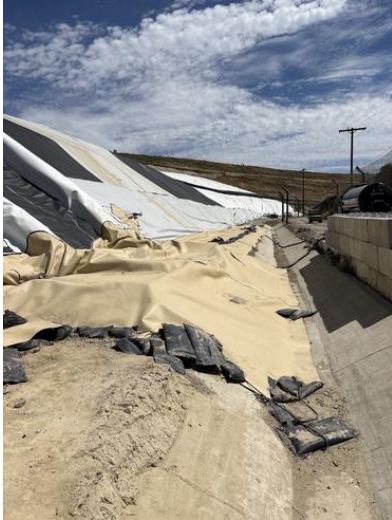
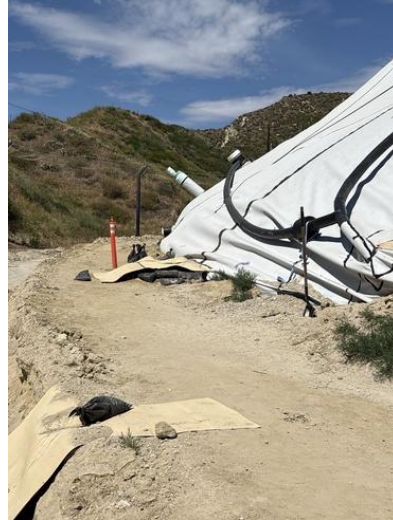
Westside perimeter road. None of the seeps that occurred in this area were observed at the time of this inspection. Area continues to be monitored and vacuumed out as needed to prevent pooling.
