Re: Chiquita Canyon, LLC's Weekly Report on the Documentation and Tracking of Cover Issues

4050 - Chiquita Reaction Area Tracking of Fissures and Tension Cracks

4050 - Geosynthetic Cover Inspection

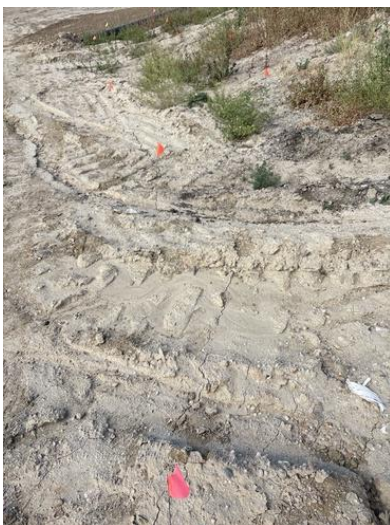
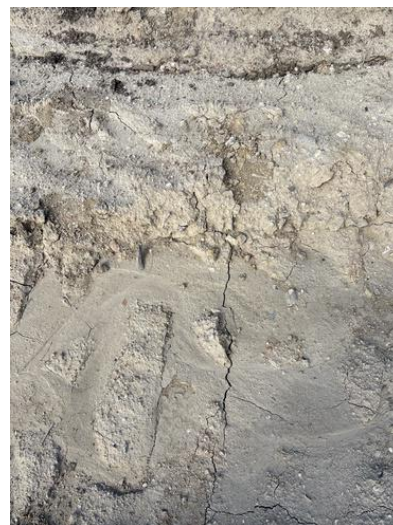
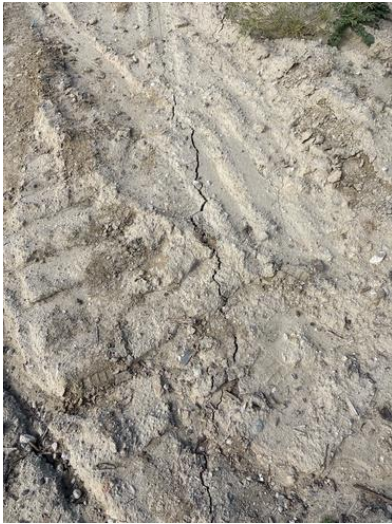
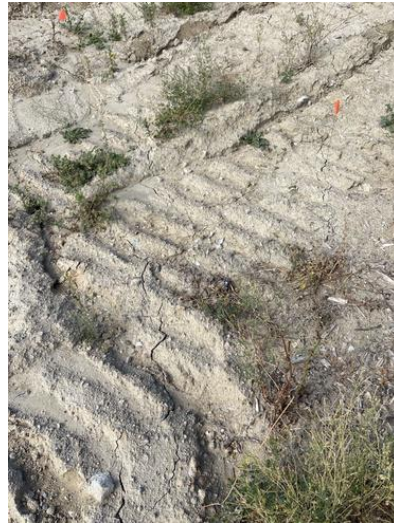
163

Length of crack (ft) or area containing multiple cracks (ft x ft)

8ft x 35ft

Horizontal Offset (width)

Small 0.5-2" in width

Vertical Offset (height)

Extra small <0.5" in height

Orientation (direction)

NE to SW

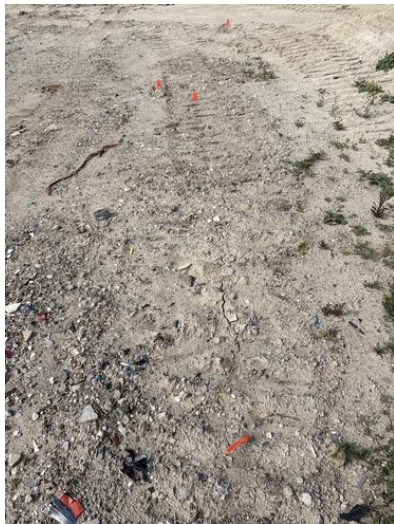
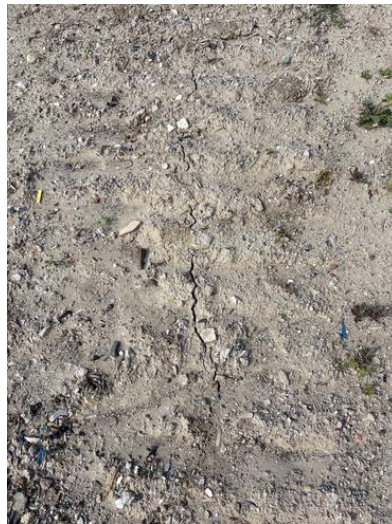
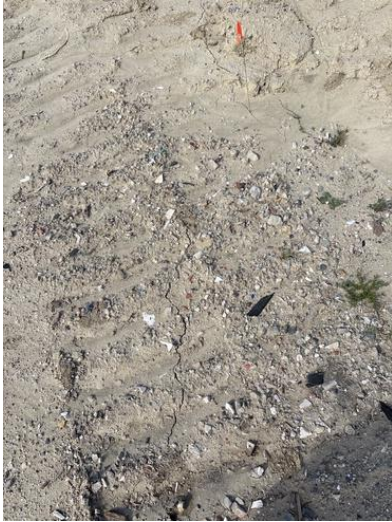
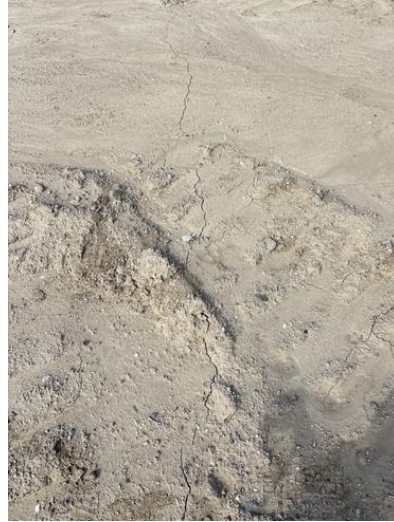
163

Length of crack (ft) or area containing multiple cracks (ft x ft) 2ft x 30ft

Horizontal Offset (width) Extra Small <0.5 in width

Vertical Offset (height) Extra small <0.5" in height

Orientation (direction) NE to SW

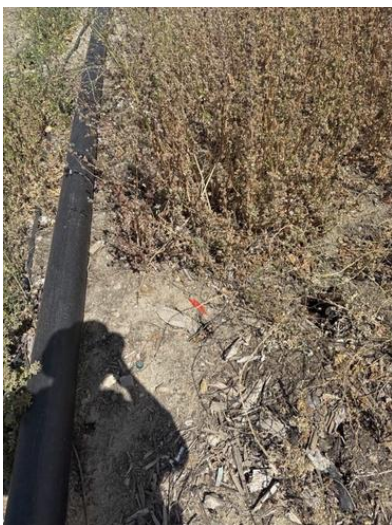
Photo 1

164

Length of crack (ft) or area containing multiple cracks (ft x ft)

1ft

Horizontal Offset (width)	Extra Small <0.5 in width
Vertical Offset (height)	Extra small <0.5" in height
Orientation (direction)	NW to SE
Location	Castaic CA 91384 United States (34.432216752413396, -118.64826043605439)
Was Fissure or Crack fixed? If yes, add photo and description of repairs performed	Yes
