CHIQUITA CANYON
A Waste Connections Company

April 1, 2026

**Subject: Leachate Spill Report
Chiquita Canyon Landfill
File No. 67-020**

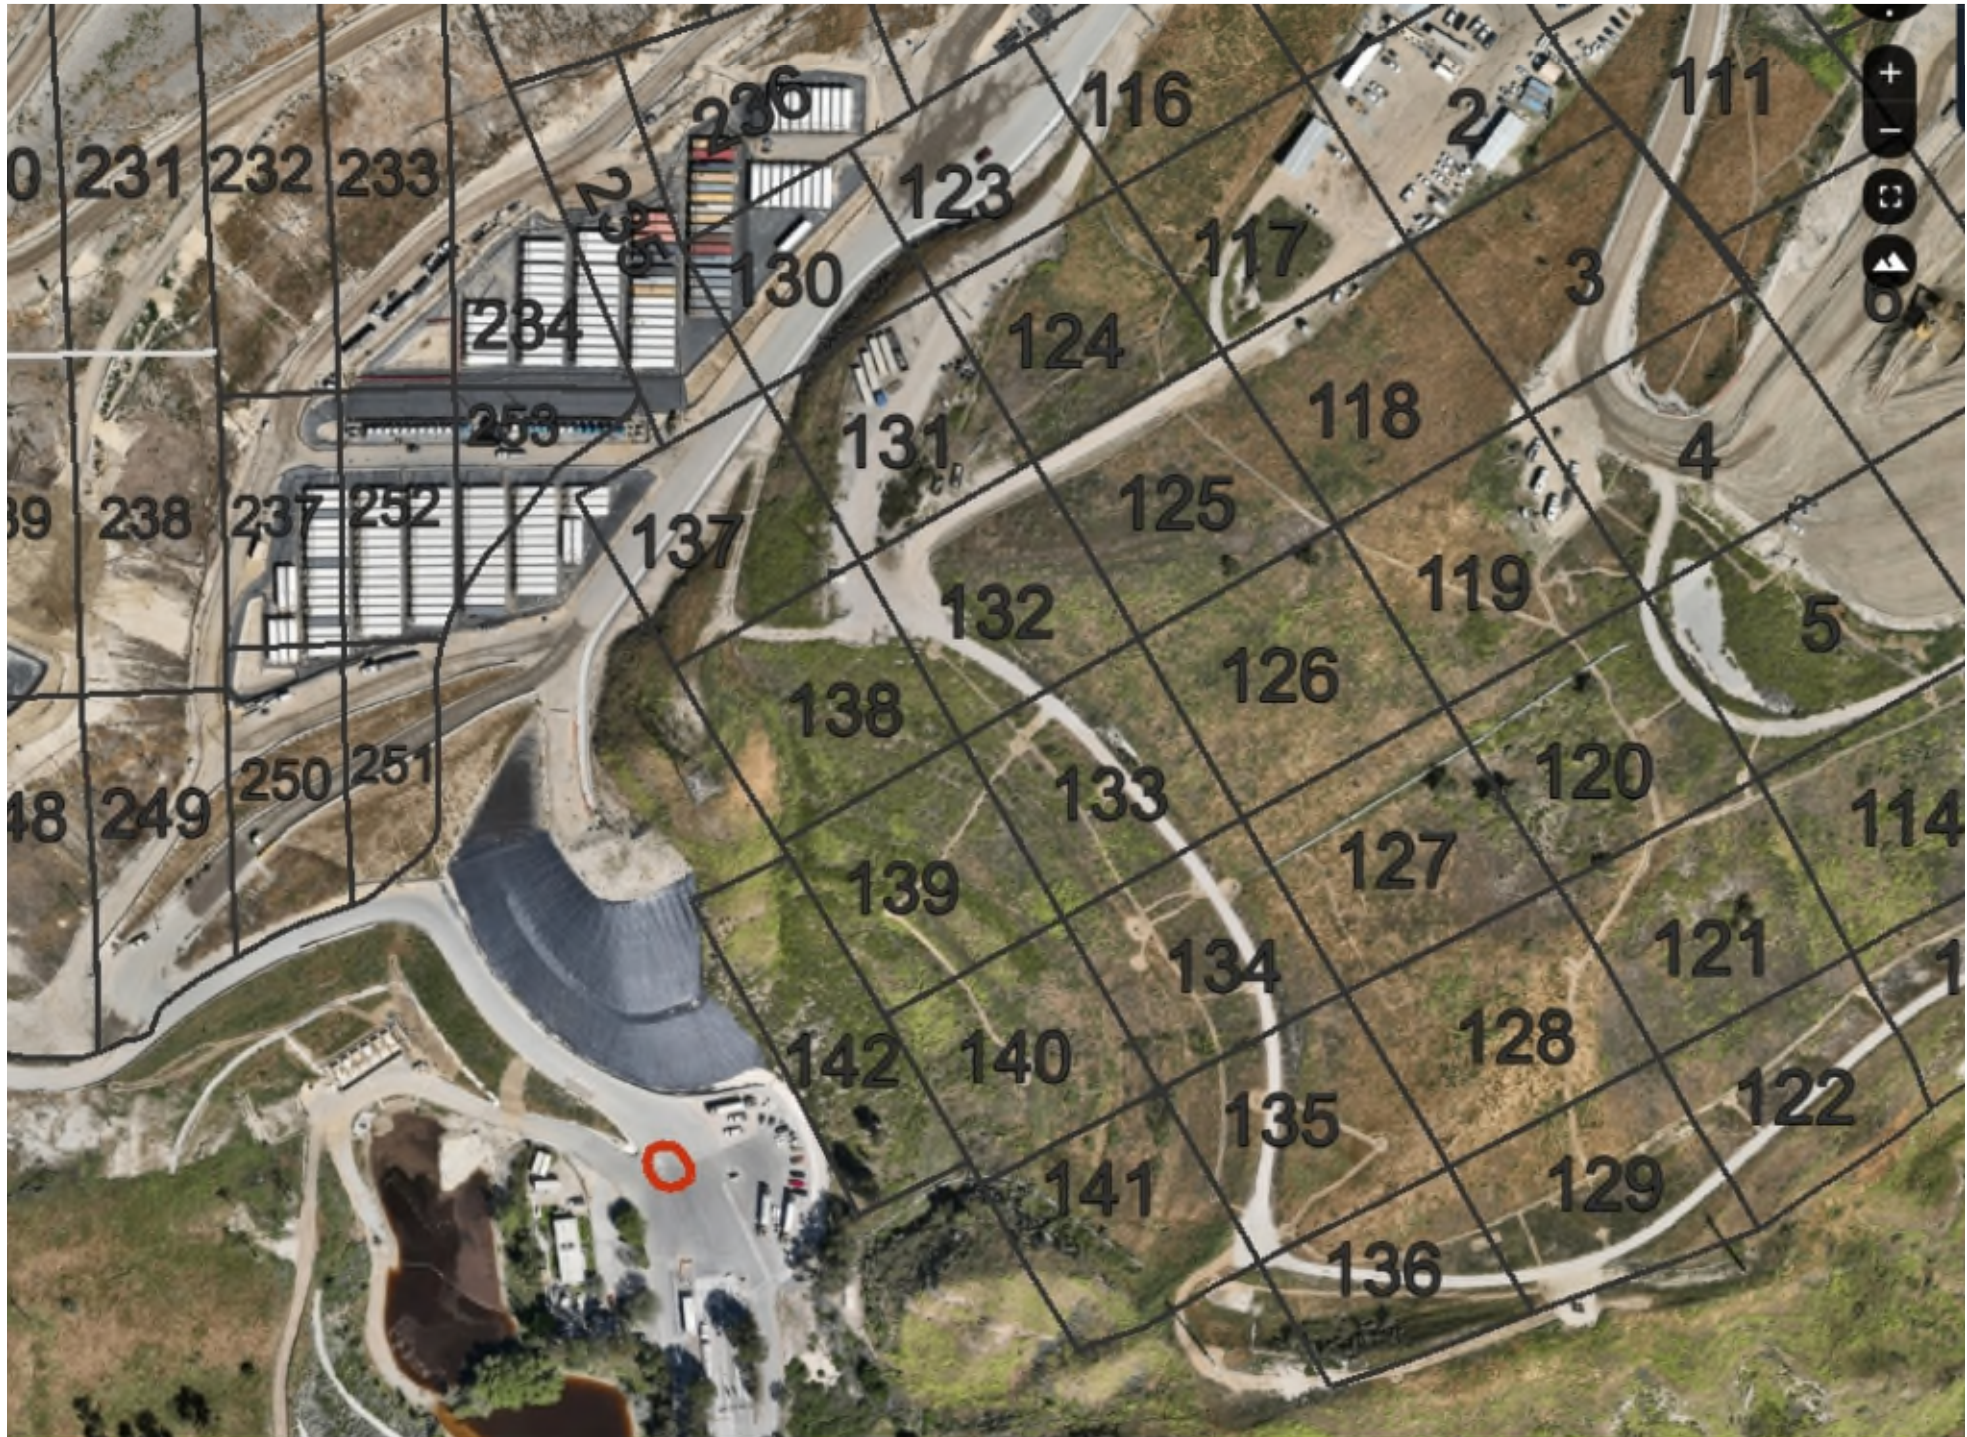
Attachment A – Map depicting the location of the spill

The spill occurred near the spill house– as depicted in **Attachment A**.

At approximately 10:45 a.m. on March 25, 2026, a spill of characteristically non-hazardous leachate was discovered near the scale house. No liquid was actively flowing when the spill was discovered. Chiquita has been unable to definitively determine the cause of this spill; however, Chiquita believes a third-party driver inadvertently left a scrubber valve on their tanker truck open, causing the small amount of liquid to spill. Only trucks carrying characteristically non-hazardous leachate were known to be in the area during the applicable time frame. Chiquita attributes this

spill to third-party driver error. The liquid was dark brown in color, with a low viscosity, and had a very low flow rate.

Upon discovering the spill, Chiquita promptly applied absorbent to the affected area. Chiquita then removed the soiled absorbent and placed it into a container for proper disposal. Cleanup commenced immediately and was completed within approximately 10 minutes. Chiquita reminded the foreman of the third-party driver's company of the need for situational awareness and to use best efforts to ensure that valves are closed prior to tanker trucks departing tank farms. Chiquita has confirmed that the company has retrained its drivers.
