Re: Chiquita Canyon, LLC's Weekly Leachate Inspection Report for Stipulated Order for Abatement (Case No. 6177-4), Condition 27(c)

Attachment: Leachate Inspection Logs from March 30 – April 5, 2026

4050 - Chiquita Leachate Seep/Pooling Inspection

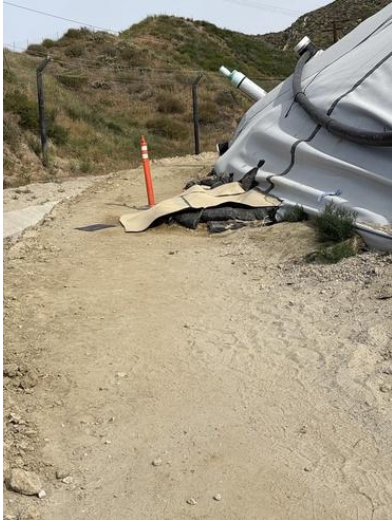
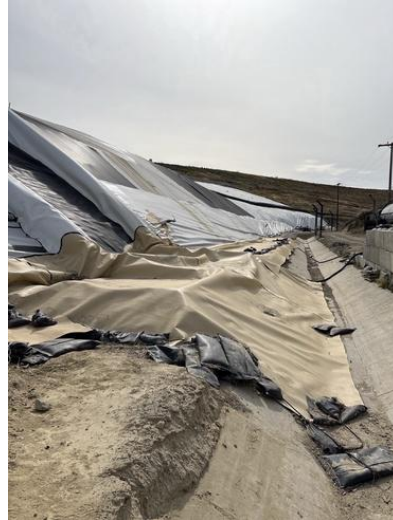
Westside perimeter road. None of the seeps that occurred in this area were observed at the time of this inspection. Area continues to be monitored and vacuumed out as needed to prevent pooling

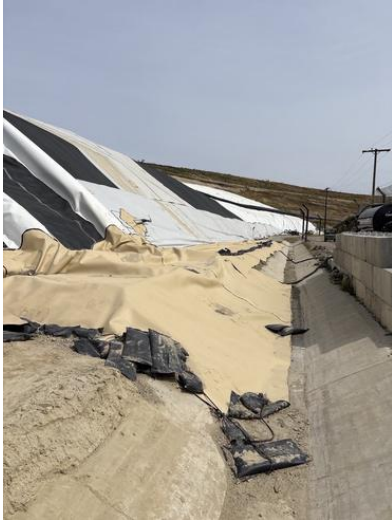
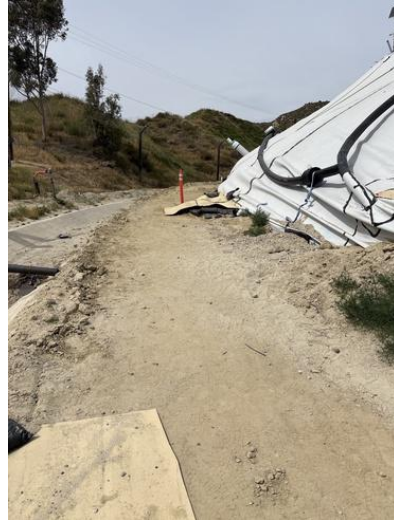
Westside perimeter road. None of the seeps that occurred in this area were observed at the time of this inspection. Area continues to be monitored and vacuumed out as needed to prevent pooling.

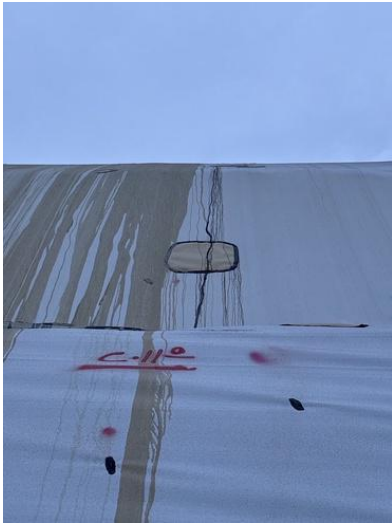
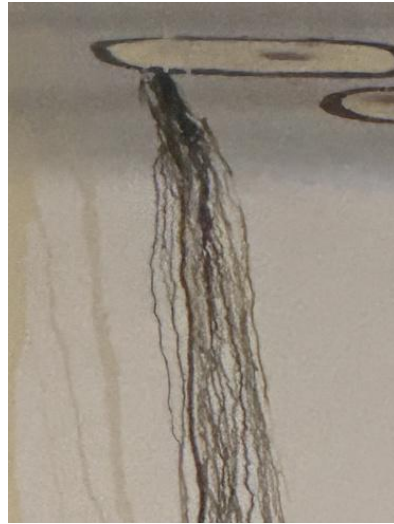
Leachate did not reach soil and was not actively coming from the failed weld. It was "semi-dry" on the liner upon observation.

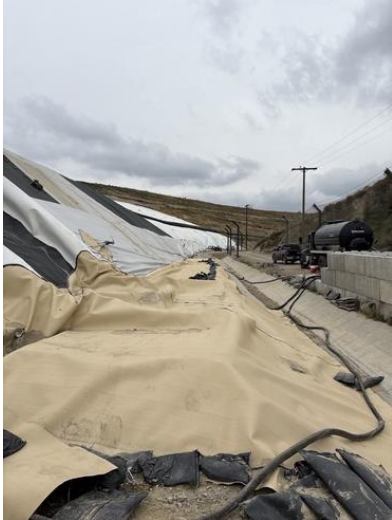
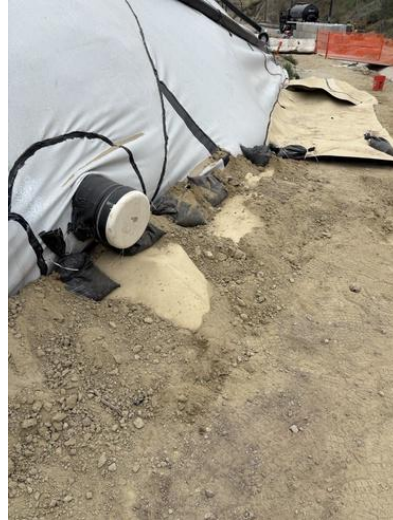
Westside perimeter road. A seep was observed in grid 207 following the morning inspection and was corrected. Neither this seep nor any of the other seeps in this area were observed during this inspection. The area continues to be monitored and vacuumed as needed to prevent pooling.

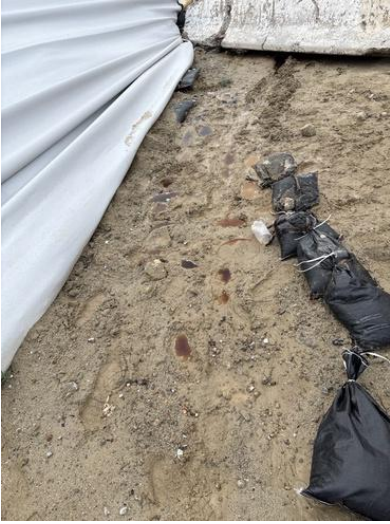
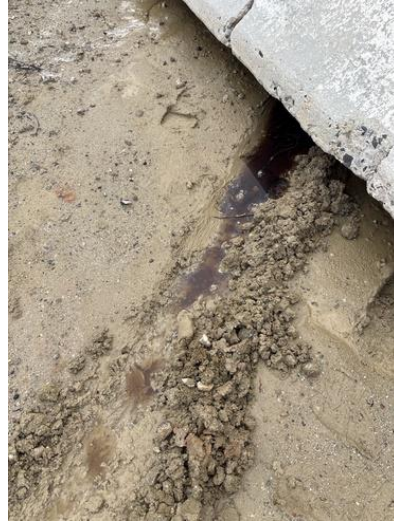
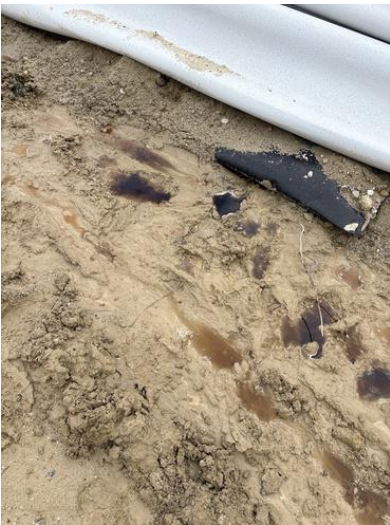
45 sq ft

4 - Strong Odor

Standing free liquid

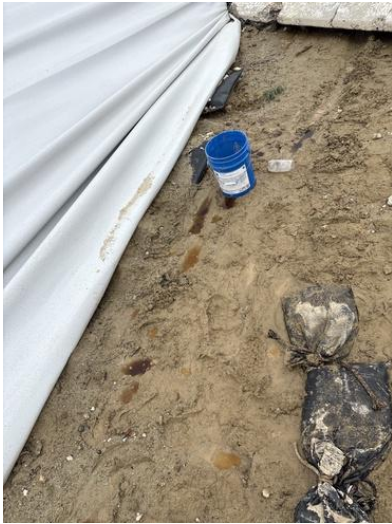
Photo 1

3 - Moderate Odor

Standing free liquid

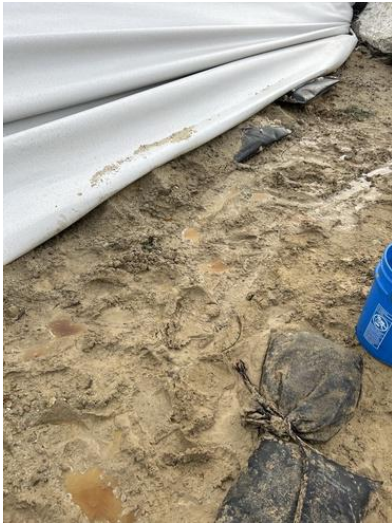
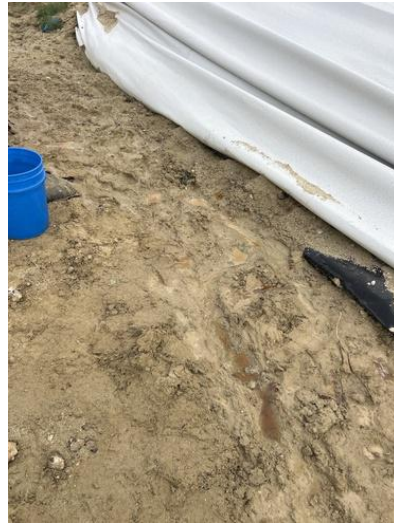
3 - Moderate Odor

Standing free liquid

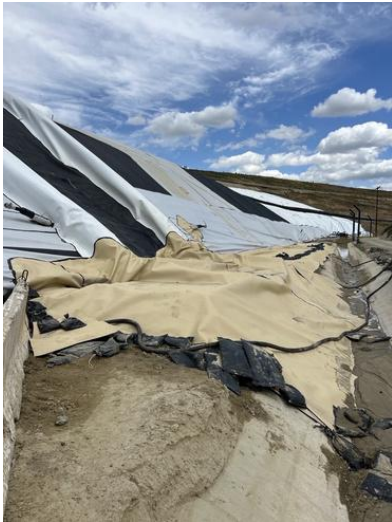
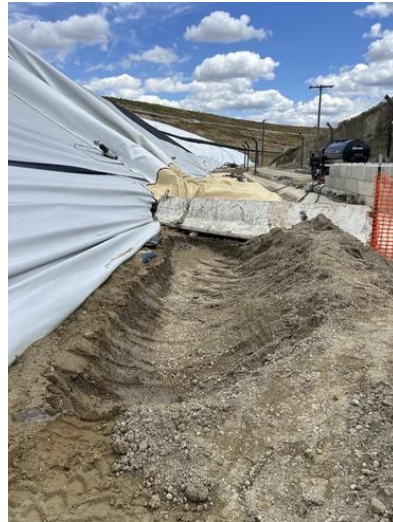
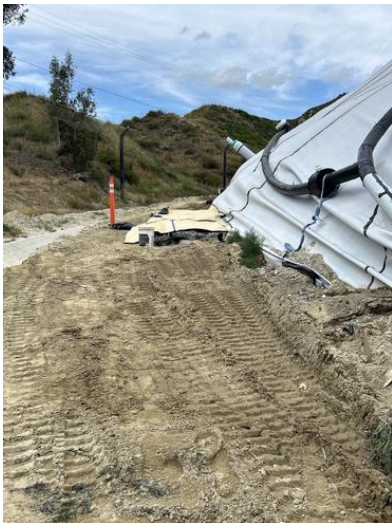
Westside perimeter road. None of the seeps that occurred in this area were observed at the time of this inspection. Area continues to be monitored and vacuumed out as needed to prevent pooling.

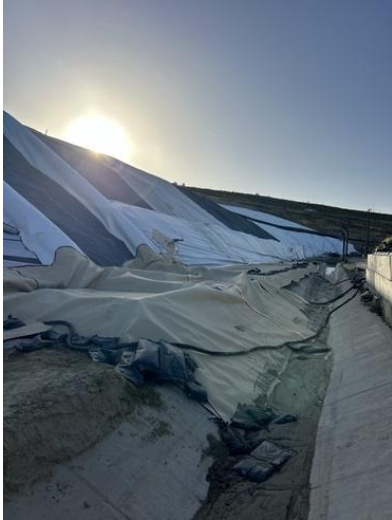
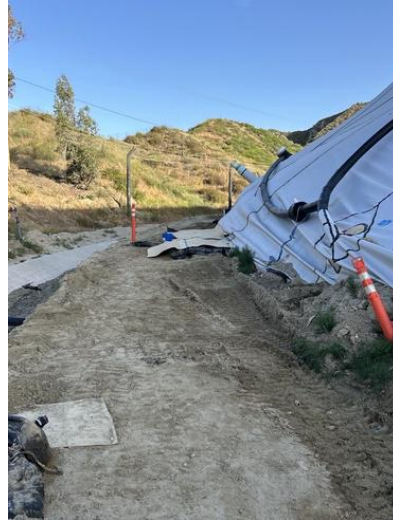
Westside perimeter road. None of the seeps that occurred in this area were observed at the time of this inspection. Area continues to be monitored and vacuumed out as needed to prevent pooling.

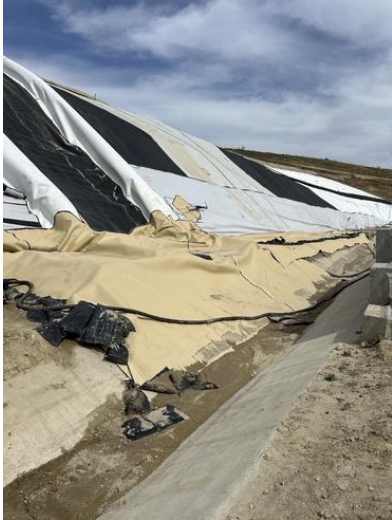
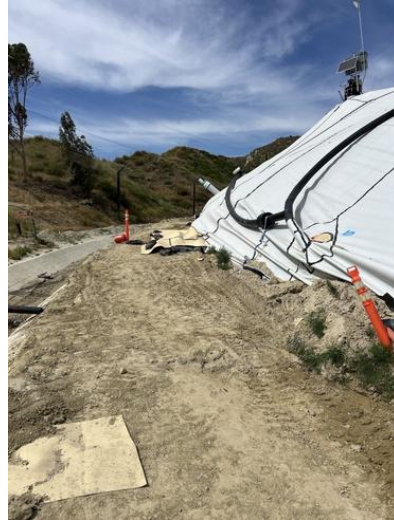
Westside perimeter road. None of the seeps that occurred in this area were observed at the time of this inspection. Area continues to be monitored and vacuumed out as needed to prevent pooling.

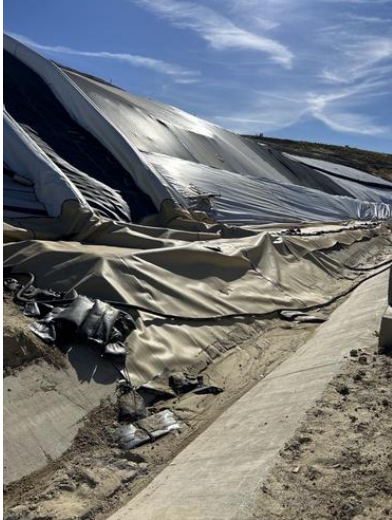
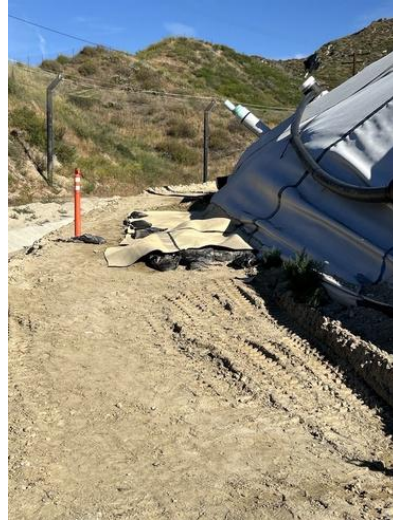
Westside perimeter road. None of the seeps that occurred in this area were observed at the time of this inspection. Area continues to be monitored and vacuumed out as needed to prevent pooling.

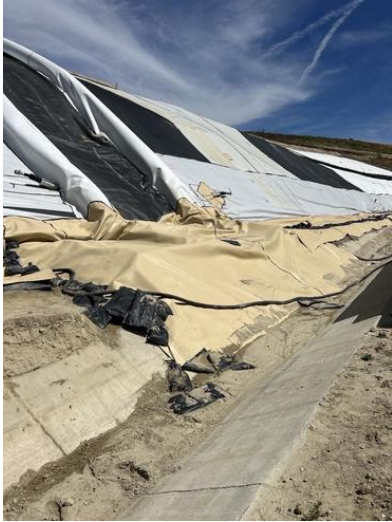
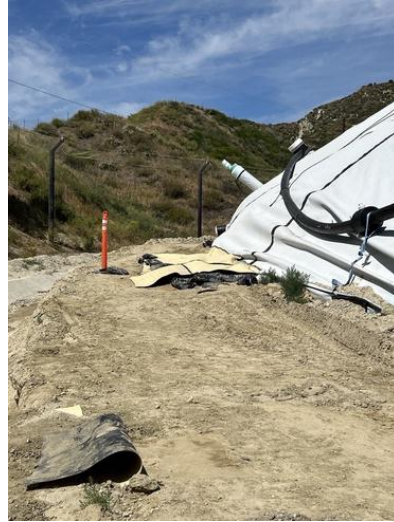
Westside perimeter road. None of the seeps that occurred in this area were observed at the time of this inspection. Area continues to be monitored and vacuumed out as needed to prevent pooling.

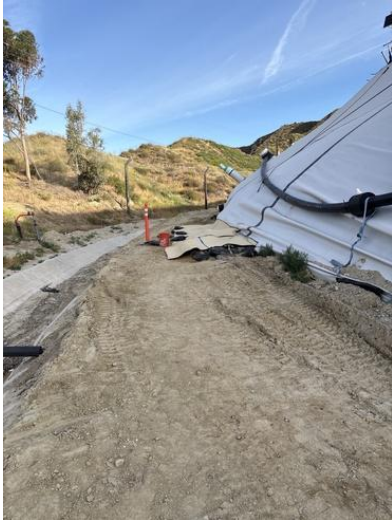
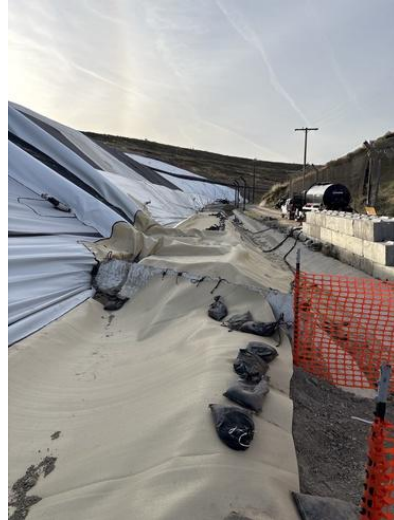
Westside perimeter road. None of the seeps that occurred in this area were observed at the time of this inspection. Area continues to be monitored and vacuumed out as needed to prevent pooling.

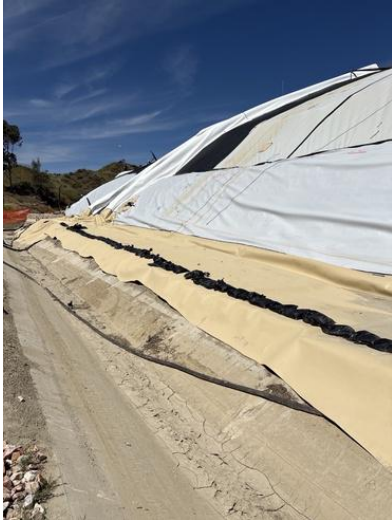
Photo 1

Westside perimeter road. None of the seeps that occurred in this area were observed at the time of this inspection. Area continues to be monitored and vacuumed out as needed to prevent pooling.
