**Re: Chiquita Canyon, LLC's Weekly Report on the Documentation and Tracking of Cover Issues**

In accordance with the Local Enforcement Agency's ("LEA") May 2, 2024 letter approving Chiquita's April 16, 2024 Second Revised Written Plan for Documenting and Tracking Cover Issues ("Second Revised Written Plan"), the LEA's May 29, 2024 letter, and the LEA's June 6, 2024 Compliance Order, Chiquita presents the enclosed report for documenting and tracking cover issues for the week of March 30, 2026 to April 4, 2026.

# 4050 - Chiquita Reaction Area Tracking of Fissures and Tension Cracks

# 4050 - Geosynthetic Cover Inspection

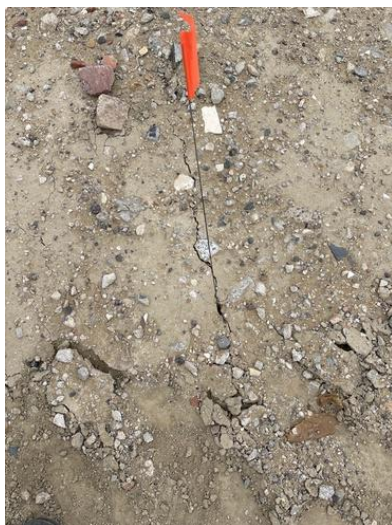
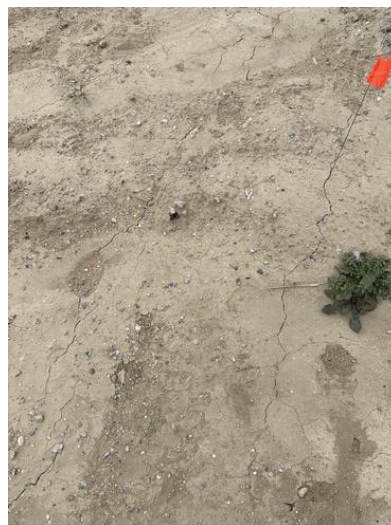
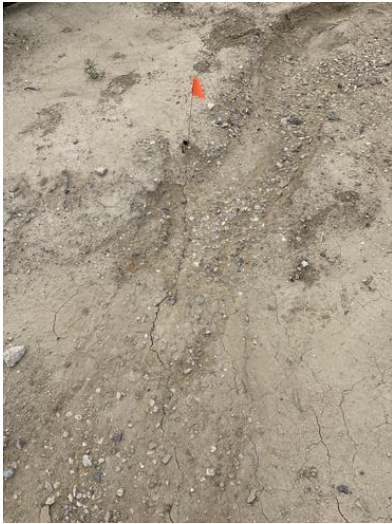
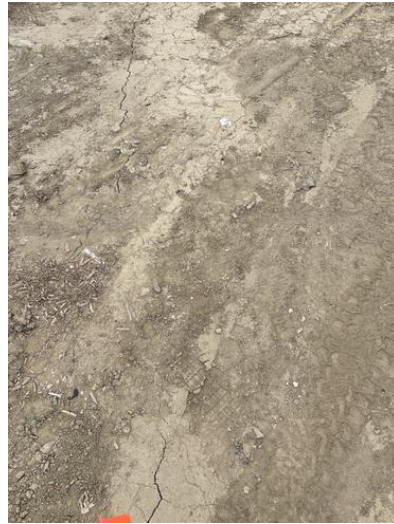
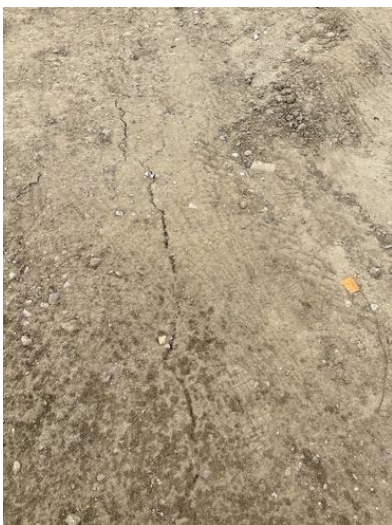
Yes

163

Crossed in to grid 160

175ft x 35ft

No individual crack 50ft or longer.

Small 0.5-2" in width

Extra small <0.5" in height

N to S

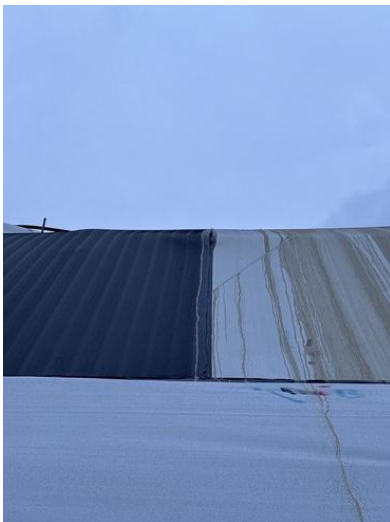
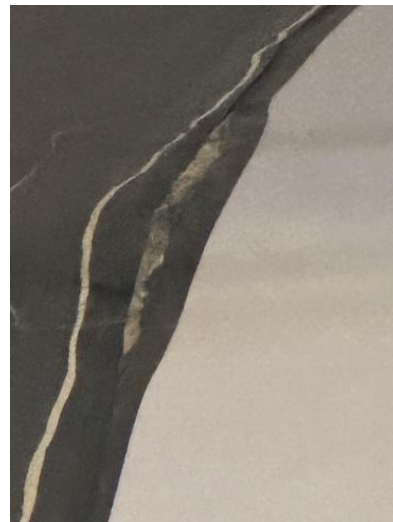
208

Tear in seam of liner. Needs to be patched/extrusion welded.

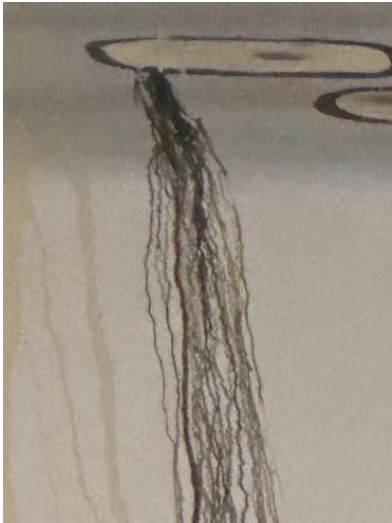
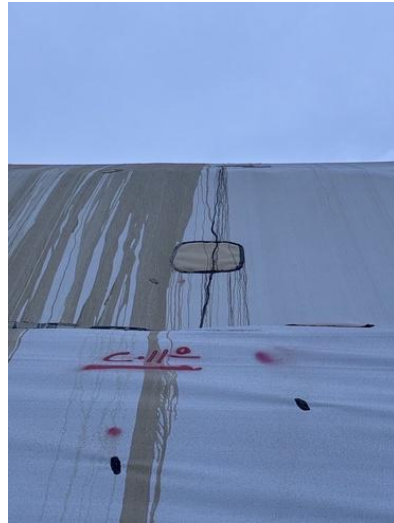
208

Weld on a previous patch failed and needs to be patched and extrusion welded.

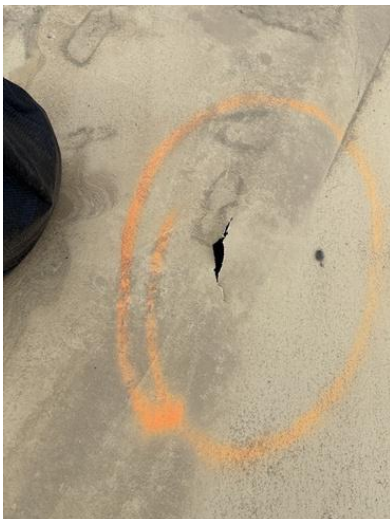
Photo 1

32

Tear in liner needs to be patched/extrusion welded.

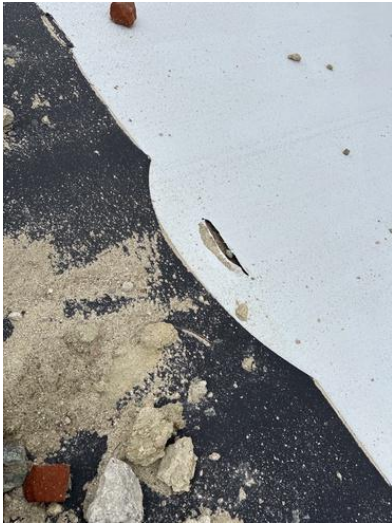
Photo 4

208

Tear in liner needs to be patched/extrusion welded.
