Re: Chiquita Canyon, LLC's Weekly Report on the Documentation and Tracking of Cover Issues, Monthly Summary and Monthly Isopach Map

4050 - Chiquita Reaction Area Tracking of Fissures and Tension Cracks

MARCH 2026 FISSURE AND TENSION CRACK MONITORING SUMMARY
CHIQUITA CANYON LANDFILL
CASTAIC, CALIFORNIA

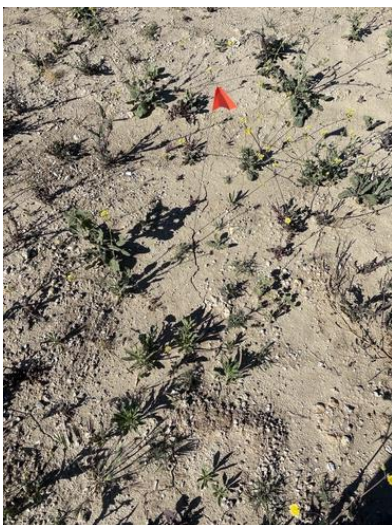
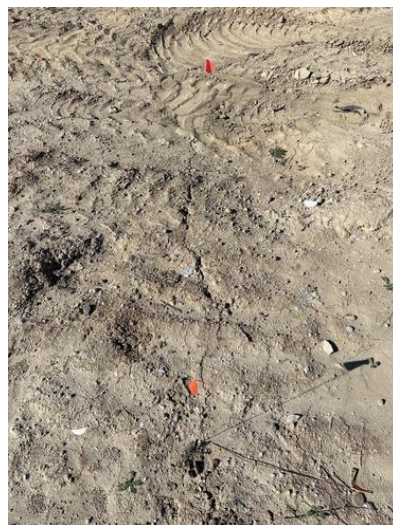
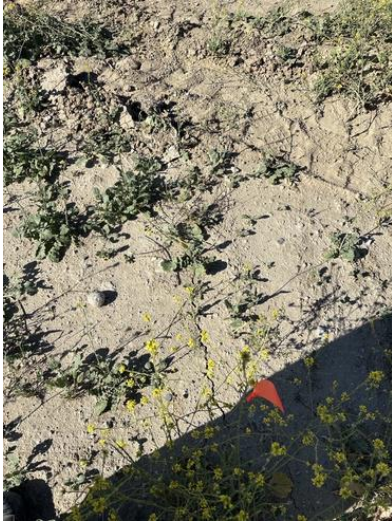
Length of crack (ft) or area containing multiple cracks (ft x ft) 15ft x 40ft

Horizontal Offset (width) Small 0.5-2" in width

Vertical Offset (height) Extra small <0.5" in height

Orientation (direction) NE to SW

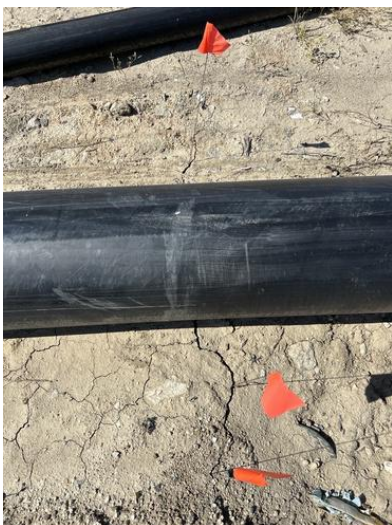
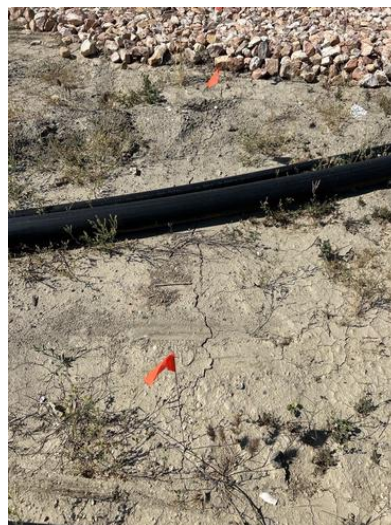
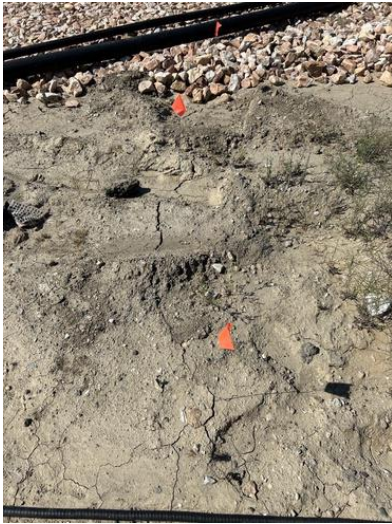
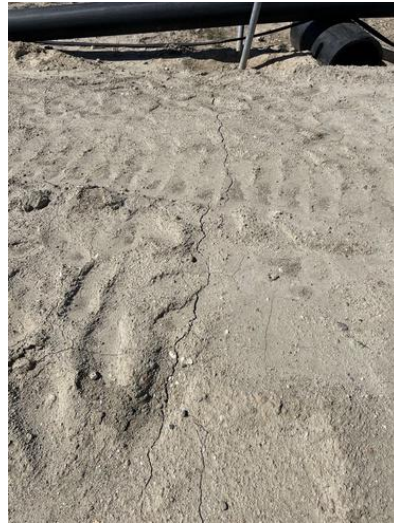
23ft x 25ft area

Extra Small <0.5 in width

Extra small <0.5" in height

NE to SW

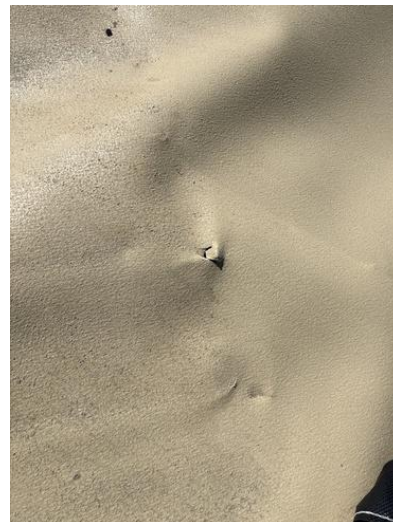
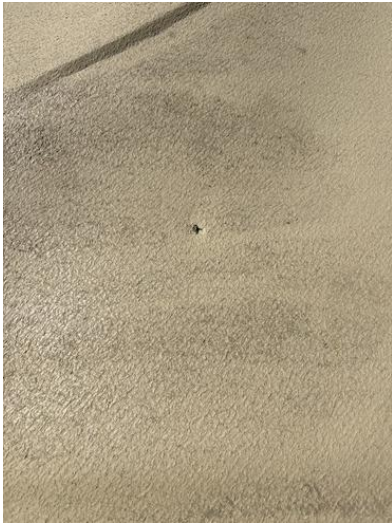
Three holes in close proximity in liner need to be patched/extrusion welded.

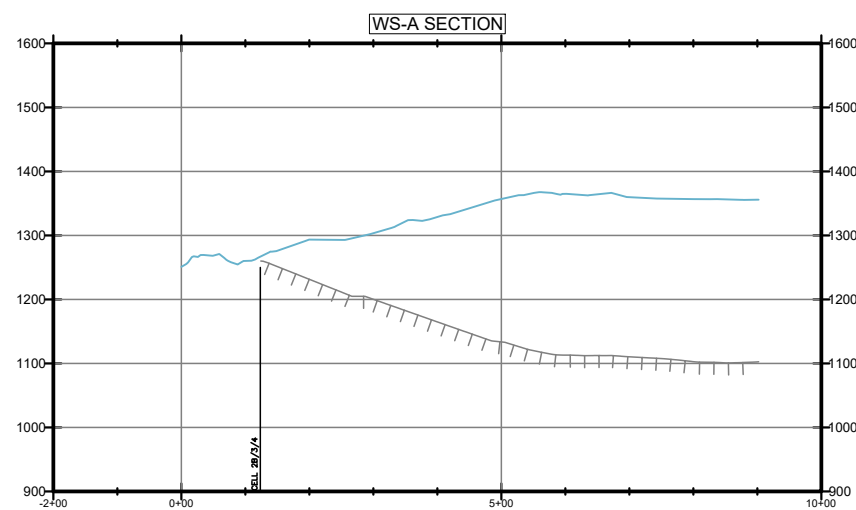
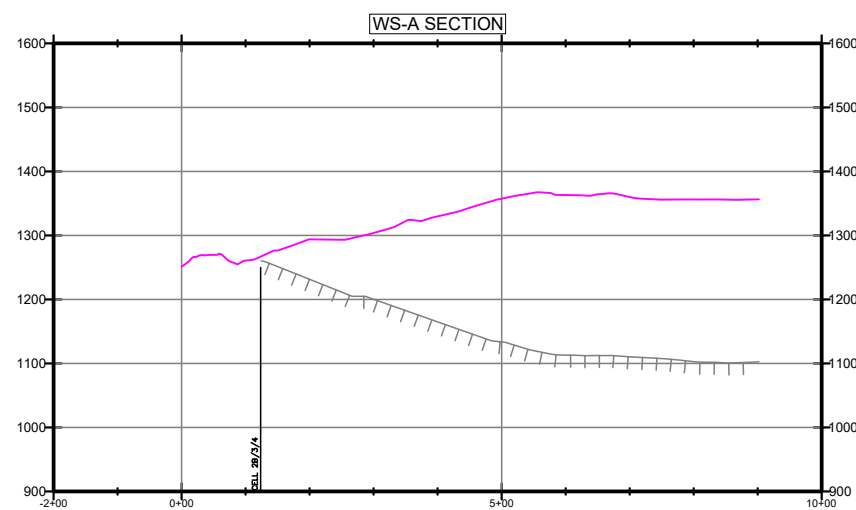
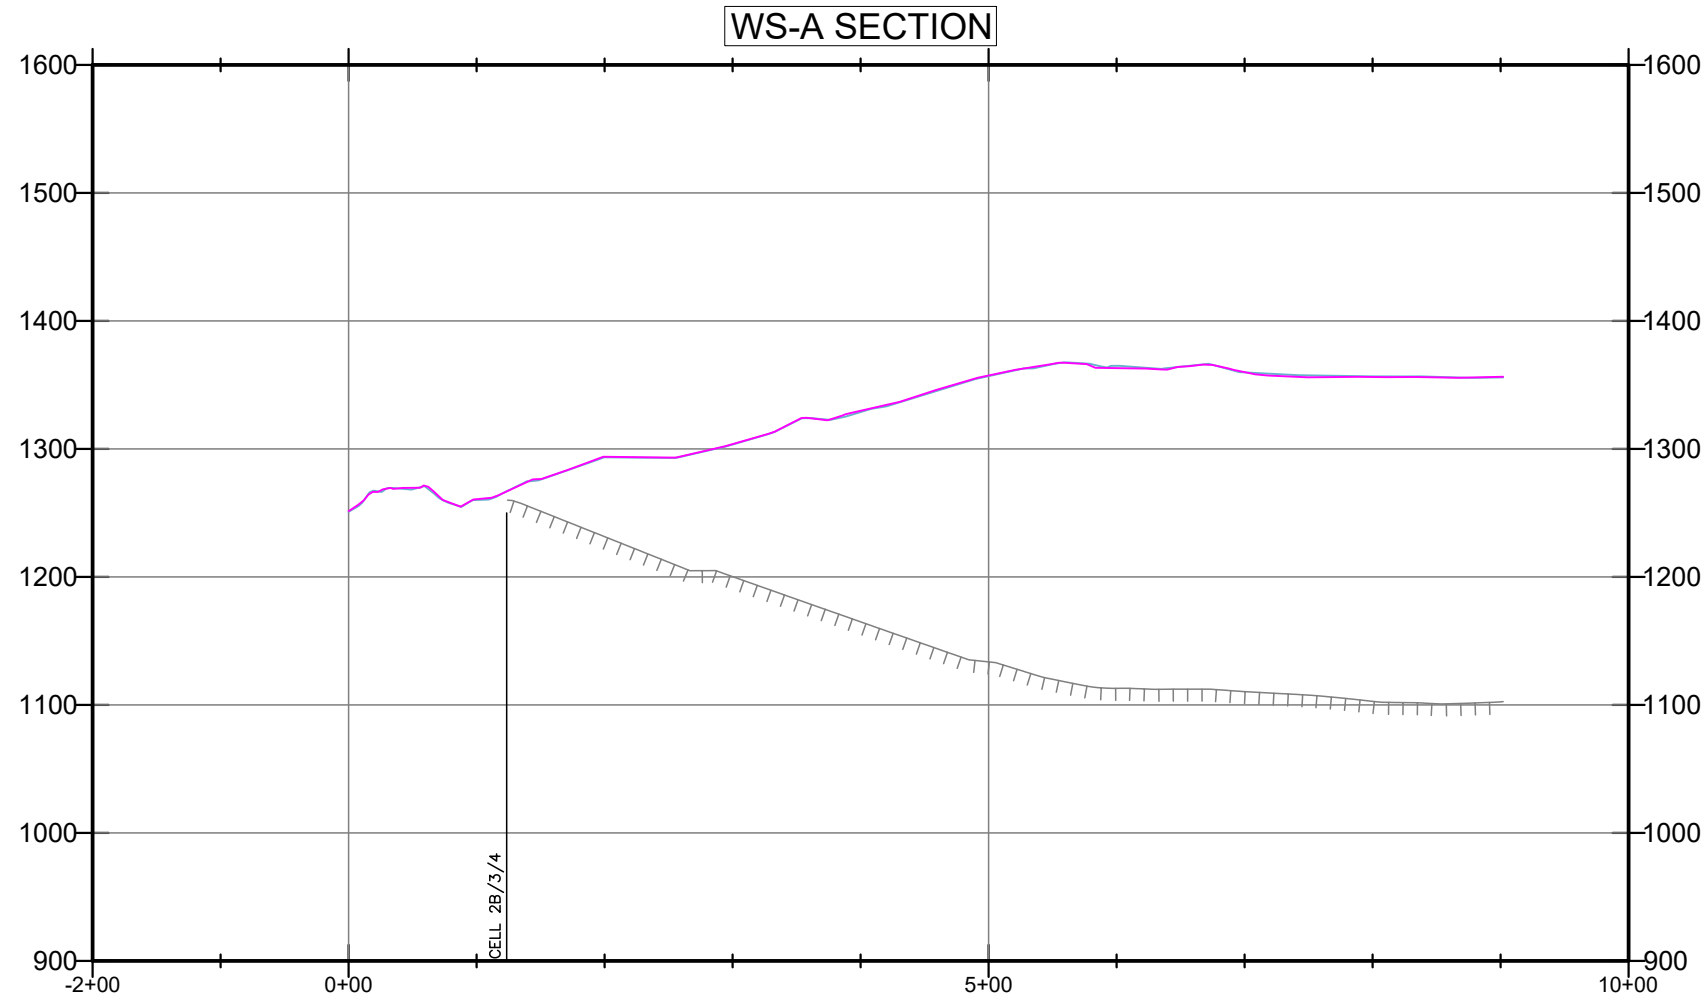
FIGURE 2A

All the cracks identified in Table 1 were repaired. Cross sections that compare February 25, 2026 and March 25, 2026 topography are shown in Figures 2A through 2E. The locations of these cross sections are shown in Figure 1. The sections show no significant differences in slope or evidence of instability between the February 2026 and March 2026 profiles, which is consistent with the observational records summarized in Tables 1 and 2.
