April 14, 2026

Re: Chiquita Canyon, LLC's Weekly Leachate Inspection Report for Stipulated Order for Abatement (Case No. 6177-4), Condition 27(c)

4050 - Chiquita Leachate Seep/Pooling Inspection

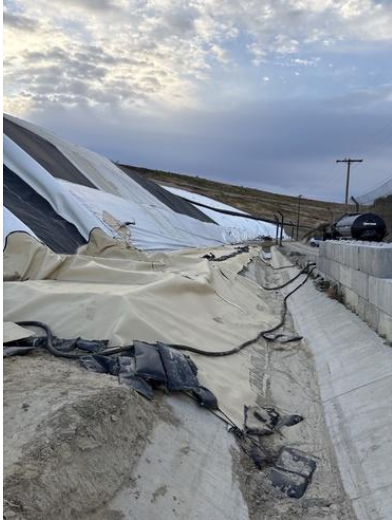
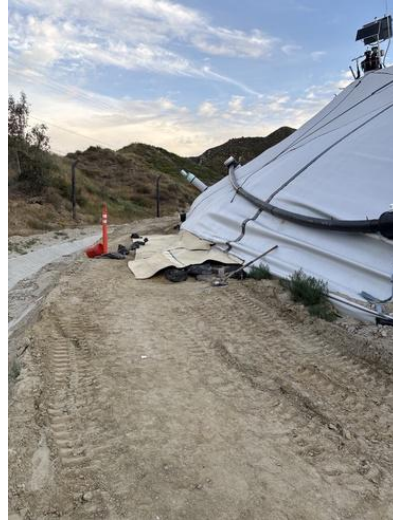
Westside perimeter road. None of the seeps that occurred in this area were observed at the time of this inspection. Area continues to be monitored and vacuumed out as needed to prevent pooling.

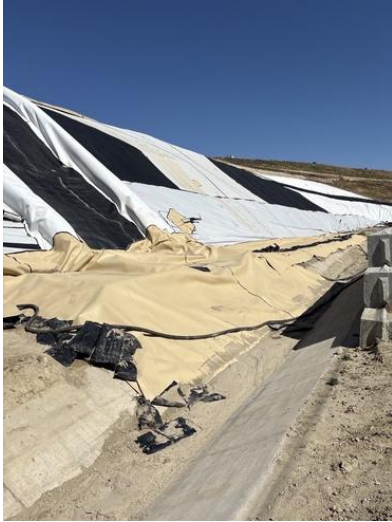
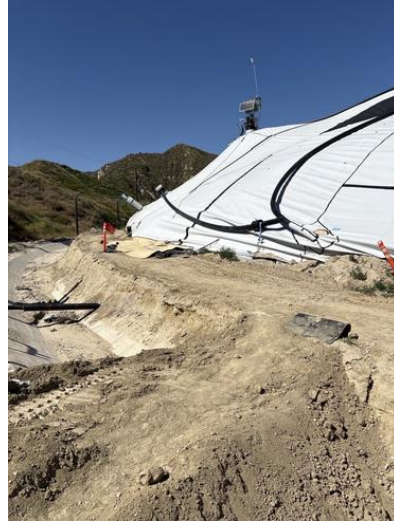
Westside perimeter road. None of the seeps that occurred in this area were observed at the time of this inspection. Area continues to be monitored and vacuumed out as needed to prevent pooling.

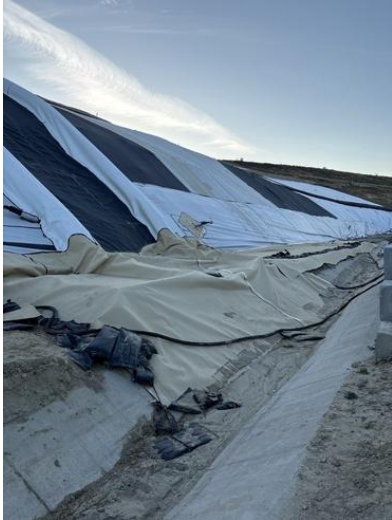
Photo 1

Westside perimeter road. None of the seeps that occurred in this area were observed at the time of this inspection. Area continues to be monitored and vacuumed out as needed to prevent pooling.

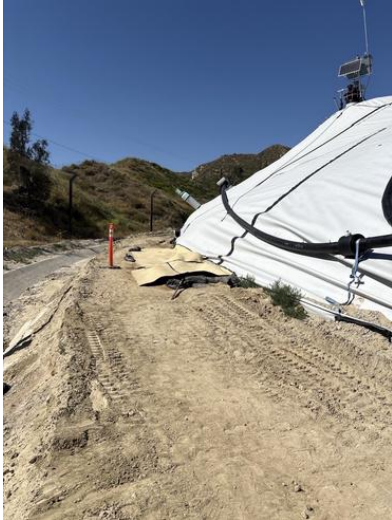
Photo 1

Westside perimeter road. None of the seeps that occurred in this area were observed at the time of this inspection. Area continues to be monitored and vacuumed out as needed to prevent pooling.

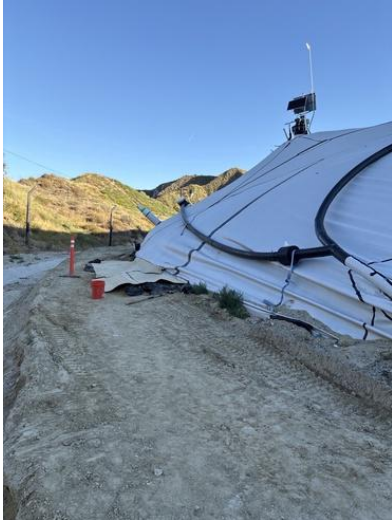
Photo 1

Westside perimeter road. None of the seeps that occurred in this area were observed at the time of this inspection. Area continues to be monitored and vacuumed out as needed to prevent pooling.

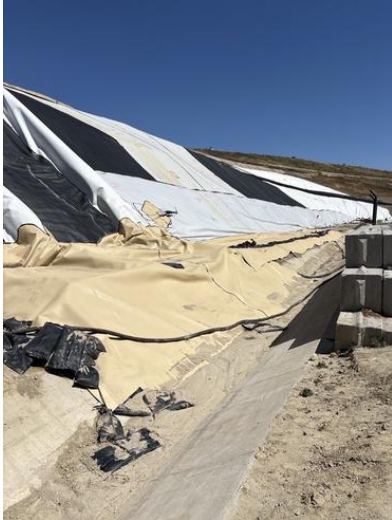
Photo 1

Westside perimeter road. None of the seeps that occurred in this area were observed at the time of this inspection. Area continues to be monitored and vacuumed out as needed to prevent pooling.

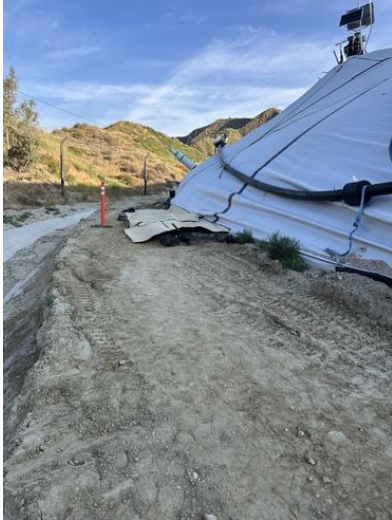
Photo 1

Westside perimeter road. None of the seeps that occurred in this area were observed at the time of this inspection. Area continues to be monitored and vacuumed out as needed to prevent pooling.

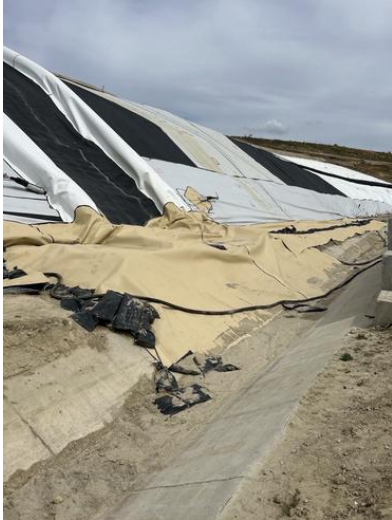
Photo 1

Westside perimeter road. None of the seeps that occurred in this area were observed at the time of this inspection. Area continues to be monitored and vacuumed out as needed to prevent pooling.

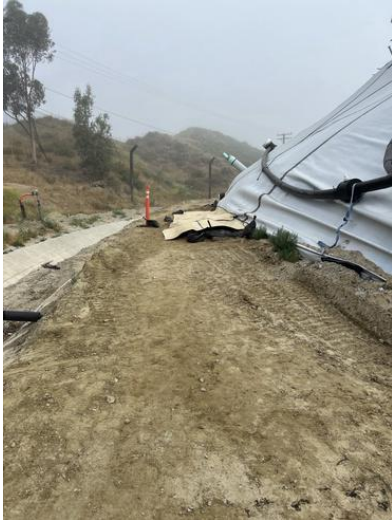
Photo 1

Westside perimeter road. None of the seeps that occurred in this area were observed at the time of this inspection. Area continues to be monitored and vacuumed out as needed to prevent pooling.

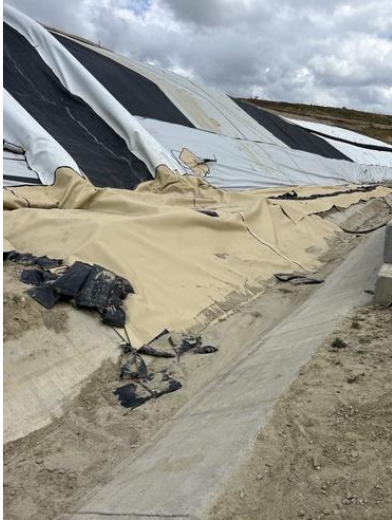
Photo 1

Westside perimeter road. None of the seeps that occurred in this area were observed at the time of this inspection. Area continues to be monitored and vacuumed out as needed to prevent pooling.

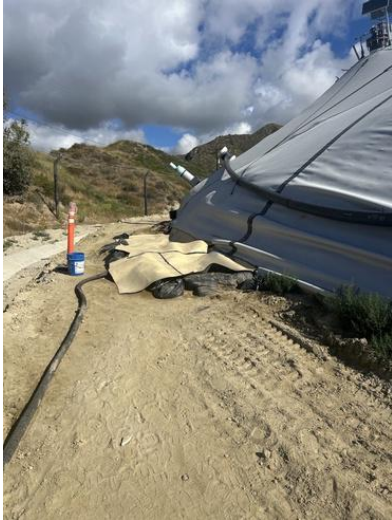
Photo 1

Westside perimeter road. None of the seeps that occurred in this area were observed at the time of this inspection. Area continues to be monitored and vacuumed out as needed to prevent pooling.

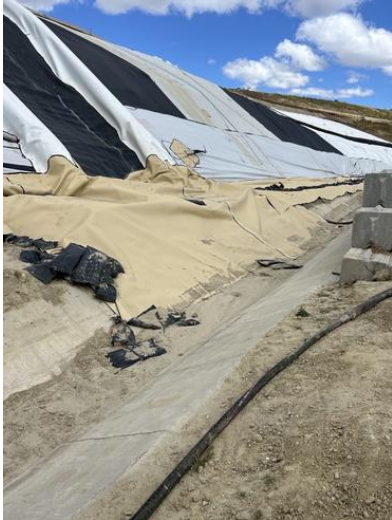
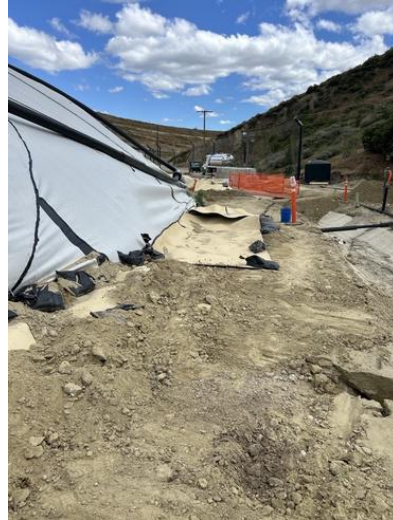
Westside perimeter road. None of the seeps that occurred in this area were observed at the time of this inspection. Area continues to be monitored and vacuumed out as needed to prevent pooling.

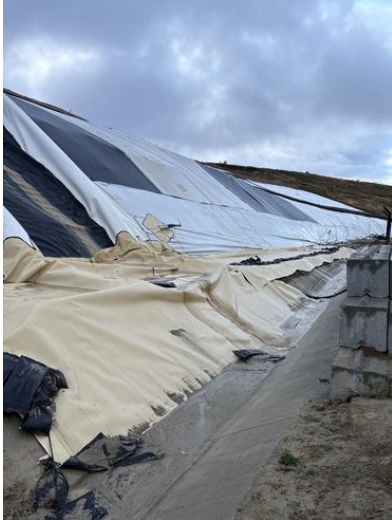
Photo 1

Westside perimeter road. None of the seeps that occurred in this area were observed at the time of this inspection. Area continues to be monitored and vacuumed out as needed to prevent pooling.

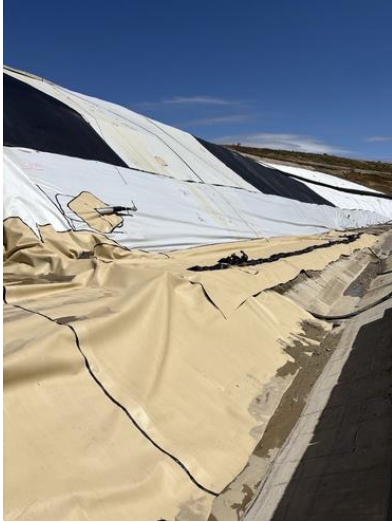
Photo 1

Westside perimeter road. None of the seeps that occurred in this area were observed at the time of this inspection. Area continues to be monitored and vacuumed out as needed to prevent pooling.
