CHIQUITA CANYON
A Waste Connections Company

Re: Chiquita Canyon, LLC's Weekly Report on the Documentation and Tracking of Cover Issues

Attachment: April 21, 2026 Weekly Cover Issues Report

4050 - Chiquita Reaction Area Tracking of Fissures and Tension Cracks

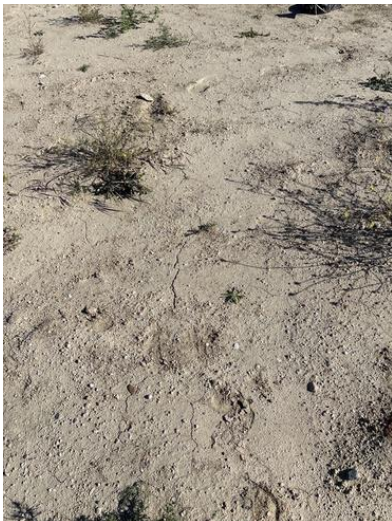
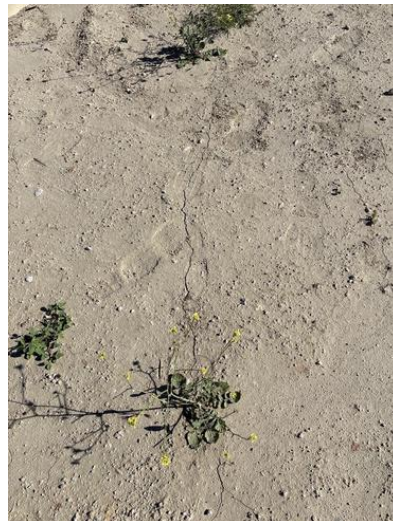
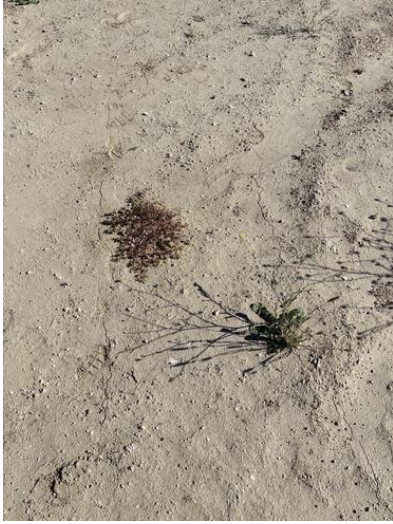
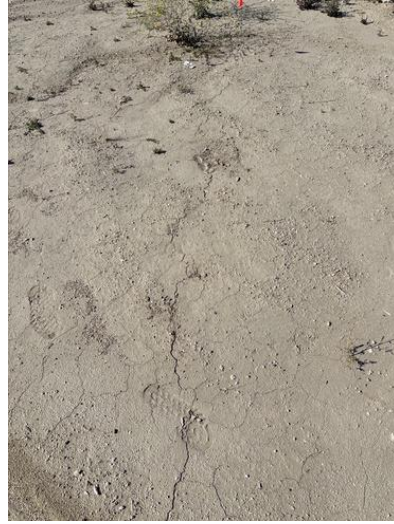
164

15ft x 65ft

No individual crack 50ft or longer

Extra Small <0.5 in width

Extra small <0.5" in height

N to S

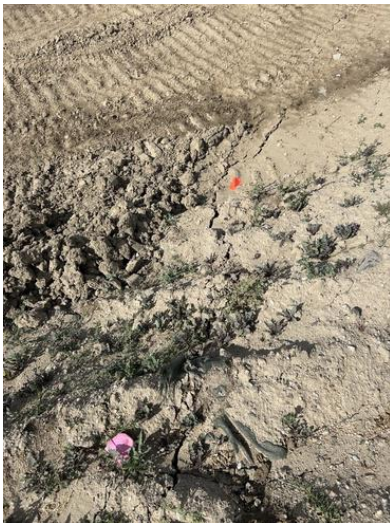
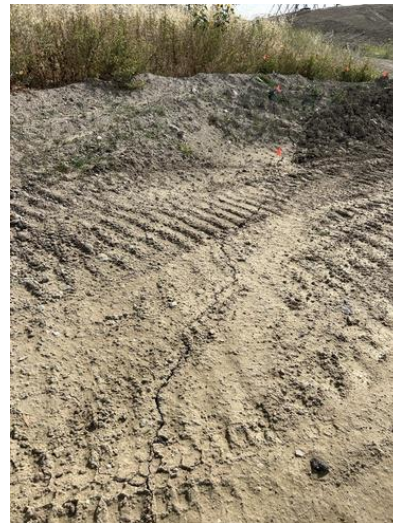
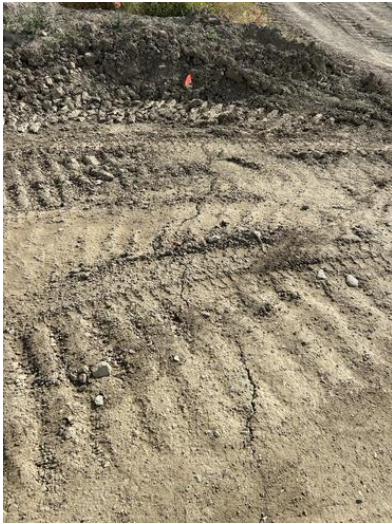
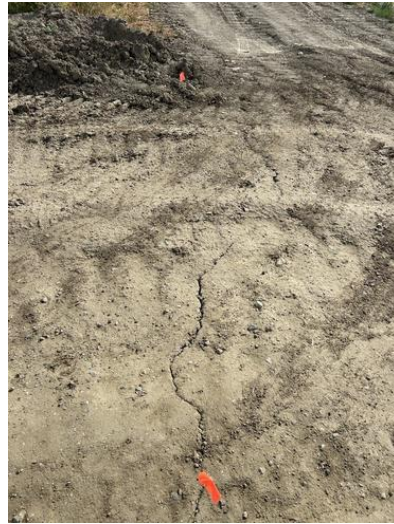
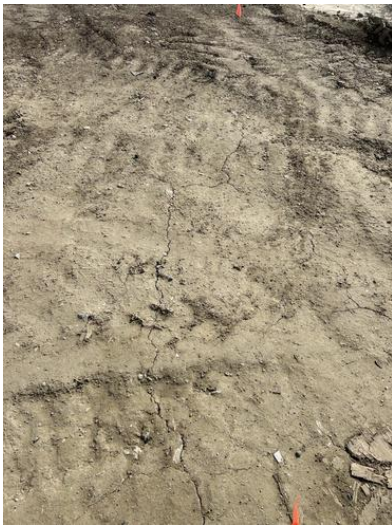
209

Length of crack (ft) or area containing multiple cracks (ft x ft)	25ft x 20ft area
Horizontal Offset (width)	Small 0.5-2" in width
Vertical Offset (height)	Extra small <0.5" in height
Orientation (direction)	E to W
Location	Castaic CA 91384 United States (34.43212343980033, -118.64906656703948)
Was Fissure or Crack fixed? If yes, add photo and description of repairs performed	Yes

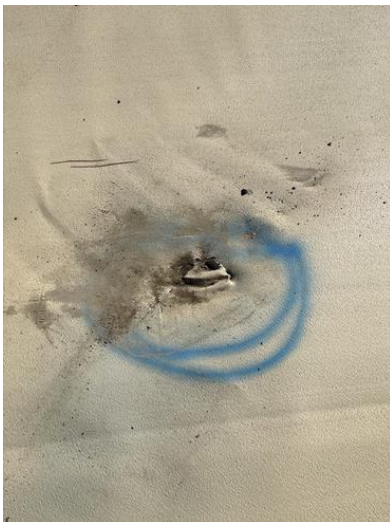
159

Tear in liner needs to be patched and extrusion welded.
