Re: Chiquita Canyon, LLC's Weekly Report on the Documentation and Tracking of Cover Issues

4050 - Chiquita Reaction Area Tracking of Fissures and Tension Cracks

4050 - Geosynthetic Cover Inspection

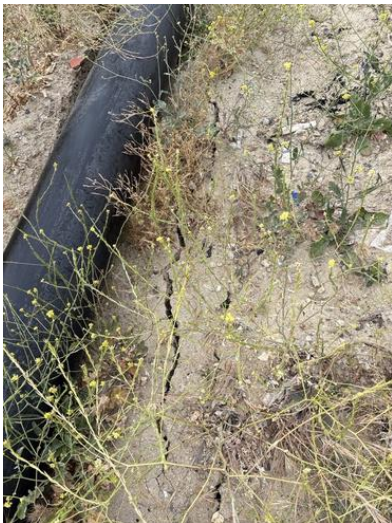
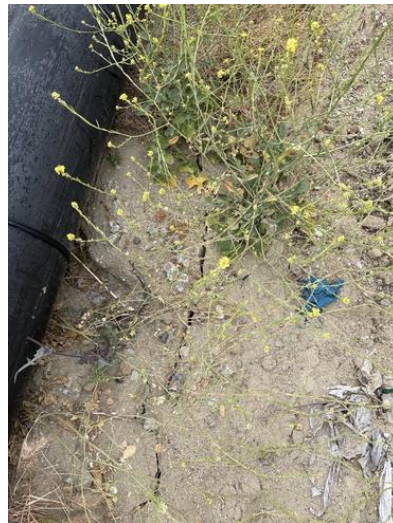
Length of crack (ft) or area containing multiple cracks (ft x ft)

15ft

| Horizontal Offset (width) | Small 0.5-2" in width |
| Vertical Offset (height) | Extra small <0.5" in height |
| Orientation (direction) | NE to SW |

| Crack was covered with dirt and compacted. | |

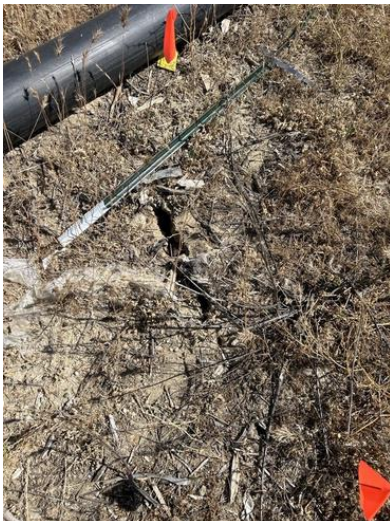
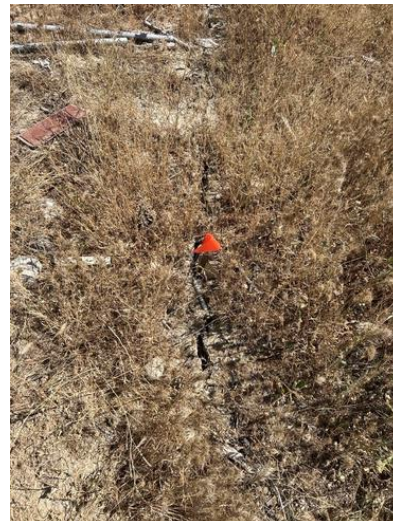
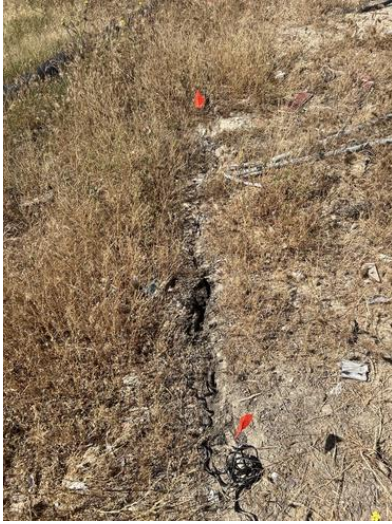
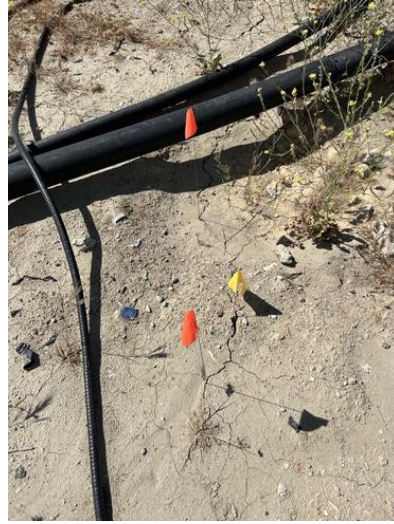
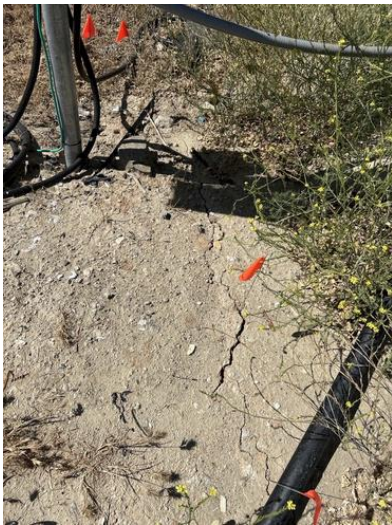
| Length of crack (ft) or area containing multiple cracks (ft x ft) | 15ft x 20ft area |
| Horizontal Offset (width) | Small 0.5-2" in width |
| Vertical Offset (height) | Extra small <0.5" in height |
| Orientation (direction) | NE to SW |

Shoveled and filled with dirt by hand

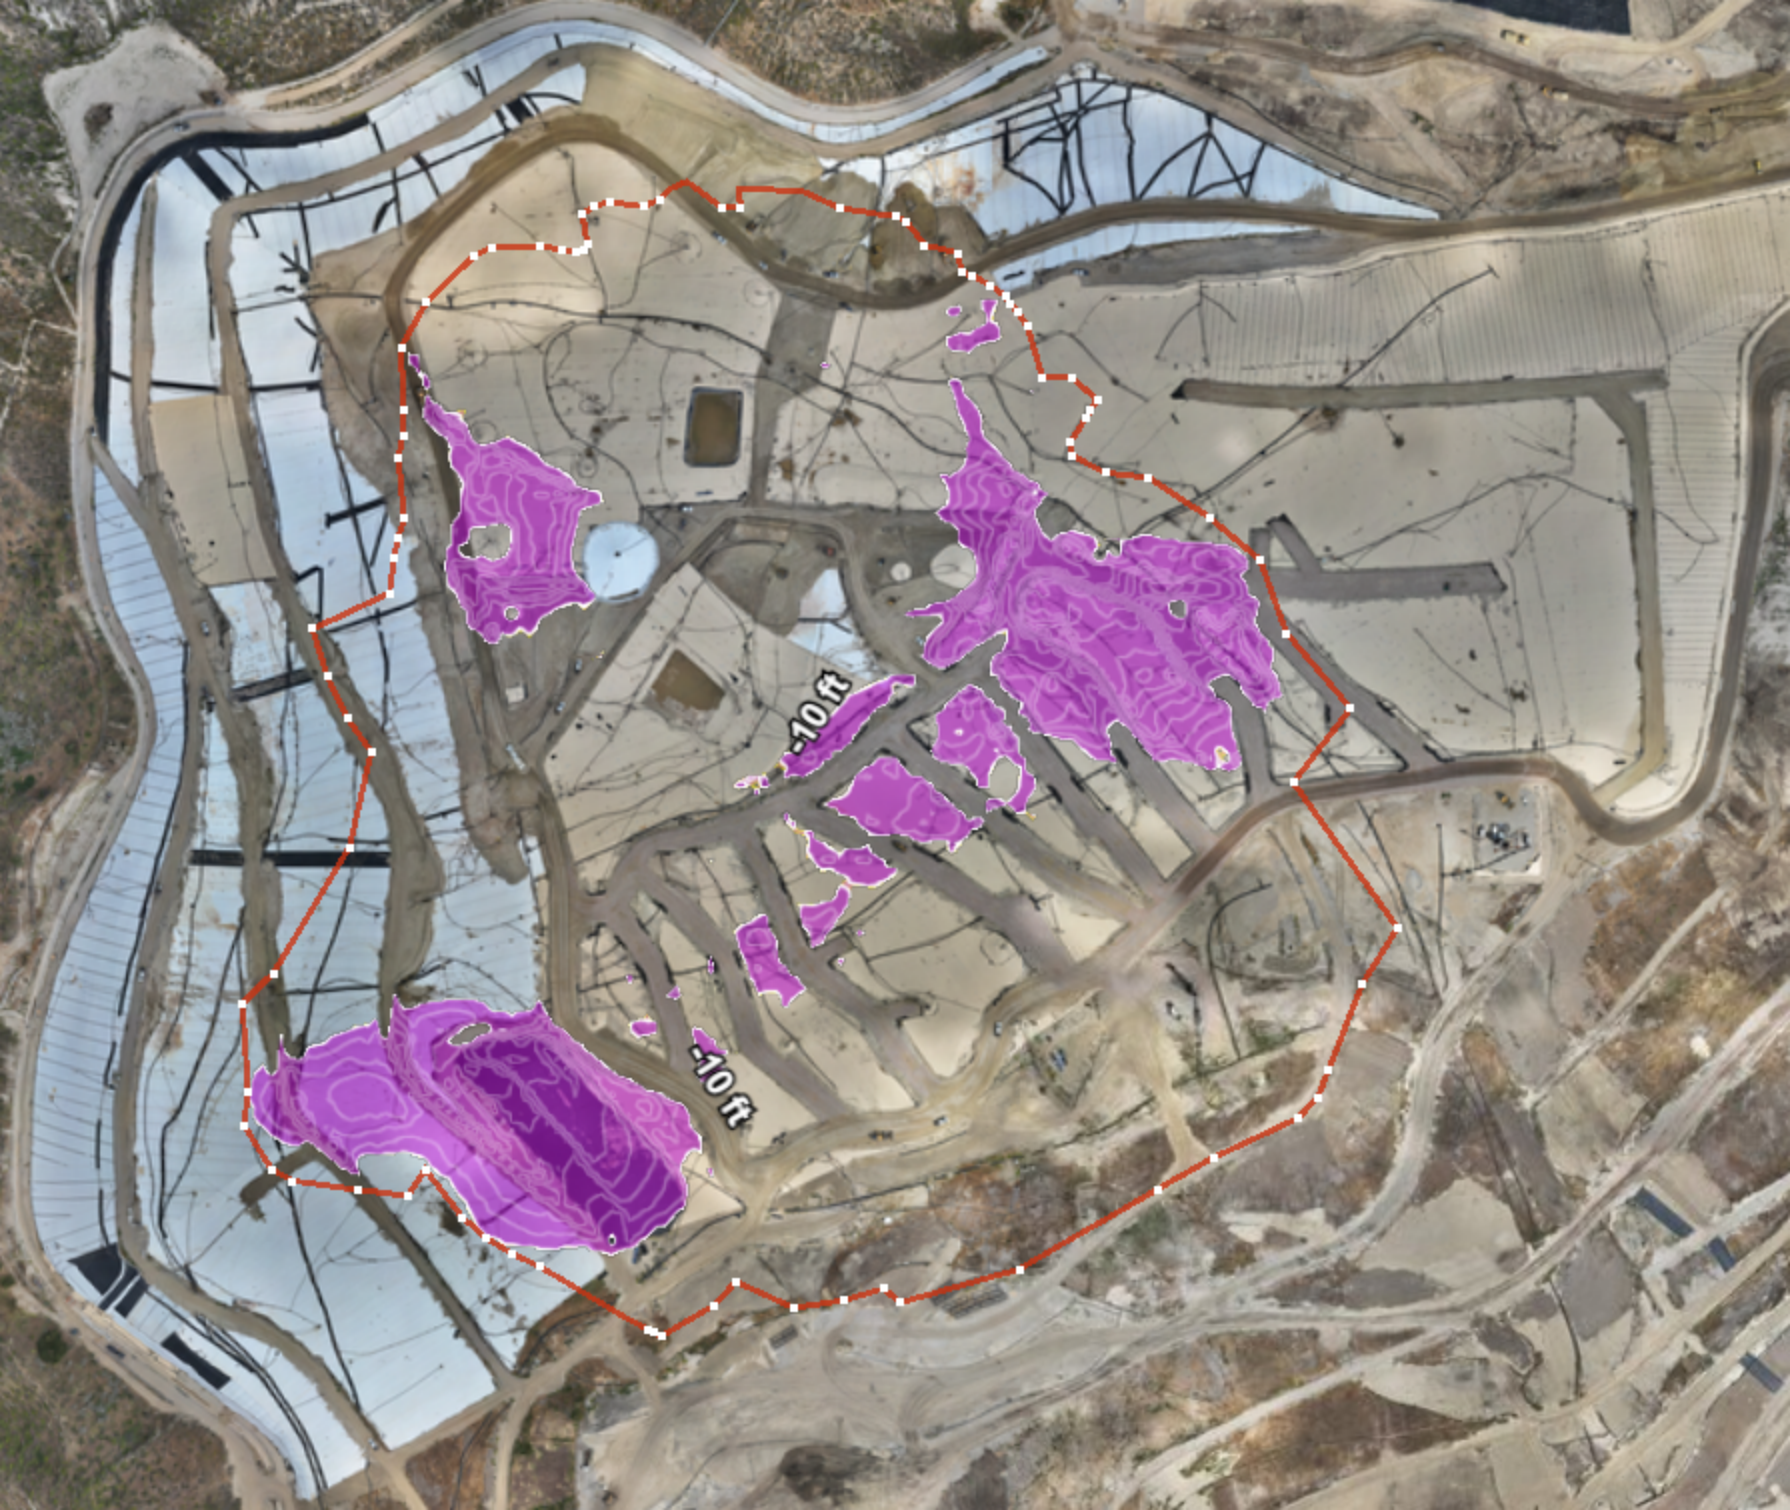
- The map shows the area between 4/23/2025 and 4/22/2026 where the grades have changed more than 10 feet. A typical MSW strain rate is 3% per year - for a landfill with a 300-foot waste column, this would be 9 feet per year.

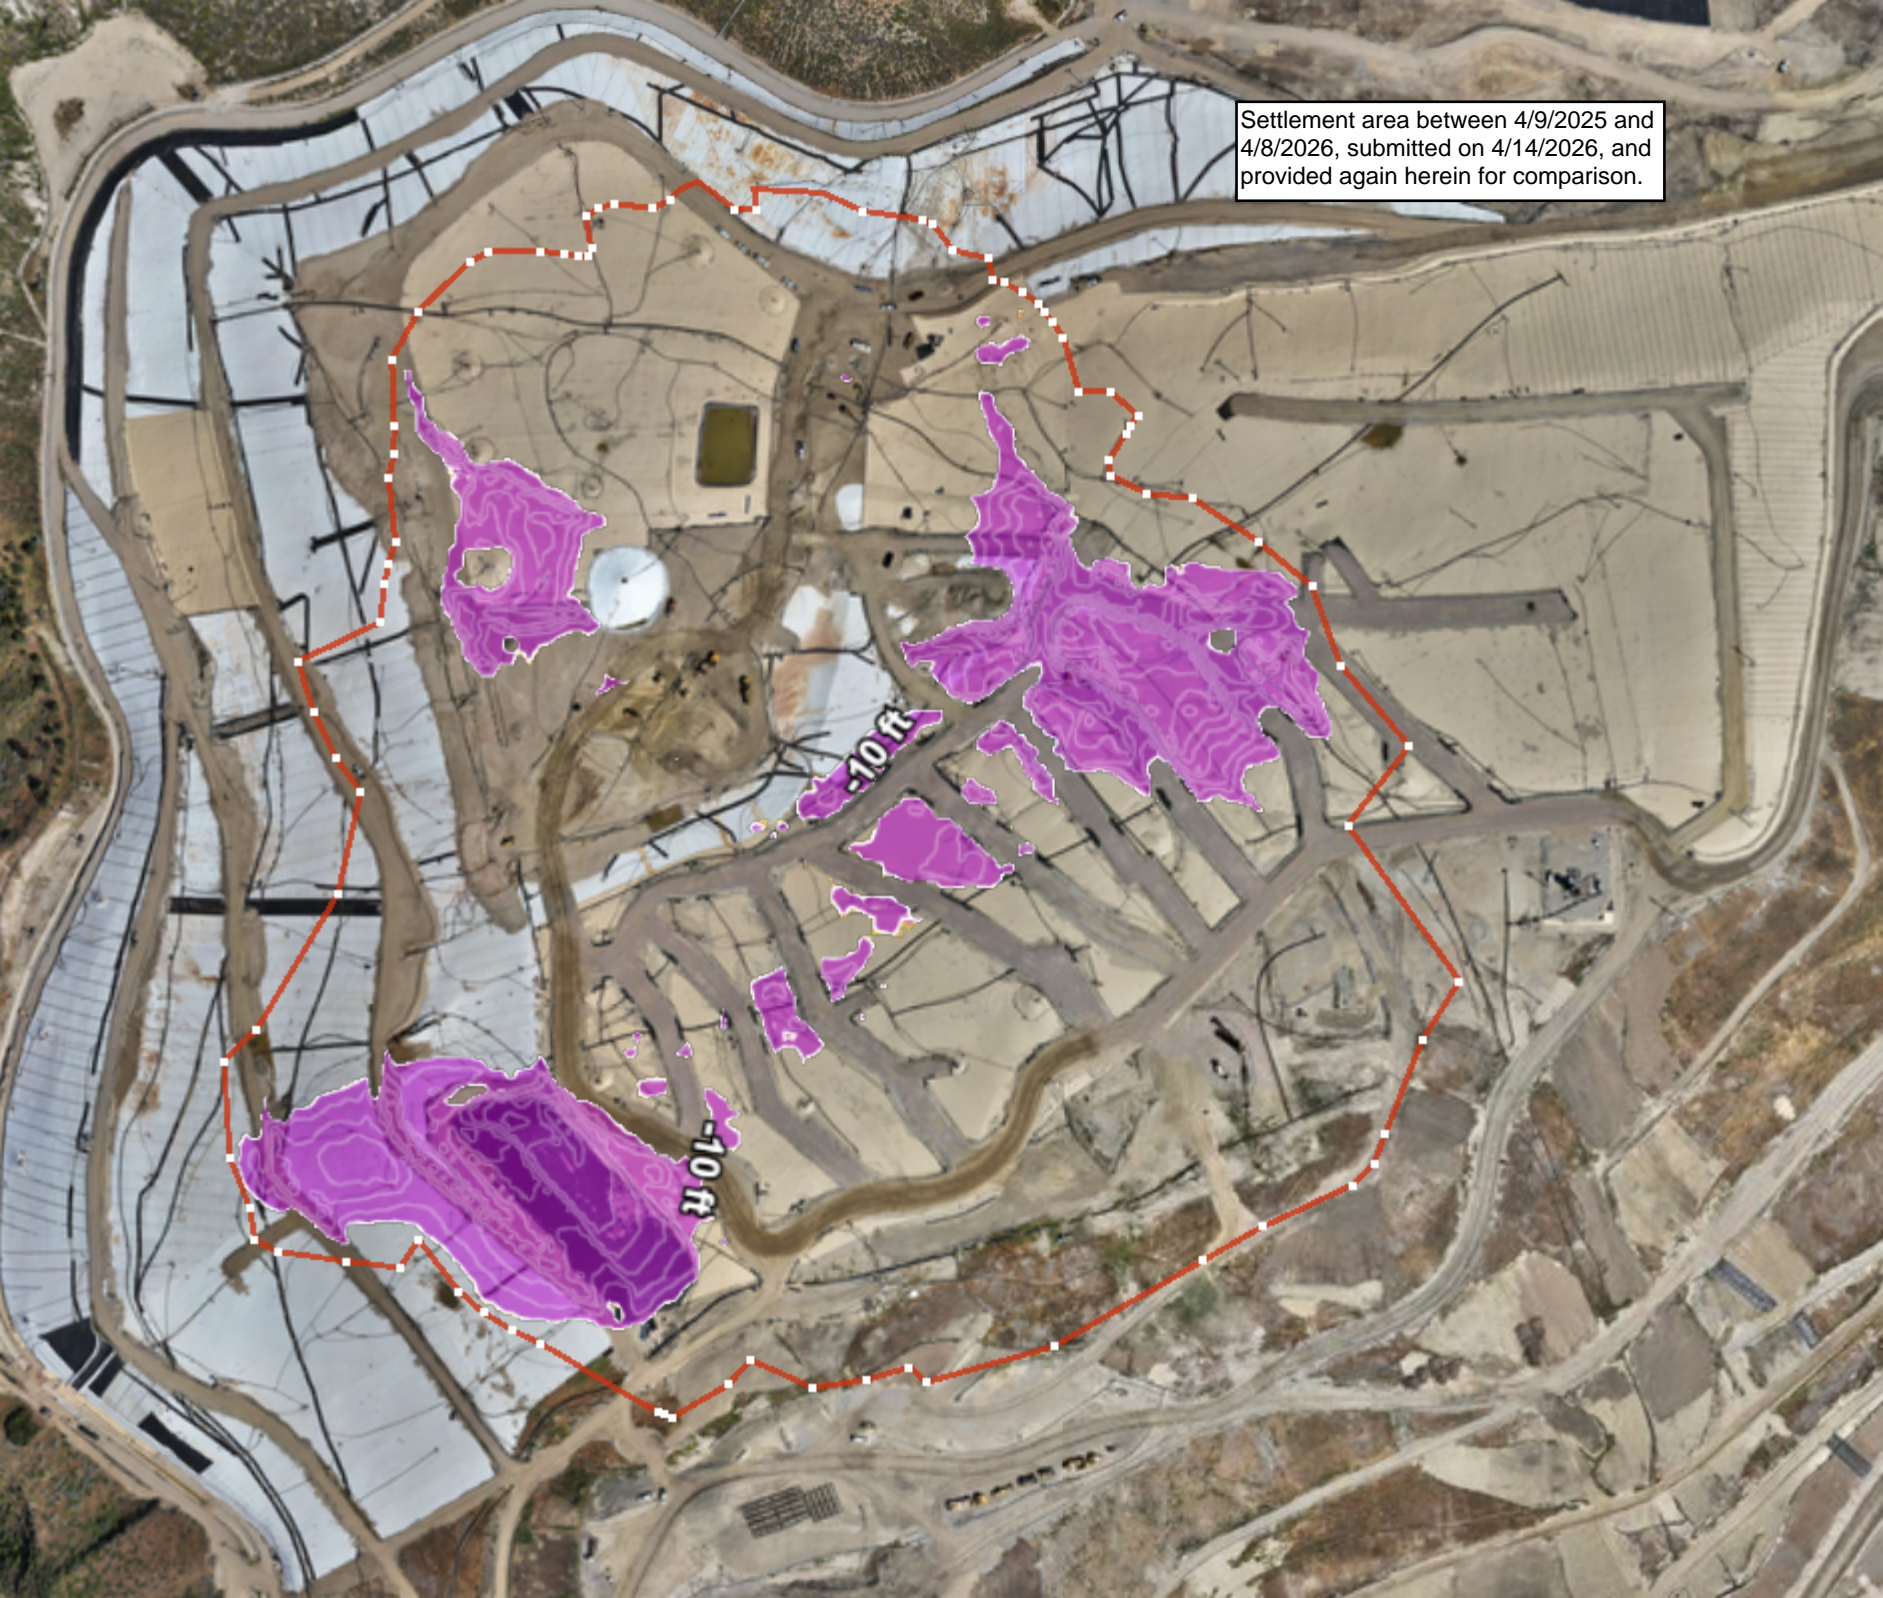
Settlement area between 4/9/2025 and 4/8/2026, submitted on 4/14/2026, and provided again herein for comparison.

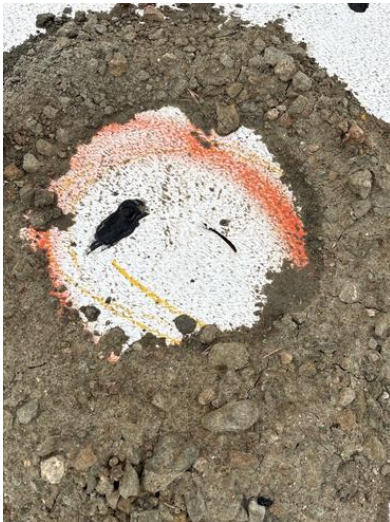
Photo 1

Tear in liner needs to be patched and extrusion welded.

Tear was covered with soil and sandbagged upon discovery; tape could not be applied as liner was wet. Permanent repairs were conducted; liner was then patched and extrusion welded

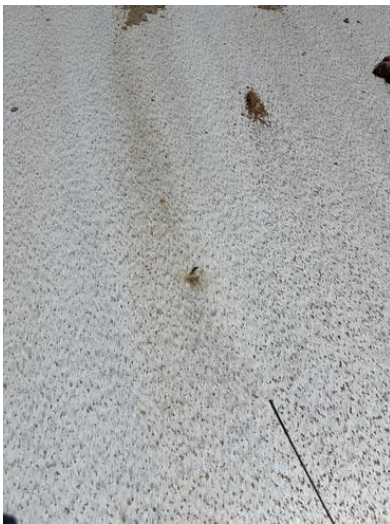
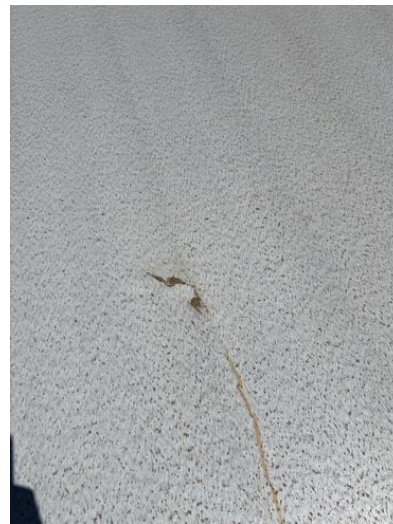
Two tears in close proximity to each other need to be patched/extrusion welded.

Tears taped upon discovery.
Permanent repairs were
conducted; liner was patched and
extrusion welded

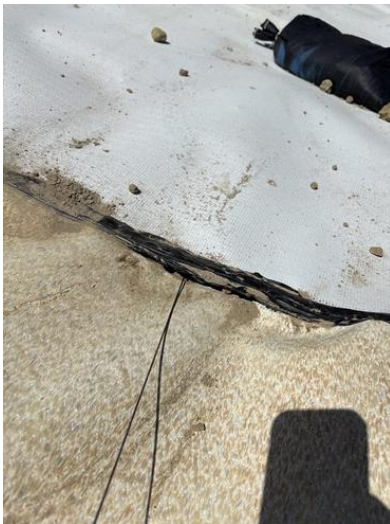
Photo 7

Tear at weld on liner needs to be extrusion welded.

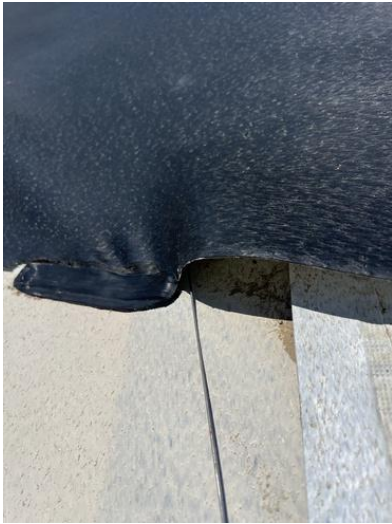
Photo 10

Small tear in liner needs to be patched/extrusion welded.

Tear taped upon discovery. Permanent repairs were conducted; rub pad was removed and tear was patched and extrusion welded
