Re: Chiquita Canyon, LLC's Weekly Leachate Inspection Report for Stipulated Order for Abatement (Case No. 6177-4), Condition 27(c)

Attachment: Leachate Inspection Logs from April 27 – May 3, 2026

4050 - Chiquita Leachate Seep/Pooling Inspection

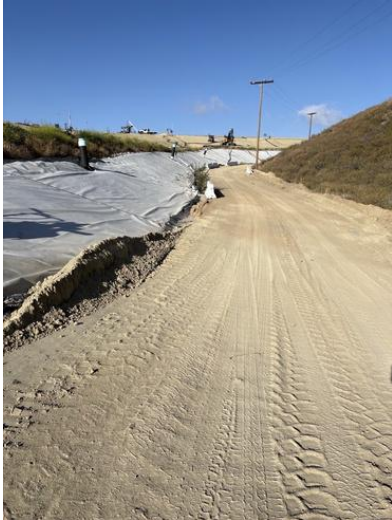
Photo 1

North side perimeter road. None of the seeps that occurred in the area of the west side perimeter road were observed at the time of this inspection. That area continues to be monitored and vacuumed out as needed to prevent pooling.

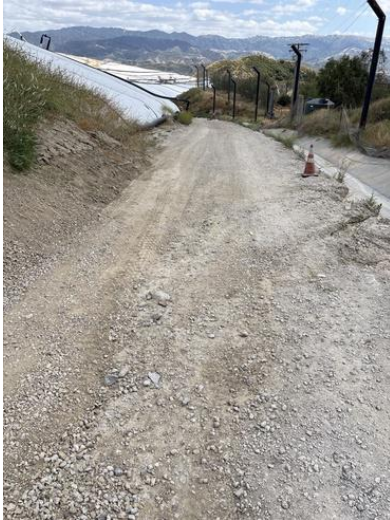
Photo 1

West side perimeter road. None of the seeps that occurred in this area were observed at the time of this inspection. Area continues to be monitored and vacuumed out as needed to prevent pooling.

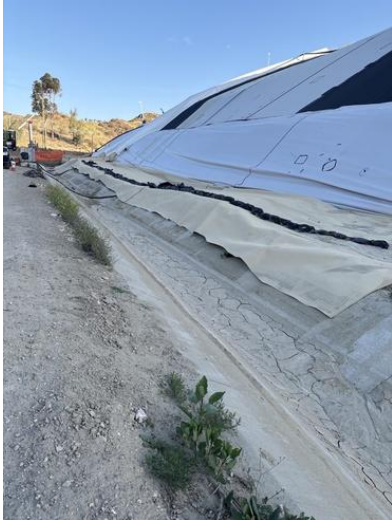
Photo 1

West side perimeter road. None of the seeps that occurred in this area were observed at the time of this inspection. Area continues to be monitored and vacuumed out as needed to prevent pooling

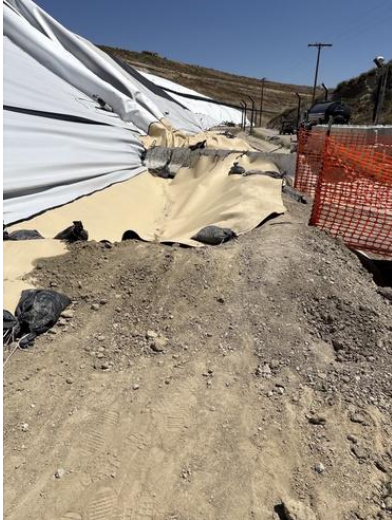
Photo 1

West side perimeter road. None of the seeps that occurred in this area were observed at the time of this inspection. Area continues to be monitored and vacuumed out as needed to prevent pooling

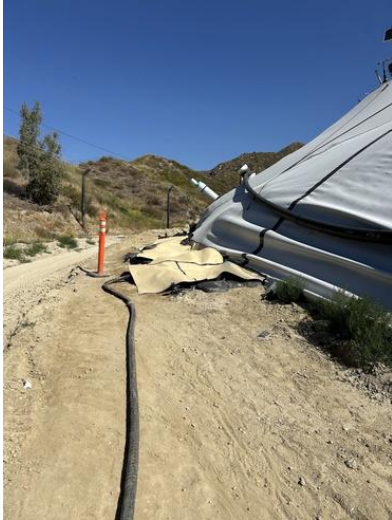
Photo 1

Westside perimeter road. None of the seeps that occurred in this area were observed at the time of this inspection. Area continues to be monitored and vacuumed out as needed to prevent pooling.

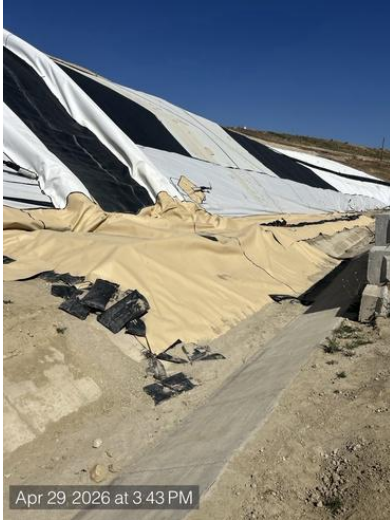
Photo 1

Westside perimeter road. None of the seeps that occurred in this area were observed at the time of this inspection. Area continues to be monitored and vacuumed out as needed to prevent pooling.

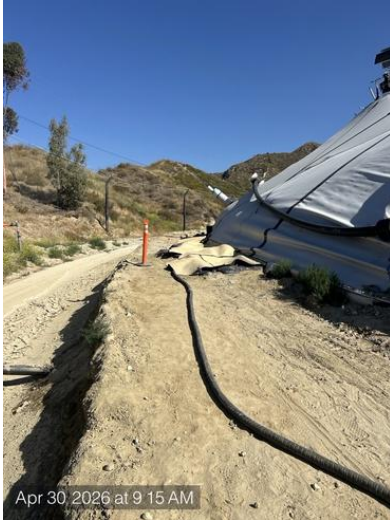
Photo 1

Westside perimeter road. None of the seeps that occurred in this area were observed at the time of this inspection. Area continues to be monitored and vacuumed out as needed to prevent pooling.

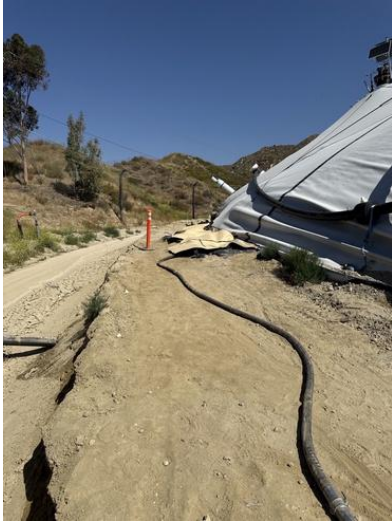
Photo 1

Westside perimeter road. None of the seeps that occurred in this area were observed at the time of this inspection. Area continues to be monitored and vacuumed out as needed to prevent pooling.

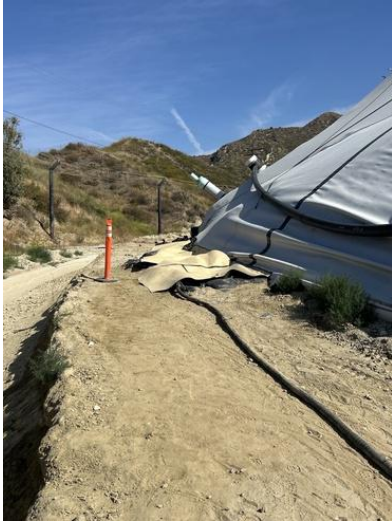
Photo 1

Westside perimeter road. None of the seeps that occurred in this area were observed at the time of this inspection. Area continues to be monitored and vacuumed out as needed to prevent pooling.

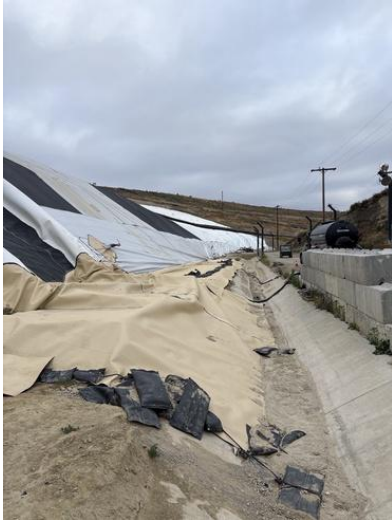
Photo 1

Westside perimeter road. None of the seeps that occurred in this area were observed at the time of this inspection. Area continues to be monitored and vacuumed out as needed to prevent pooling.

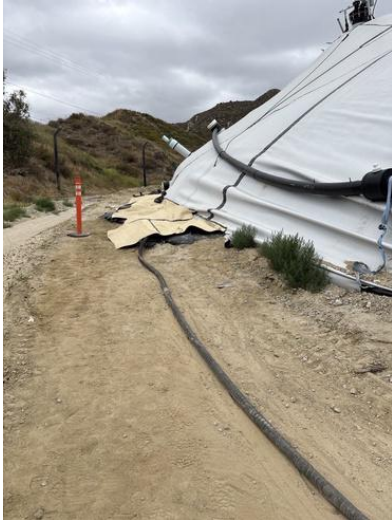
Photo 1

Westside perimeter road. None of the seeps that occurred in this area were observed at the time of this inspection. Area continues to be monitored and vacuumed out as needed to prevent pooling.
